## MEETING AGENDA & PUBLIC HEARING NOTICE

City Council

Wednesday, July 24, 2024

Subject: Inspection report regarding current structural condition of the Legion Hall Building at 311 Deschutes Avenue in Maupin, Oregon

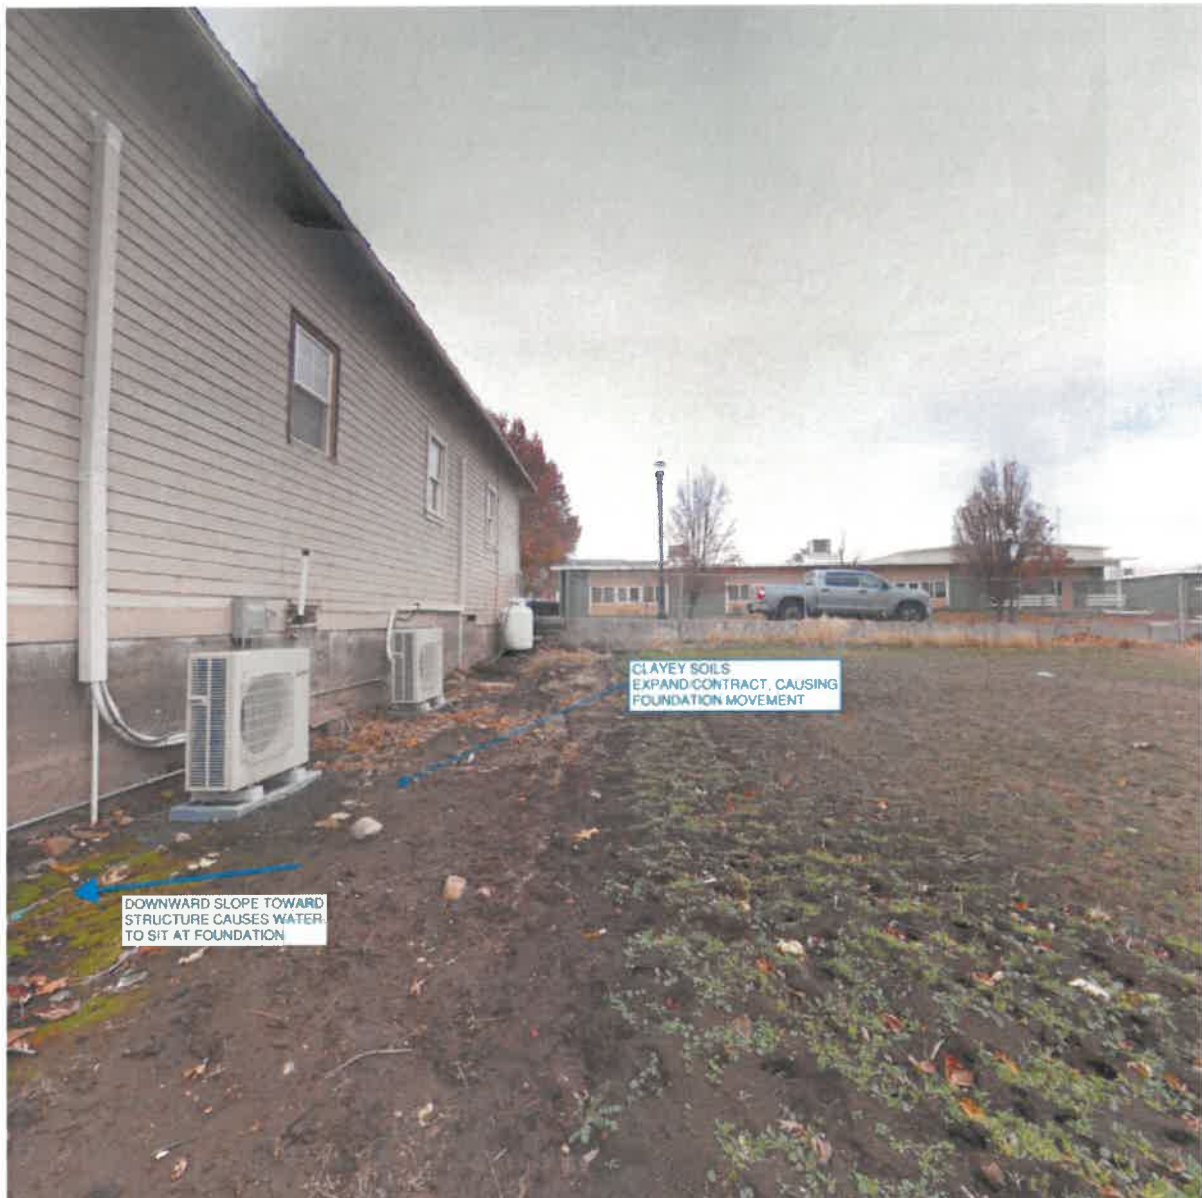
The exterior of the structure raised concerns regarding grading and water control, particularly on the east side (see Figure 1). The east roof gutters were dripping at the time of the inspection despite no rain in the past two days. Due to the poor grading on this side, the water from the gutters is unable to move away from the structure, and may even be leading to the foundation in some locations. This in conjunction with clayey soils identified at this area, which may expand and contract with wetting and drying cycles, make the foundation vulnerable to degradation due to moisture. Excessive water and movement of a foundation can create vertical cracks, which were identified at this inspection and in previous reports (see Figure 2 and Figure 3). **To improve the longevity of the structure, it is recommended to repair and/or replace the roof gutter system, provide a connection to an approved point of discharge, and regrade around the structure to ensure moisture is not flowing towards the foundation.**

**FIGURE 1: GRADING AT EAST SIDE OF STRUCTURE ATTRACTS WATER TO THE FOUNDATION, WHICH CAN CREATE VERTICAL CRACKS (FACING NORTH)**

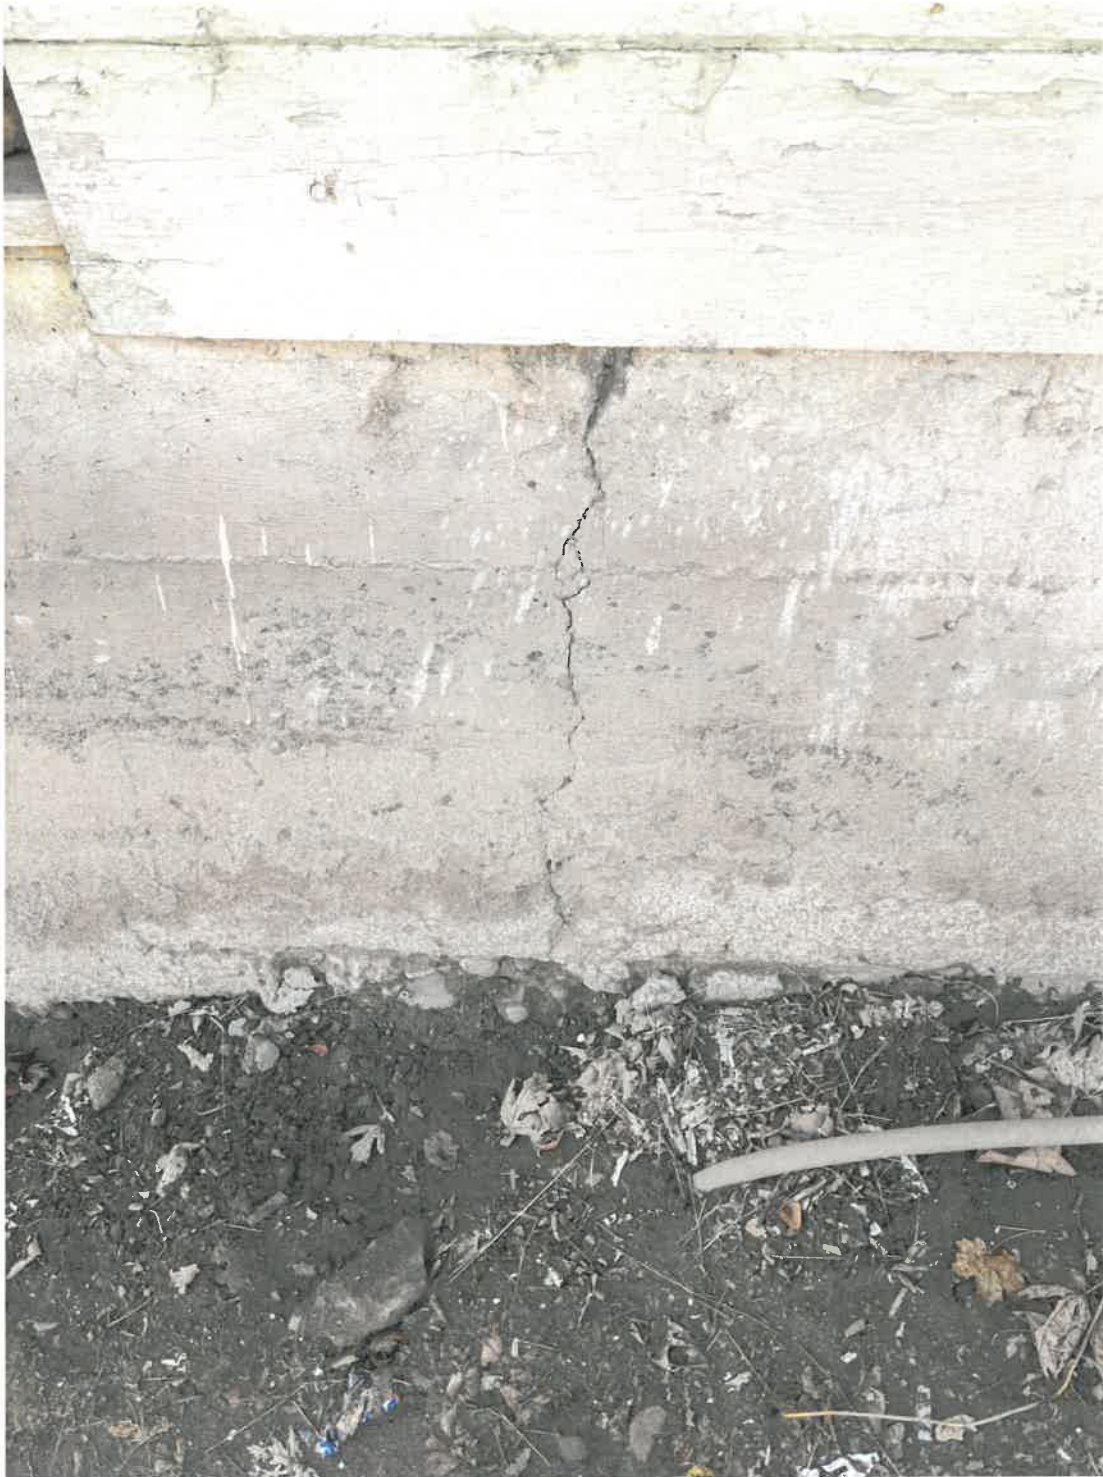
The existing foundation of the original structure is a plain (unreinforced) concrete stem wall. The concrete stem wall is six inches in thickness, and extends about three feet above finished grade and one foot below grade at the east side before the addition foundation. Although, this may widen somewhat, we did not find a footing under the stemwall. As previously mentioned, this side of the foundation has been affected by moisture that has caused expansion of the soils, and therefore some vertical cracking has appeared as a result (see Figure 2 and Figure 3).

**FIGURE 2: VERTICAL FOUNDATION CRACK AT EAST SIDE OF STRUCTURE FOUNDATION, LIKELY CAUSED BY EXPANSION AND CONTRACTION OF THE CLAYEY SOILS DUE TO PRESENCE OF WATER.**

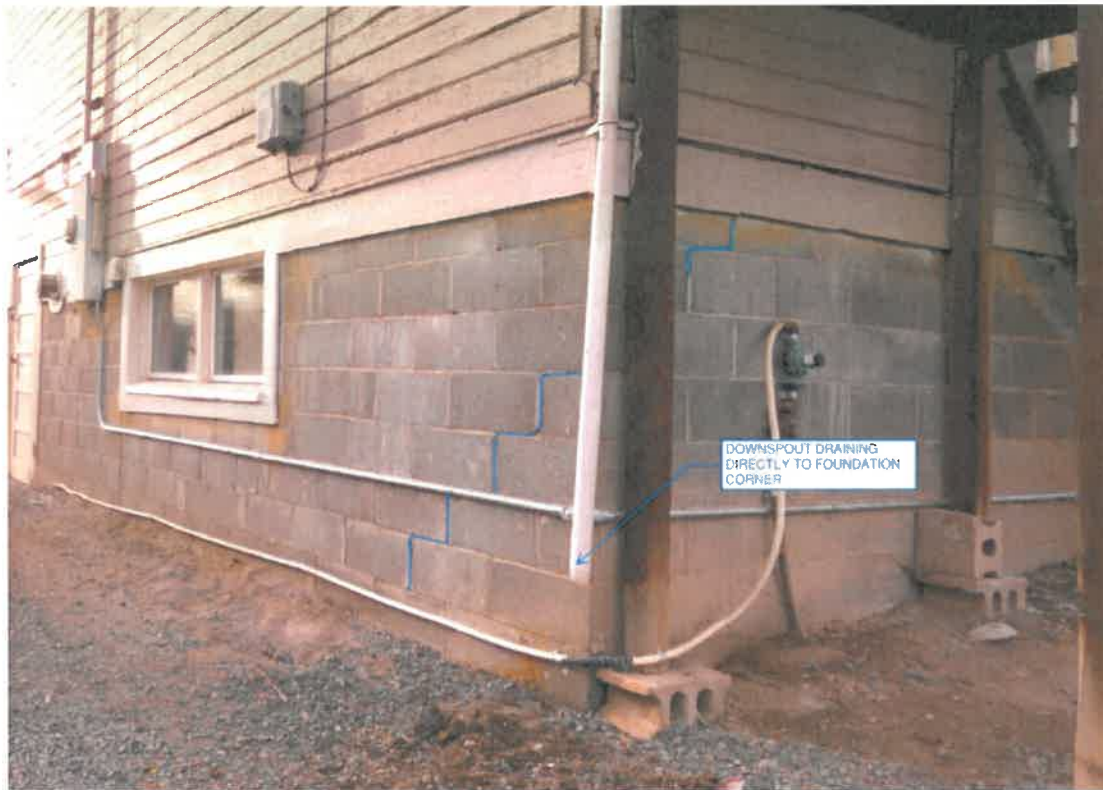
Similarly, the existing gutter and downspout system is draining to undesirable locations. At the southeast corner of the building, a downspout is draining directly to a corner of the foundation (see Figure 4). The high volume of water at this location is causing significant soil movement, and subsequent foundation movement, identified through stepped cracking in the CMU foundation wall (see Figure 4). The stepped cracking was largest near the top of the foundation wall (approximately 0.11 inches), and smaller near the base of it (approximately 0.06 inches), which is common at cracking caused by soil expansion. **Again, it is recommended to repair and/or replace the roof gutter system, with particular attention to where water drains, ensuring it is not to the foundation.**

The south side of the structure is the costume room addition, which is a CMU stem wall that extends approximately five feet above finished grade. Some cracking was identified in this portion of the foundation which was mentioned previously (see Figure 4), but otherwise no major concerns were identified.

**FIGURE 4: SOUTHEAST BUILDING CORNER (FACING NORTHWEST) SHOWING CRACKING DUE TO FOUNDATION MOVEMENT CAUSED BY MOISTURE FROM DOWNSPOUT.**

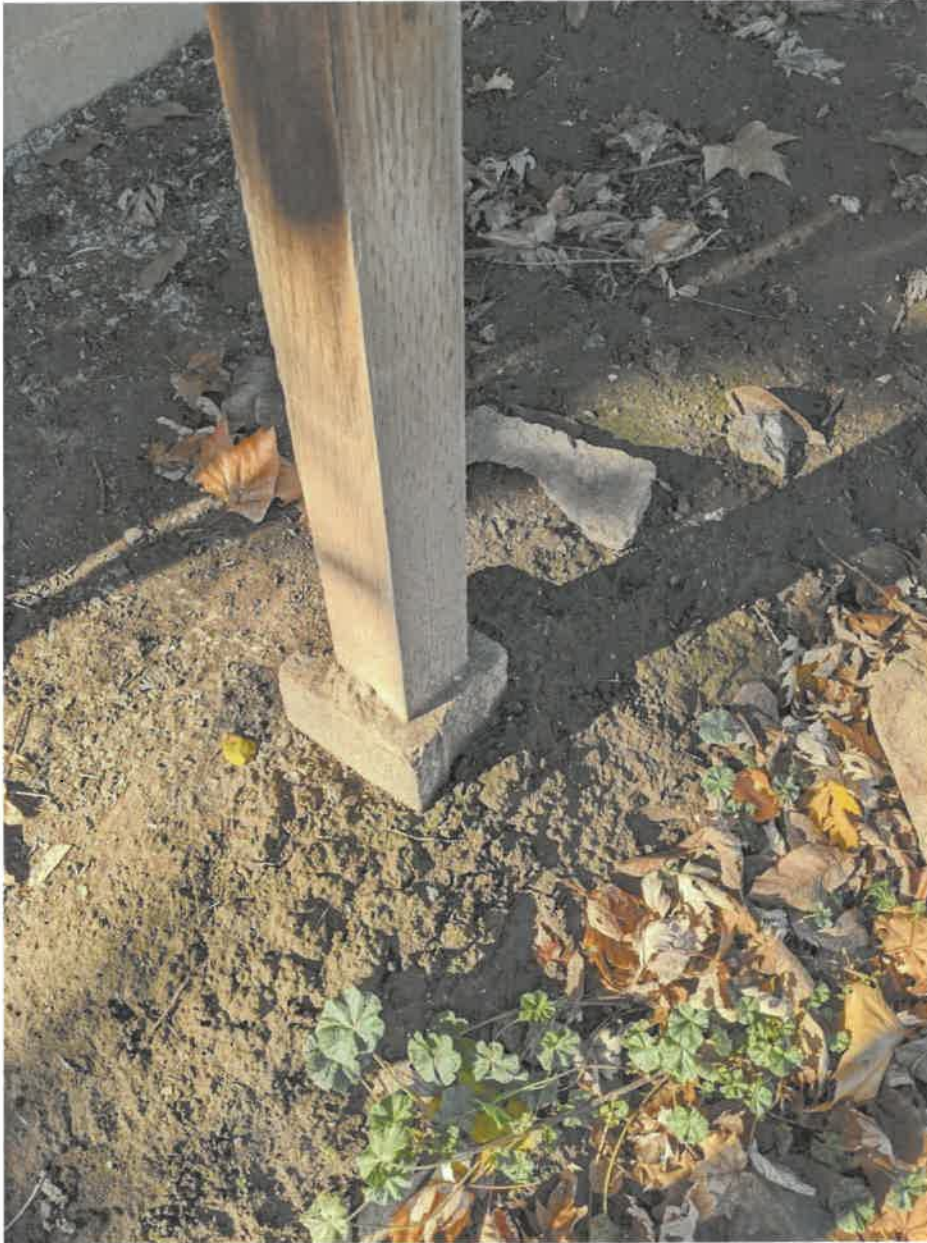
FIGURE 5: A PRESSURE-TREATED 4X4 POST AT THE SOUTHEAST STAIRWELL SERVING THE 1940S COSTUME ROOM ADDITION, SITTING UNCONNECTED TO A CMU BLOCK FOOTING. THIS CONDITION IS CONSIDERED UNSAFE.

capacity to restrain a person falling, and it is unlikely that the railing in its current condition has this capacity (see Figure 7). For these reasons, **the stairwell from the east side of the structure to the costume room is deemed unsafe and is not recommended to be used. It is suggested that the owner replace the stairwell to meet current standards, or consult with an architect if the egress location is desired to be removed entirely.**

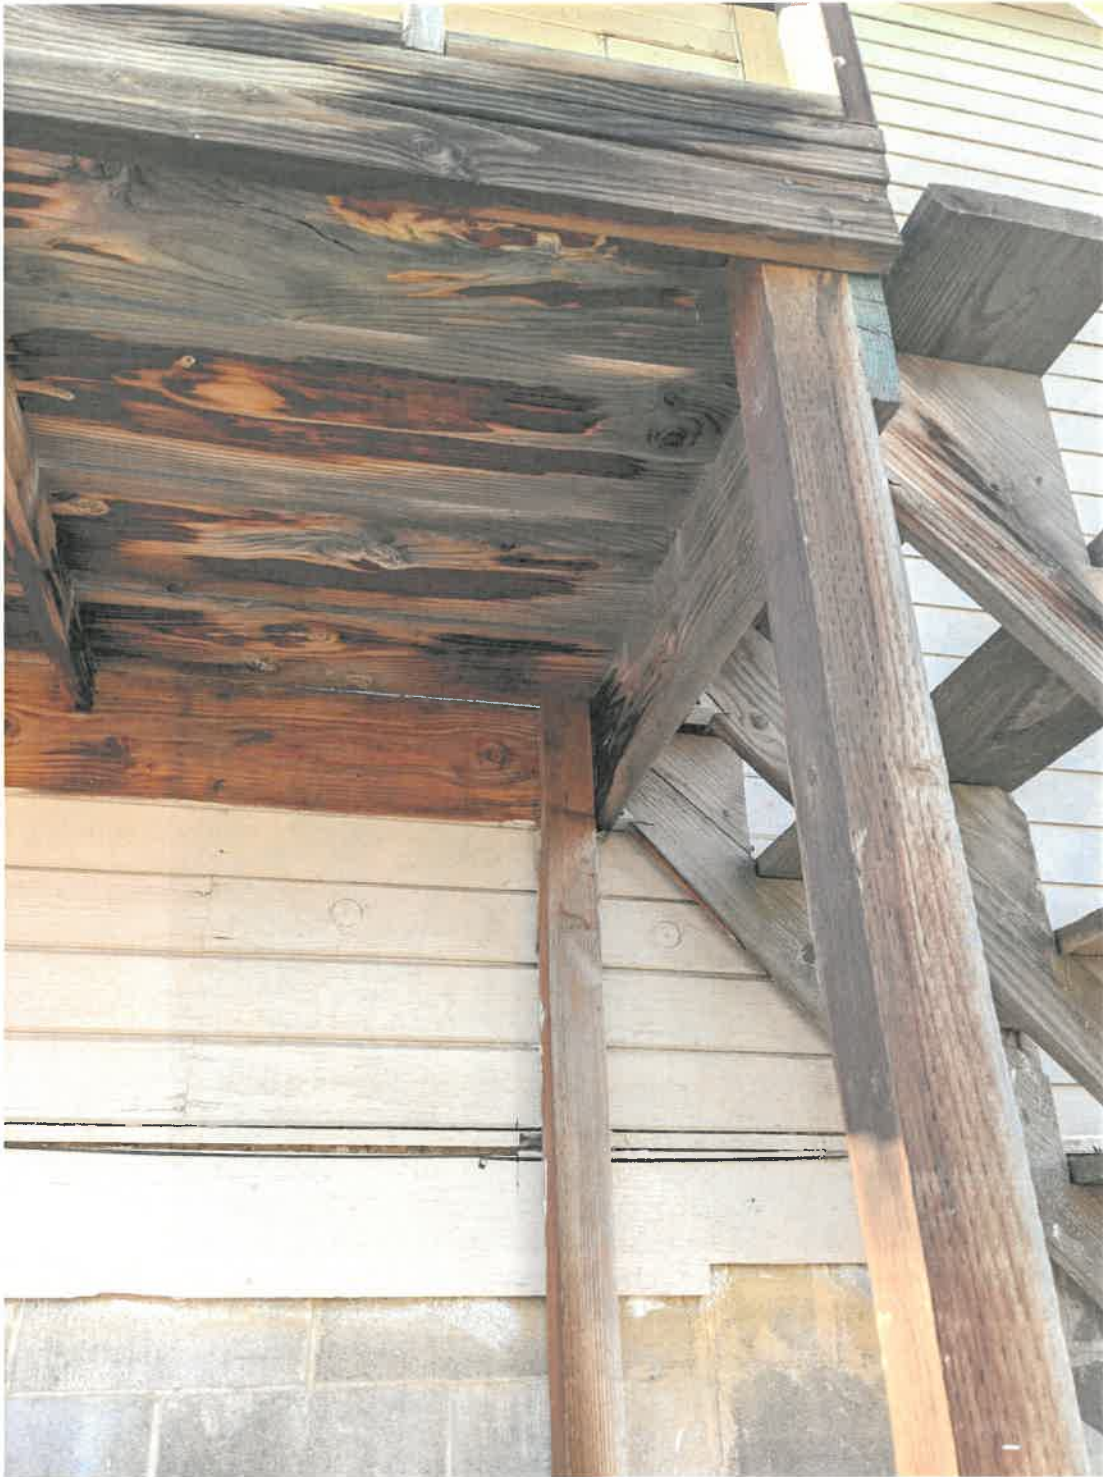
On the east side of the structure, there are two wooden staircases. One stairwell leads to the costume room, while the other leads to the main hall. The stairwell at the southeast (leading to the costume room) is approximately seven feet in height with eight stairs. The stairwell was constructed without a connection to the footings, and the footings themselves are hollow CMU blocks (see Figure 5). Without adequate connections or footings, this stairwell has limited capacity and does not meet current codes. Furthermore, this stairwell shows signs of impending moisture damage (see Figure 6). Lastly, current codes require stairwell railings to have the

**FIGURE 6: MOISTURE DAMAGE AT THE SOUTHEAST EXTERIOR STAIRWELL IS LIKELY TO LEAD TO DECAY AND ROT. THE POST CONNECTION TO BEAMS IS INADEQUATE FOR THE REQUIRED LOADING AND DOES NOT MEET CURRENT CODE REQUIREMENTS.**

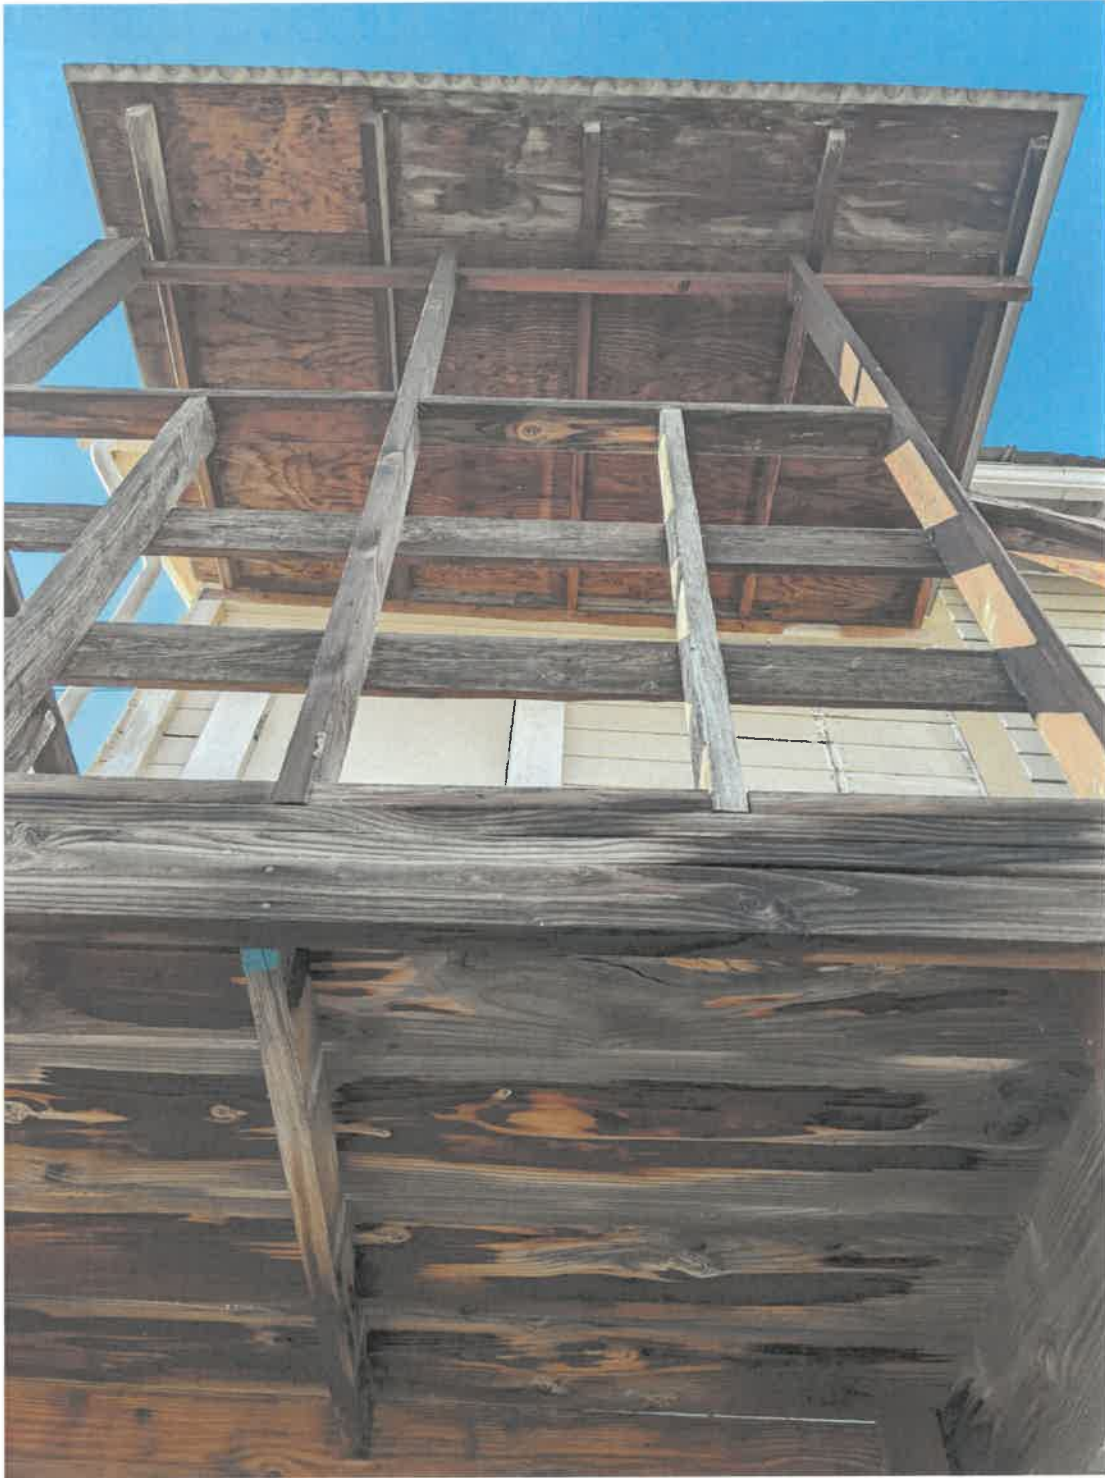
FIGURE 7: THE RAILING SYSTEM AT THE SOUTHEAST STAIRWELL DOES NOT MEET CURRENT CODE REQUIREMENTS.

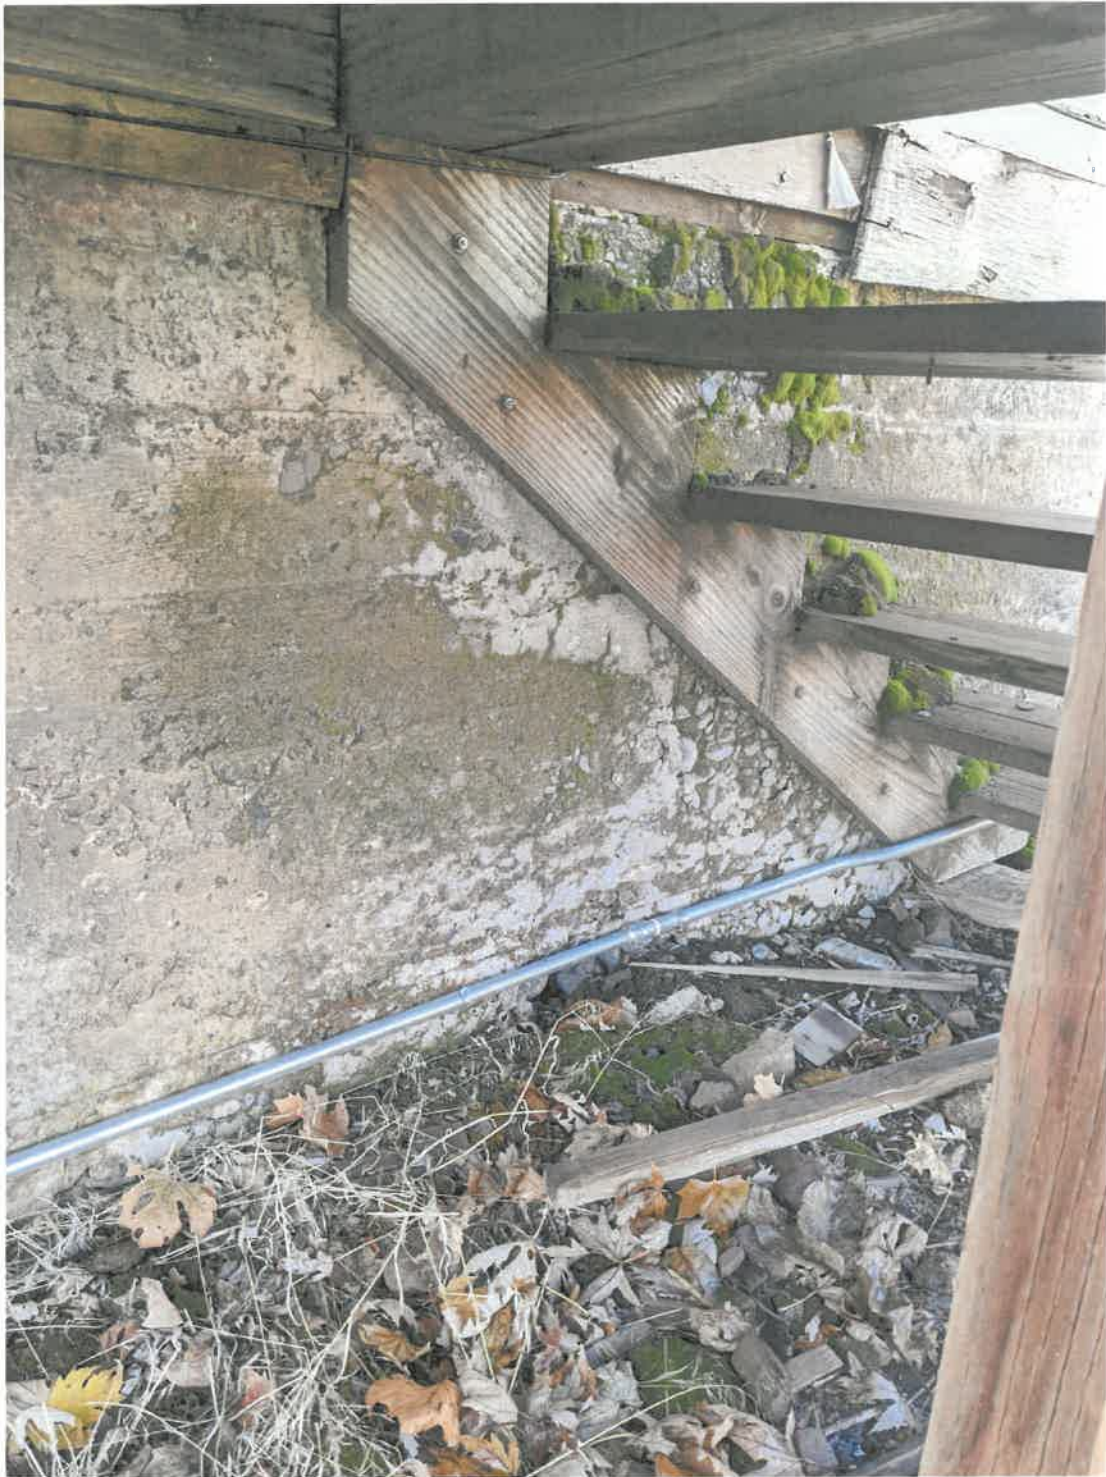
The shorter stairwell to the main hall is approximately four feet in height with seven stairs. Plant growth at the stairwell suggests consistent moisture presence (see Figure 8), which can lead to wood decay and rot. The current stairwell has footings and steel connections, but the railing again does not meet current standards to support a falling person (see Figure 9). Furthermore, the stairwell is attached to the main structure rim joist which is experiencing out-of-plane loading and may not be adequate for the existing condition. **If the building is renovated, it is recommended to replace this stairwell with one that meets current codes and is adequately protected against moisture.** We have not evaluated the capacity of the railing; however, it does not appear to be immediately unsafe.

FIGURE 8: PLANT GROWTH AT THE STAIRWELL SUGGESTS MOISTURE PRESENCE, WHICH CAN LEAD TO WOOD DECAY.

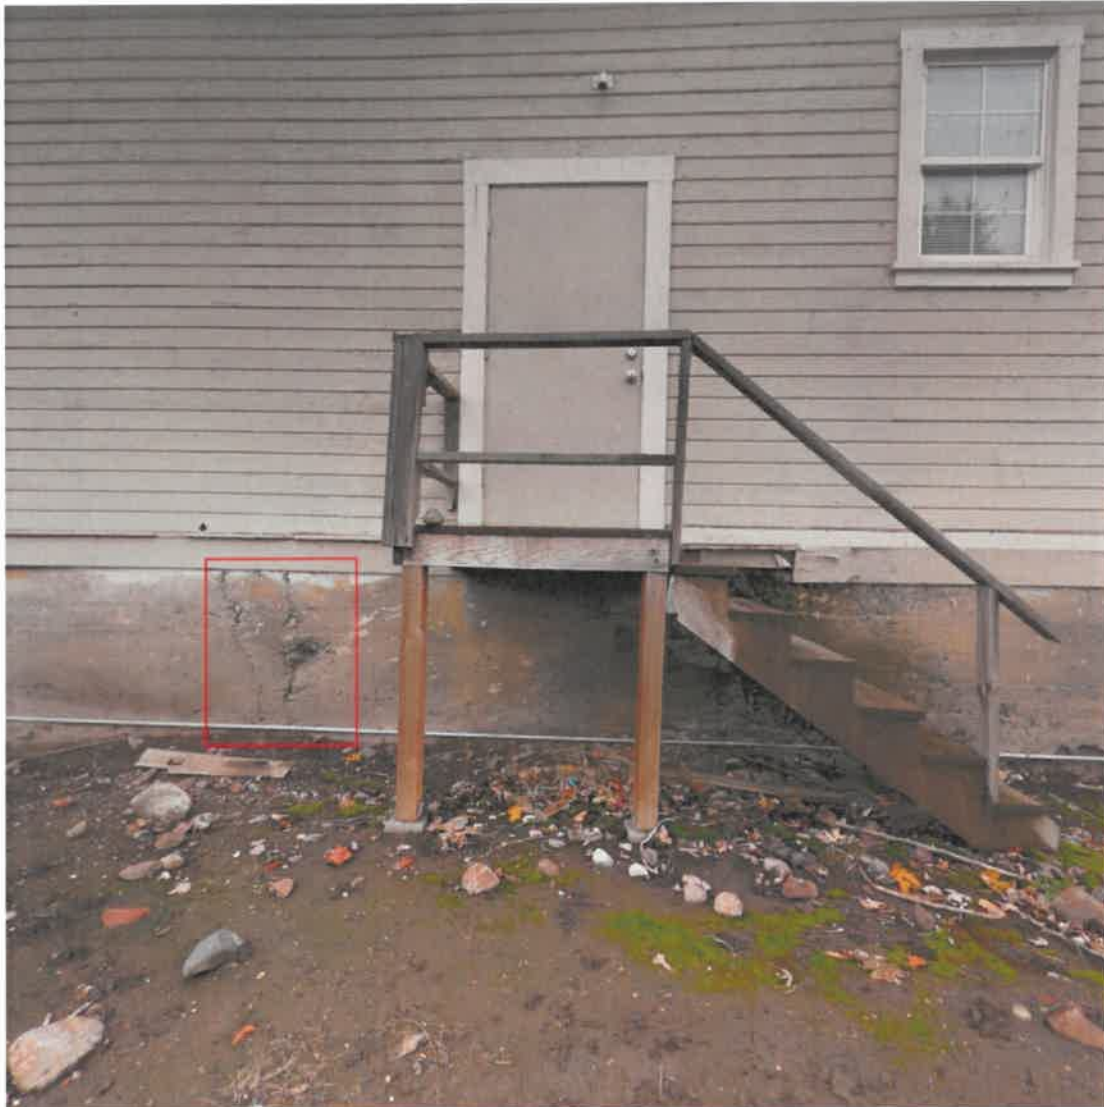
Additionally at the east side of the structure, it was evident that poor batches of concrete were used during construction, which has resulted in significant reduction in cement content and strength (see Figure 9 and Figure 10). **If a complete foundation replacement is not feasible, the minimum foundation repair we recommend at this location would be to seal vertical cracks with non-structural epoxy to avoid entry of moisture or pests into the crawlspace or basement. It is further recommended to remove moisture affecting the foundation at this location per aforementioned recommendations regarding grading and gutter repairs. Additionally, the owner should monitor crack sizes regularly to ensure cracks are not increasing in size. Nonetheless, it is recommended to fully replace the location of foundation where pour concrete was used. This would require the affected areas (approximately 5' – 10') to be sawcut, removed and repoured with a reinforced connection to the remaining foundation.**

FIGURE 9: STAIRWELL AT EAST SIDE OF STRUCTURE LEADING TO THE MAIN HALL THAT IS RECOMMENDED TO BE REPLACED. THE RED BOX LOCATES AN AREA WITH POOR CONCRETE, WHICH HAS CAUSED SIGNIFICANT LOSS OF CEMENT AND LOAD-CARRYING CAPACITY.

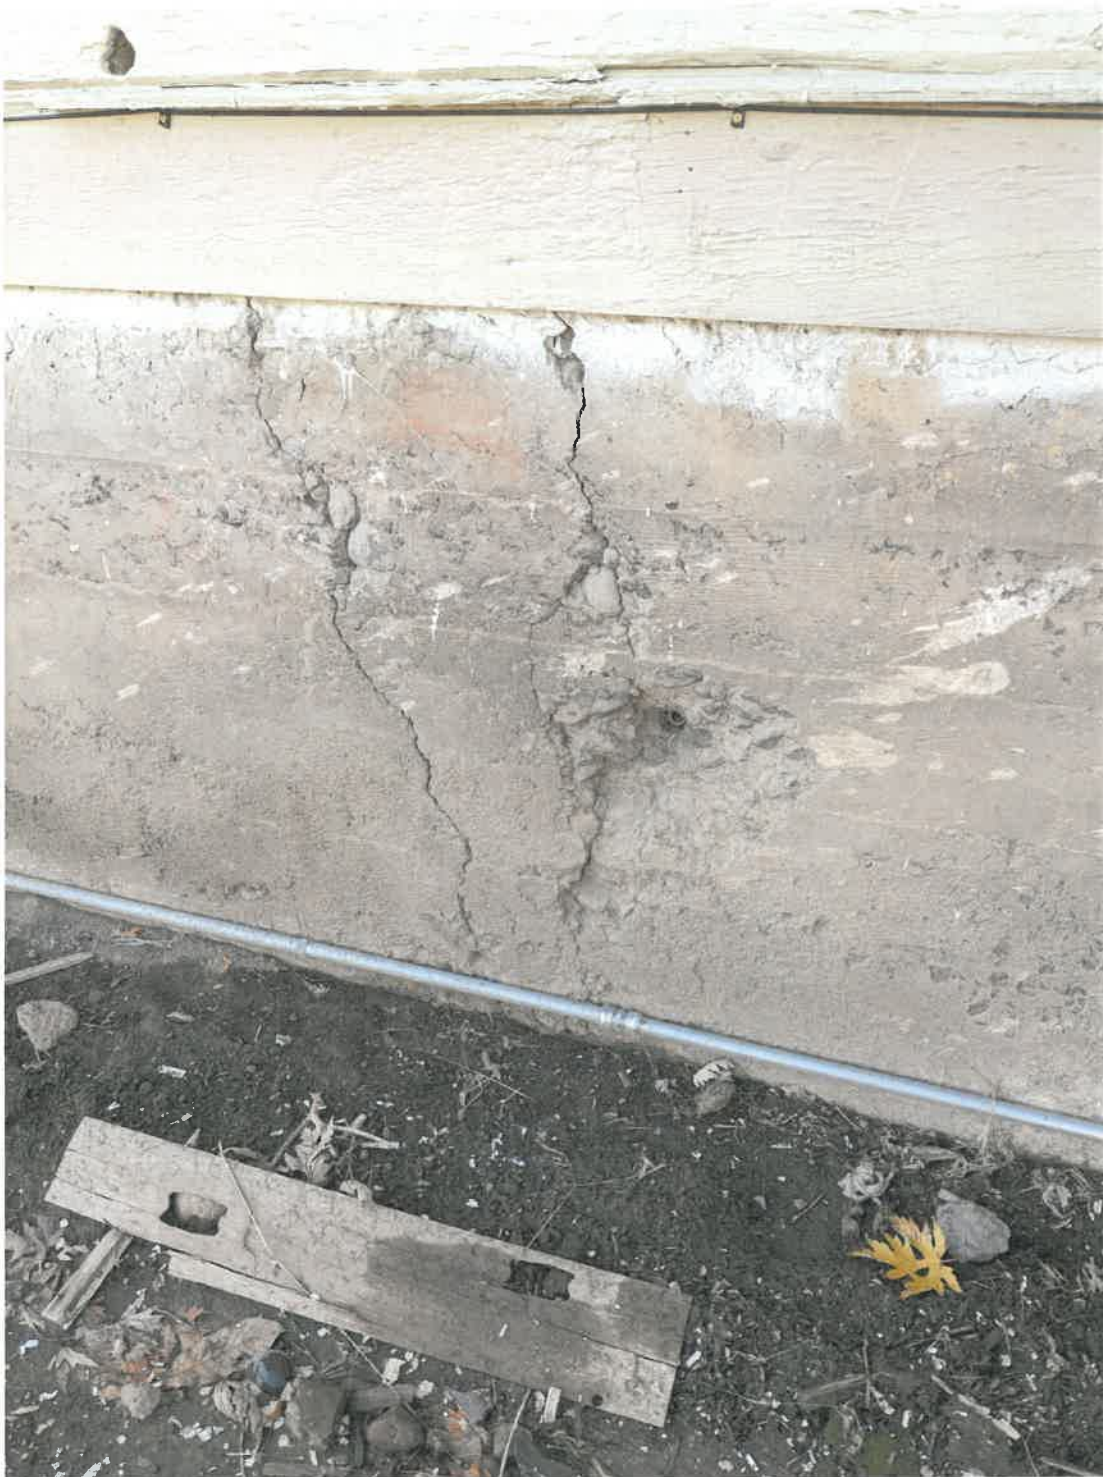
FIGURE 10: CLOSE UP AT POOR CONCRETE ON EAST SIDE OF STRUCTURE.

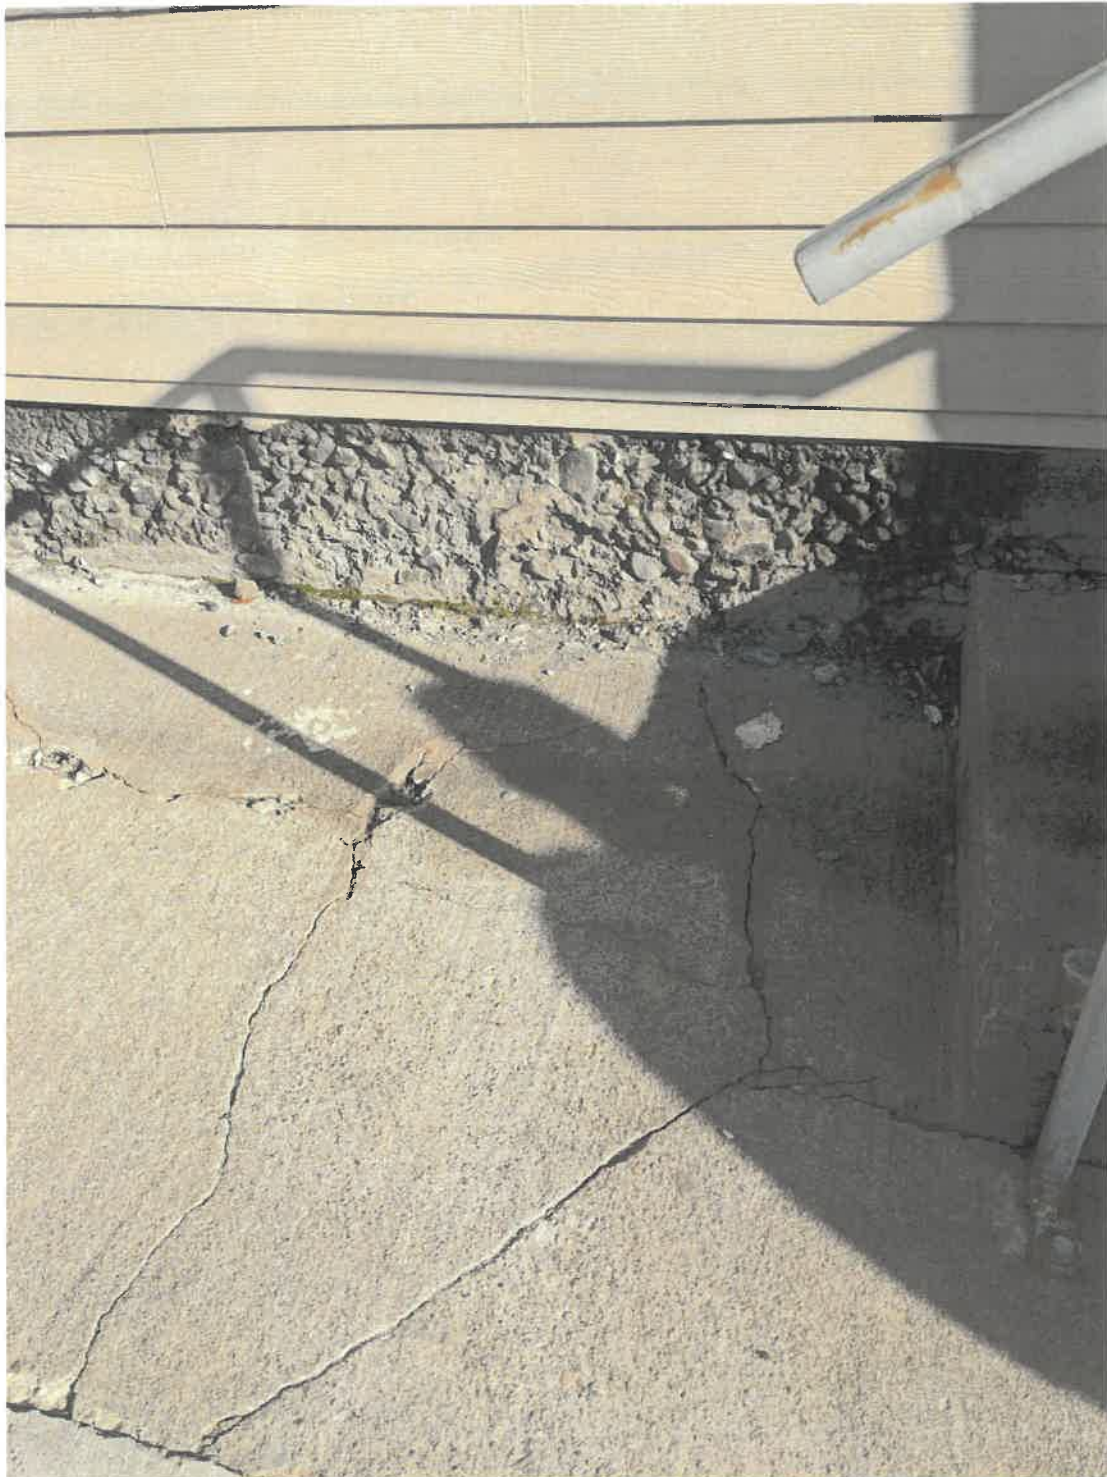
FIGURE 11: SCALING AND SPALLING AT FOUNDATION AT WEST SIDE OF STRUCTURE.

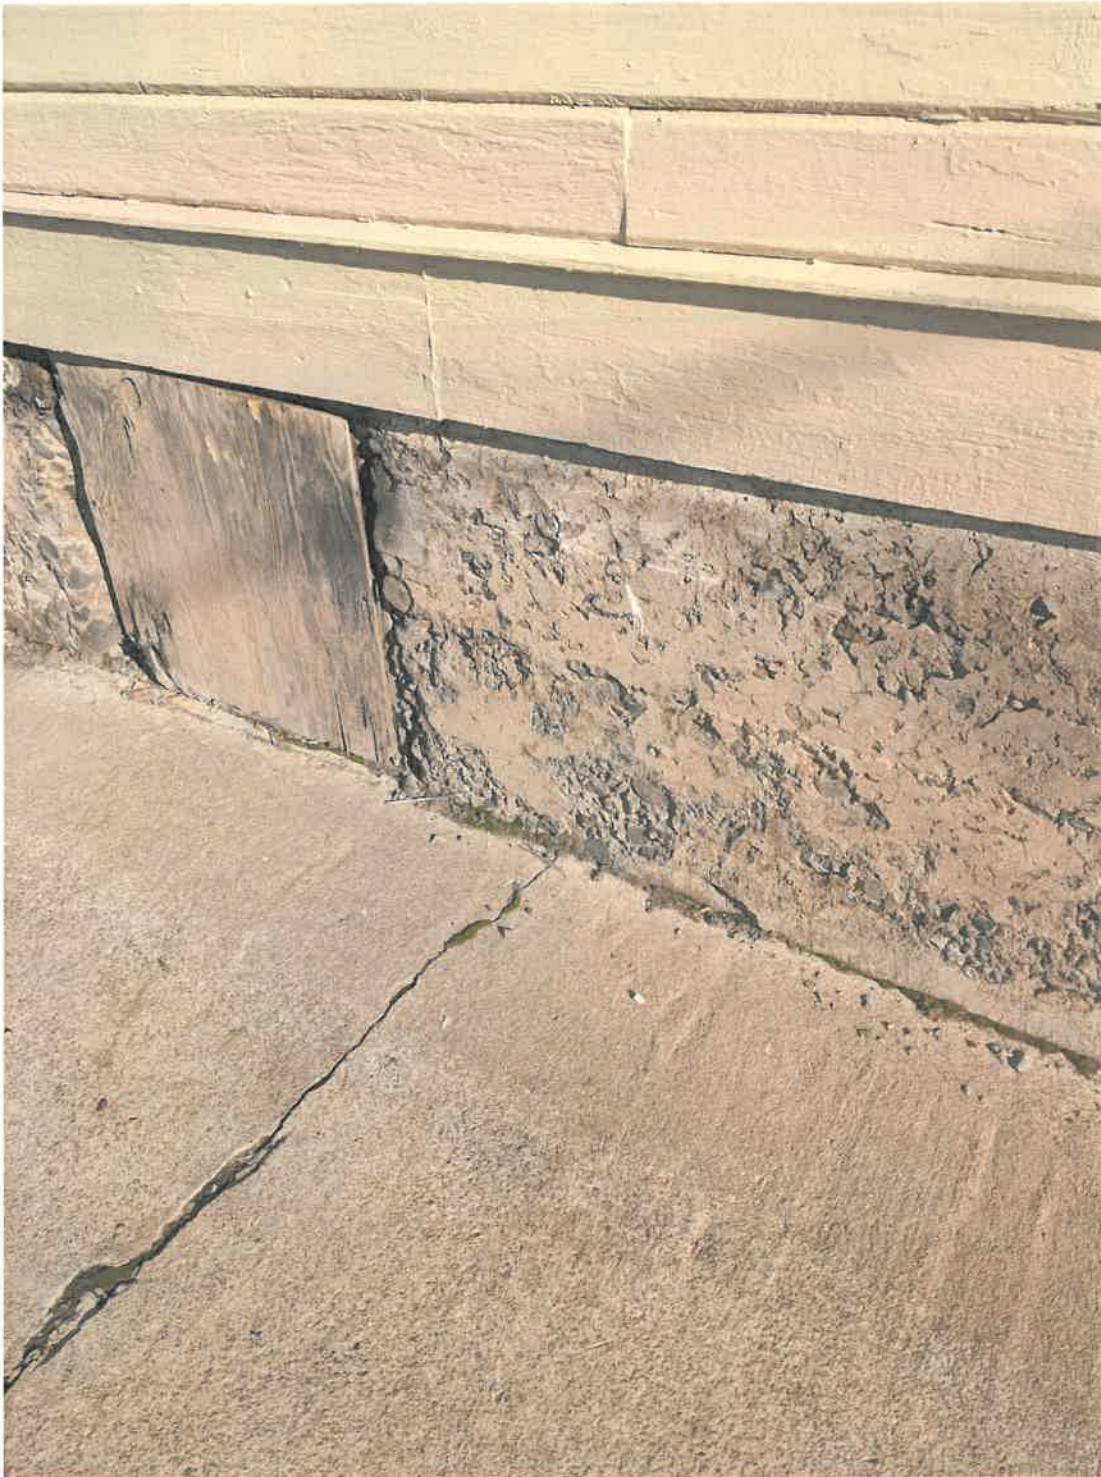
FIGURE 12: SCALING AND SPALLING AT FOUNDATION AT WEST SIDE OF STRUCTURE.

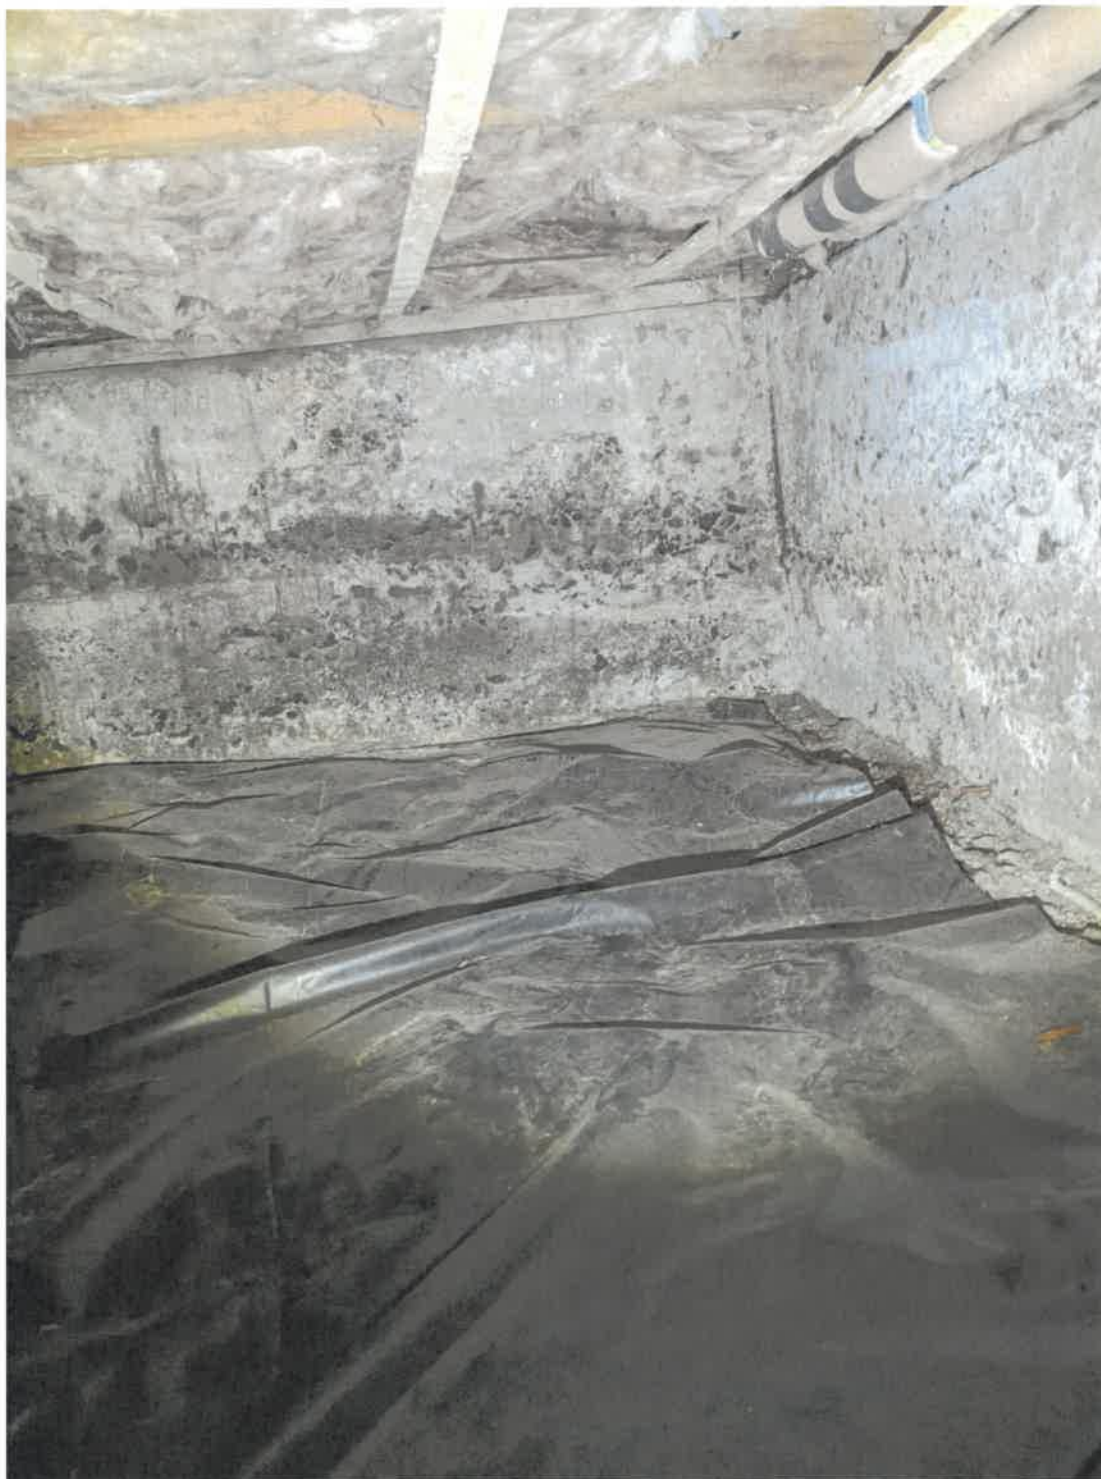
FIGURE 13: INTERIOR FOUNDATION WALL AT NORTHEAST BUILDING CORNER, SHOWING SPALLING AT NORTH END.

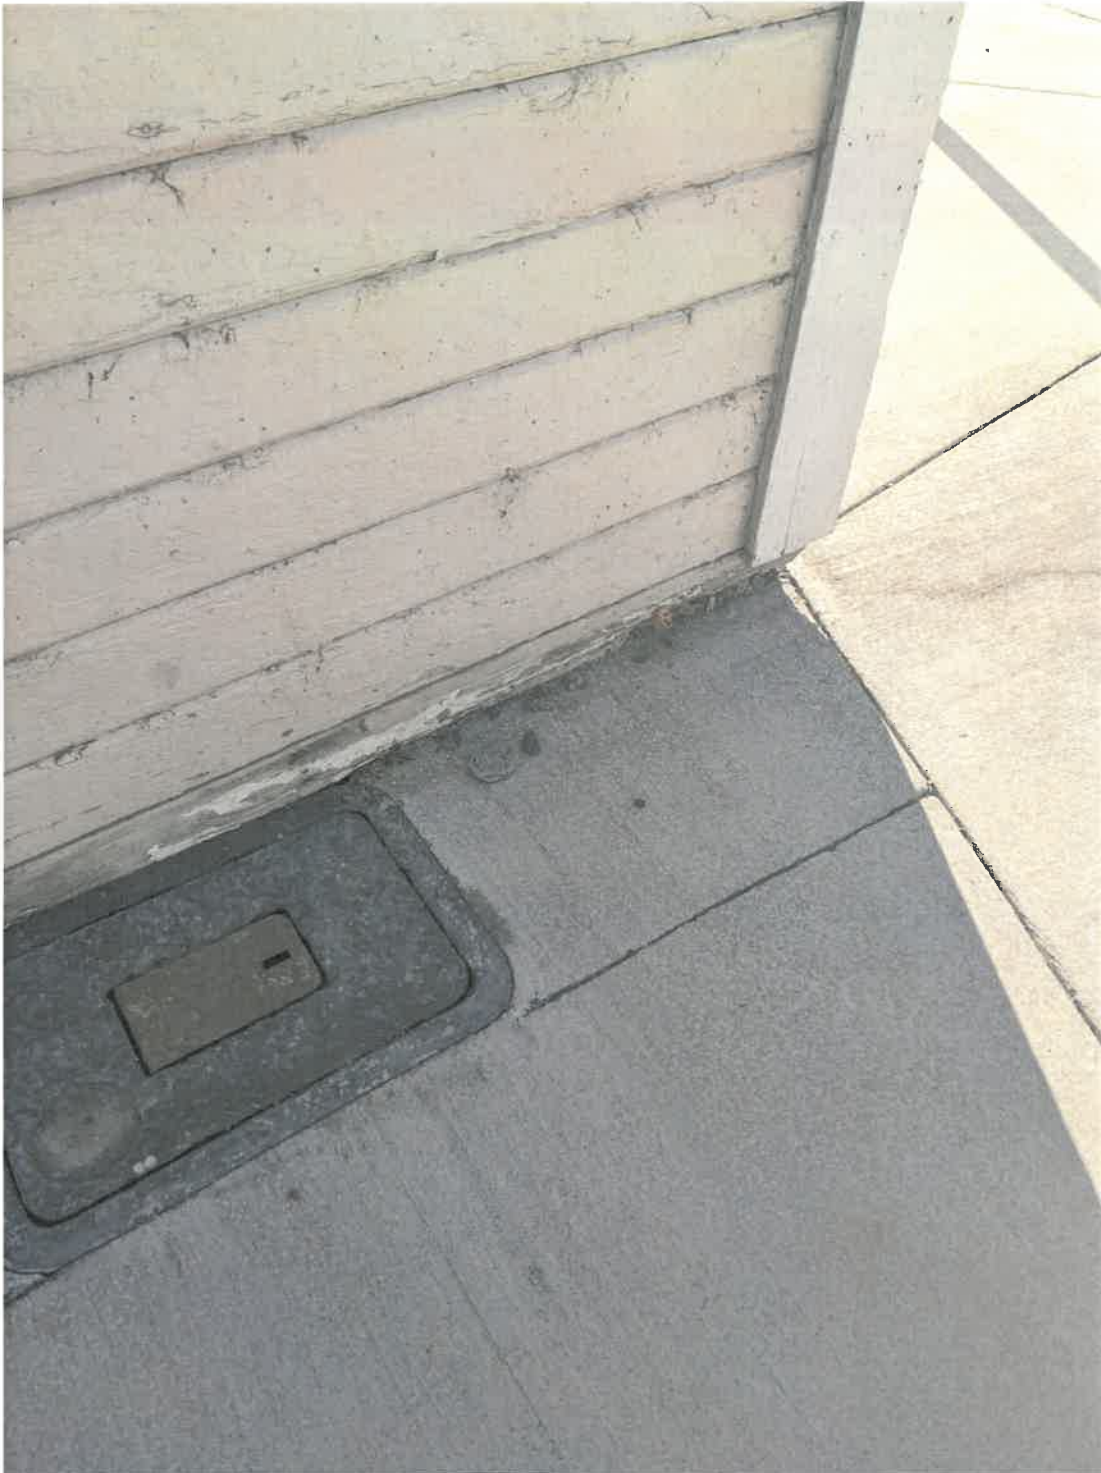
**FIGURE 14: ROTTING FINISH WOOD AT NORTHWEST CORNER OF STRUCTURE, ASSUMED TO BE CAUSED BY EXPOSURE FROM MOISTURE IN CONCRETE.**

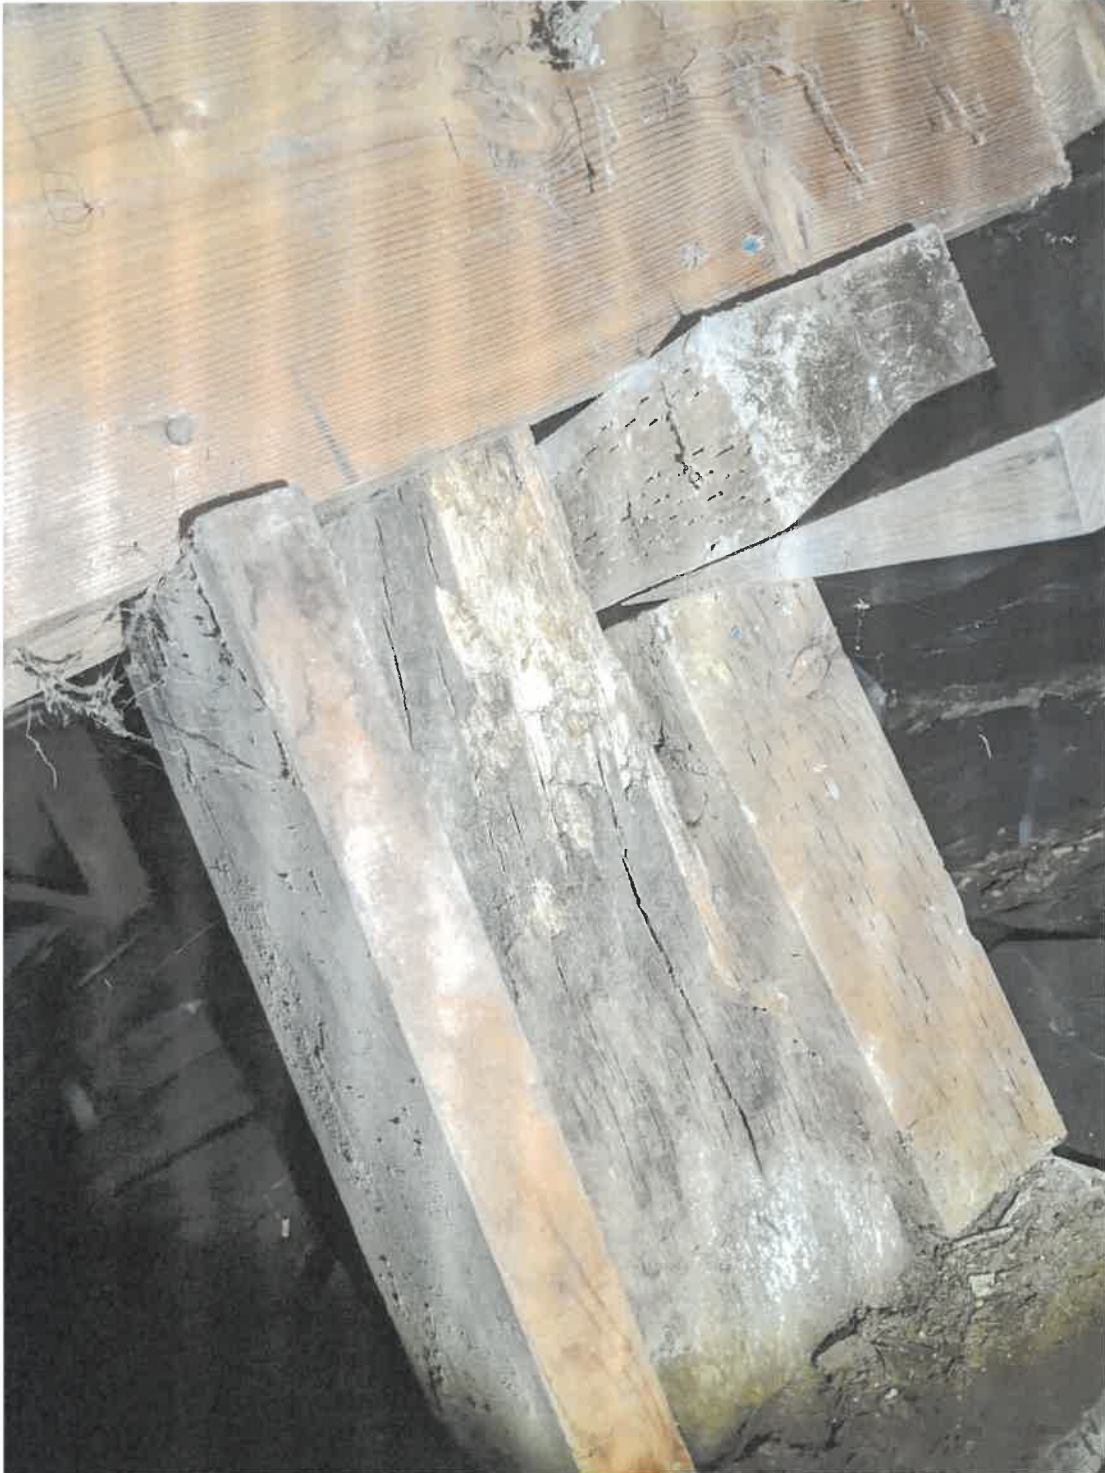
FIGURE 15: FUNGAL DECAY AT 6X6 POST IN CRAWLSPACE BELOW THE MAIN HALL.
