## MEETING AGENDA & PUBLIC HEARING NOTICE

City Council

Wednesday, July 24, 2024

Subject: Inspection report regarding current structural condition of the Legion Hall Building at 311 Deschutes Avenue in Maupin, Oregon

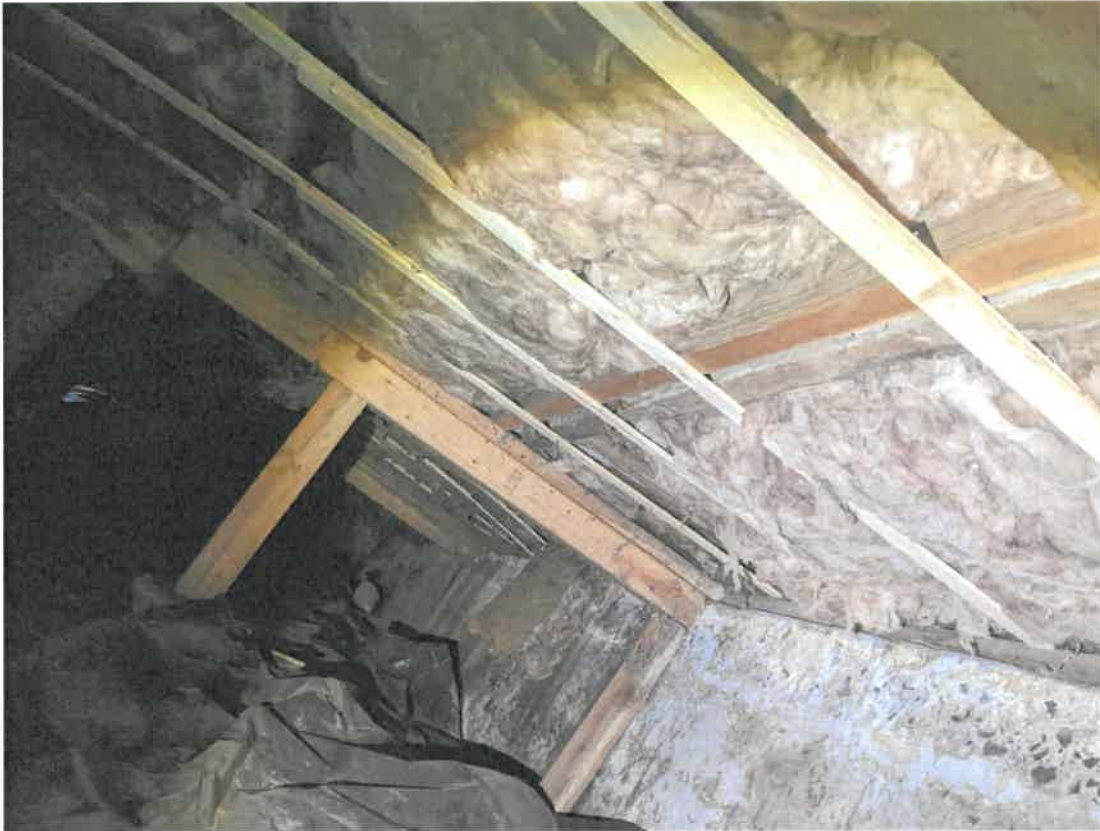
**FIGURE 16: DOUBLE 2X8 FLOOR JOIST AT NORTH END OF STRUCTURE WHERE ONE IS CLEARLY DAMAGED (RIGHT). THIS SUGGESTS THAT DOUBLED JOISTS MAY NOT BE ORIGINAL, BUT WERE RETROFITS TO REINFORCE EXISTING JOISTS.**

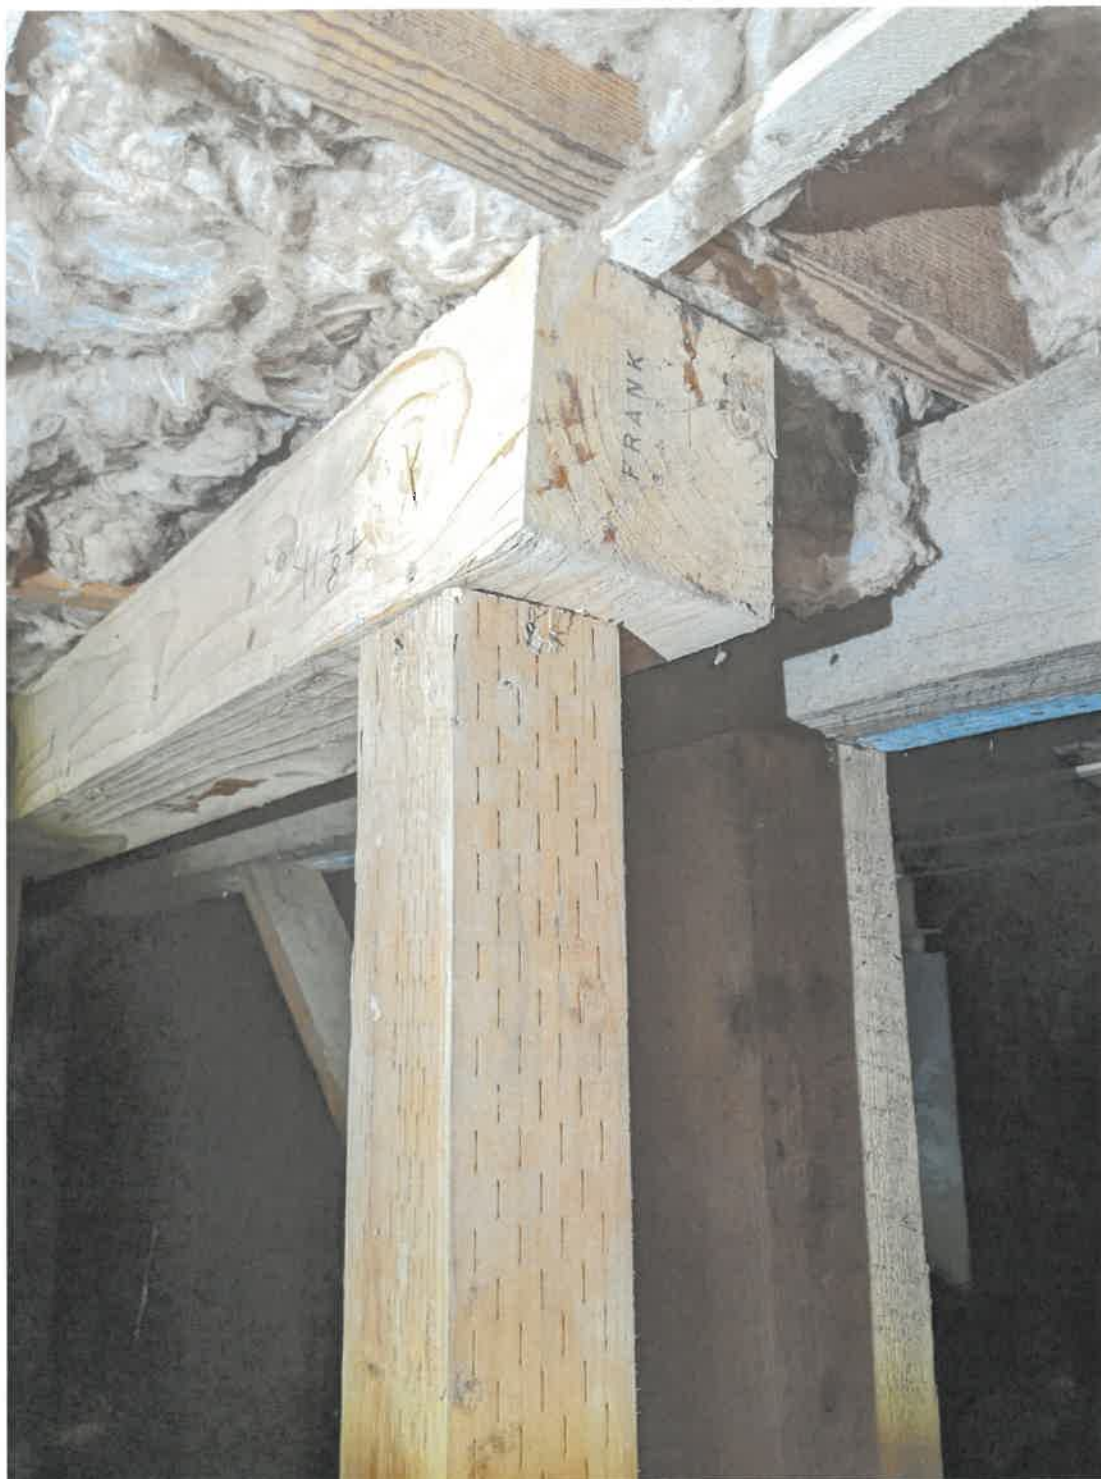
FIGURE 17: ONE OF TWO LOCATIONS WHERE POSTS AND BEAMS WERE INSTALLED TO COMBAT MOISTURE DAMAGED ELEMENTS AT EAST END OF STRUCTURE. IT IS UNKNOWN WHEN THESE WAS INSTALLED.

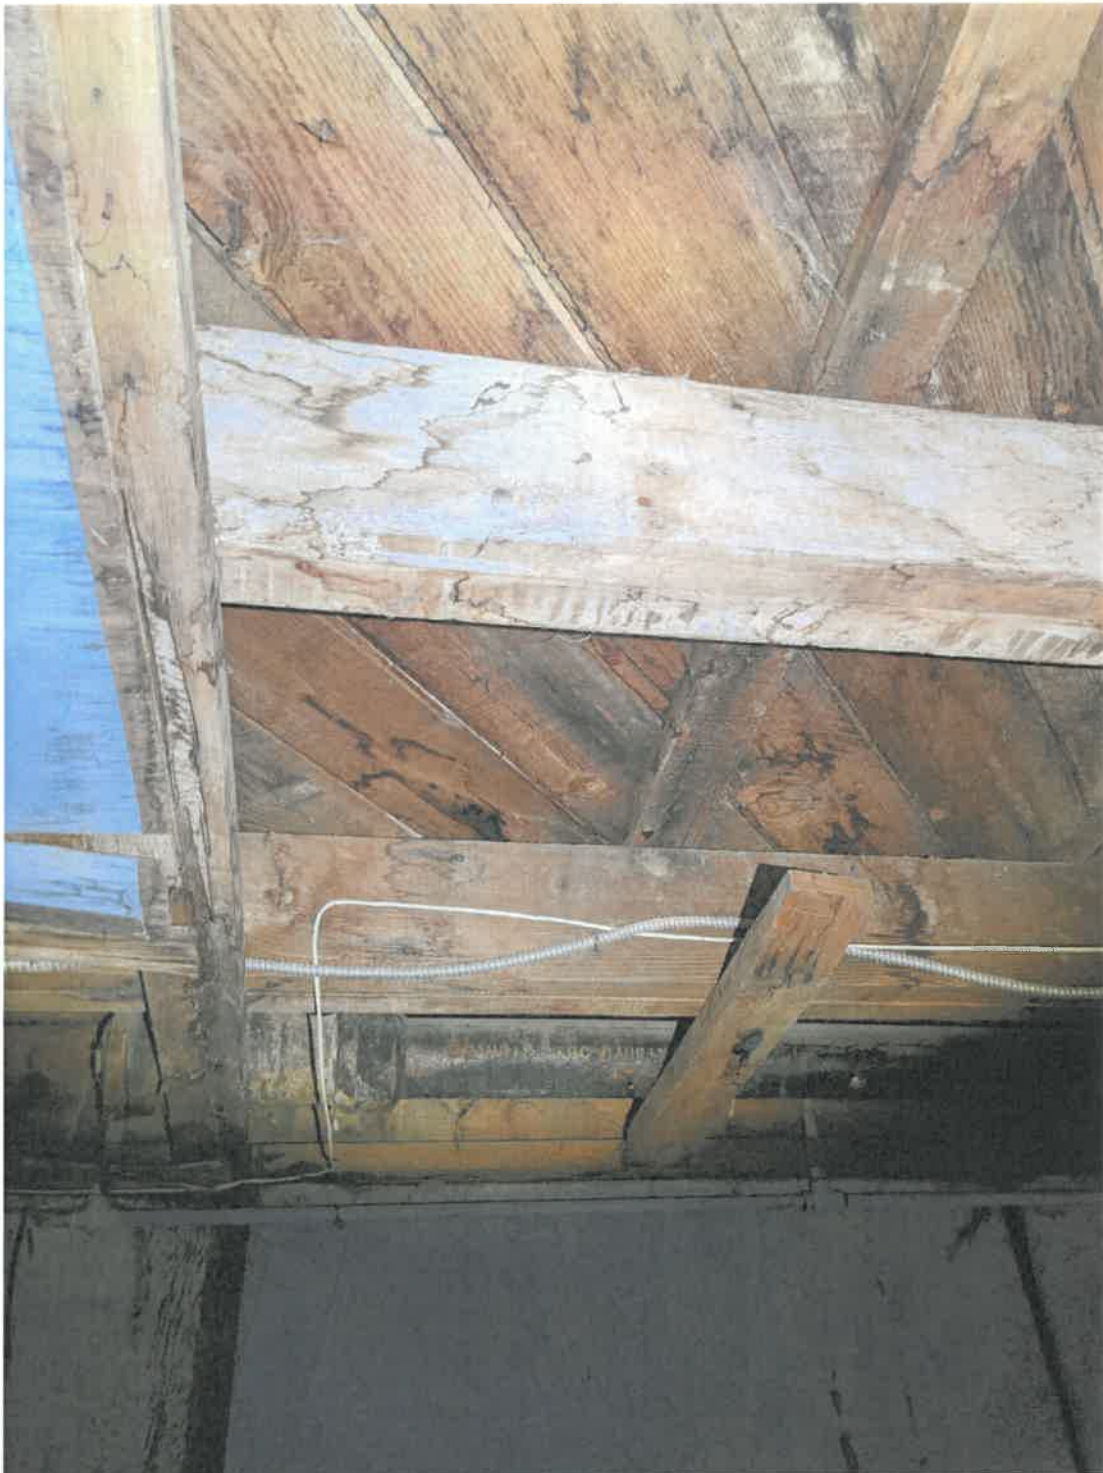
**FIGURE 18: WATER DAMAGED DOUBLE FLOOR JOISTS WITH DIAGONAL TONGUE AND GROOVE ABOVE TO SUPPORT THE STAGE (FACING EAST).**

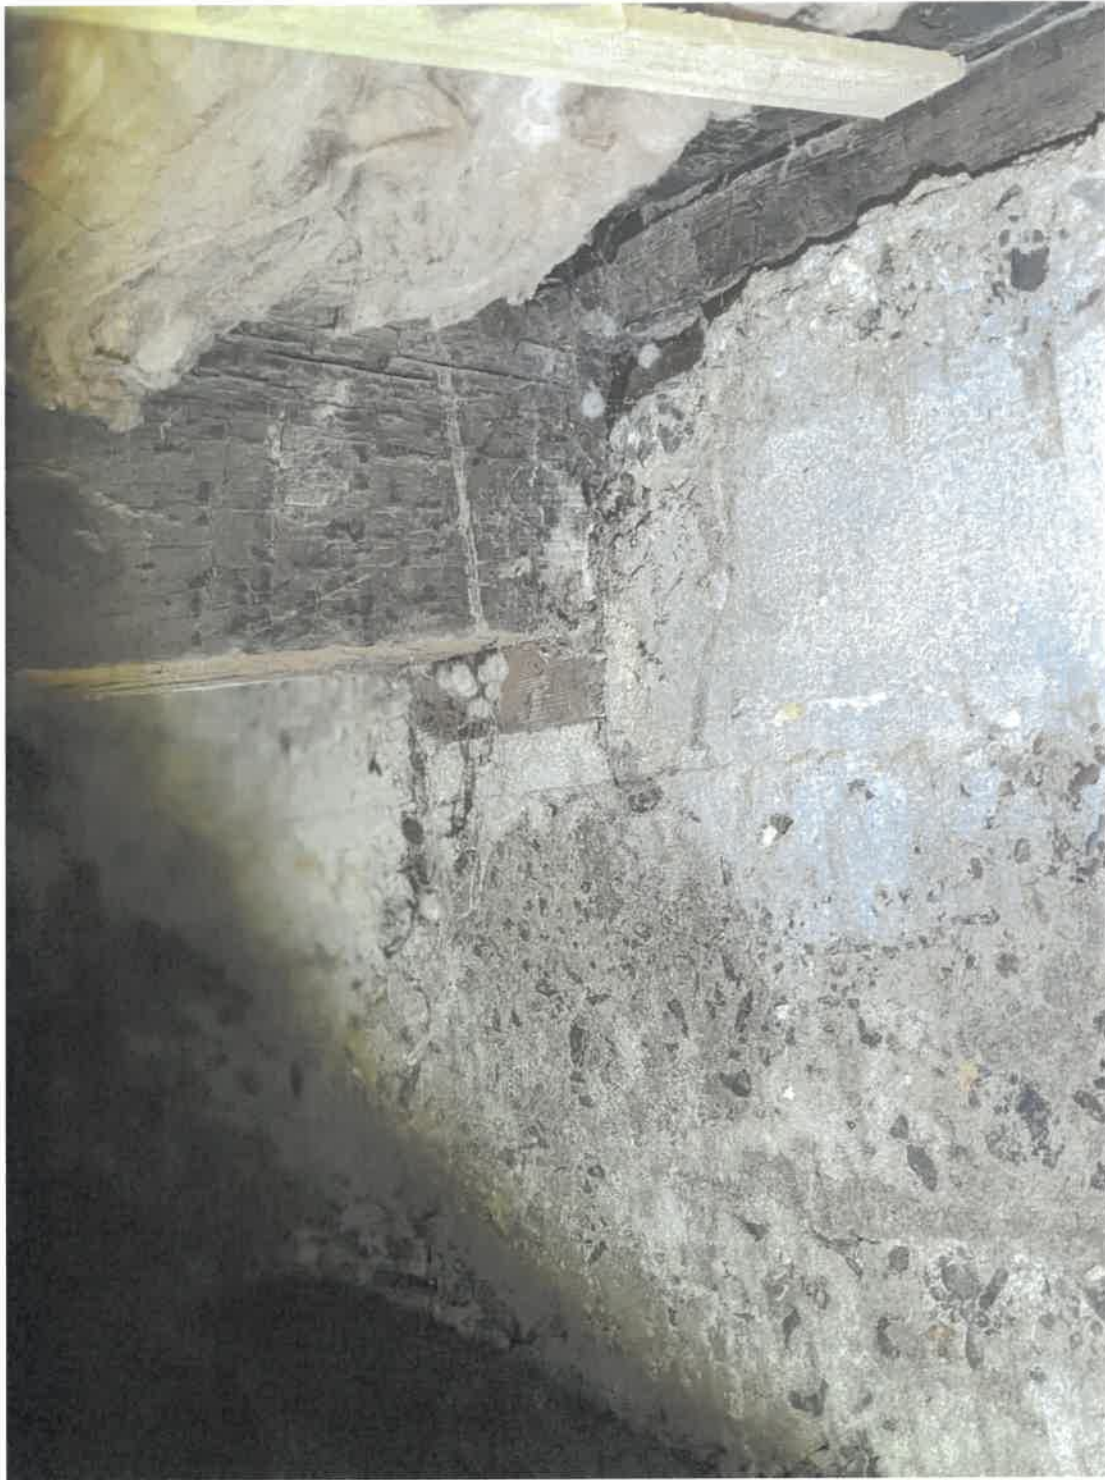
that are common and expected for wood of this age. However, most damage has been a result of moisture intrusion previously mentioned. Lastly, some floor joists at the main entry have experienced fire damage (see Figure 19 and Figure 20). Although much of this location has been replaced with new pressure-treated lumber, some existing fire damaged framing remains with little to no remaining structural capacity. Although not imminently hazardous to the building, the rim joist in particular appears to have significant damage and loss of capacity. This could result in long term settling of the north wall and should be replaced if other work is done in this area.

**FIGURE 19: CHARRED AND FIRE-DAMAGED WOOD LEFT IN PLACE AT NORTH END OF STRUCTURE. THE RIM JOIST IS THE MOST SIGNIFICANTLY DAMAGED ELEMENT.**

**In summary of the main hall, it is recommended to reinforce or replace the existing joists at locations that are rotted, completely charred, or have experienced structural damage such as large cracks under the guidance of a qualified engineer. More importantly, it is required to remove the underlying cause of the moisture intrusion into the crawl space. This can be completed through consultation with an architect to provide adequate vapor barriers, flashing, and other moisture protection detailing for the exterior siding, rim joist and crawl space to protect the framing from moisture in the future.**

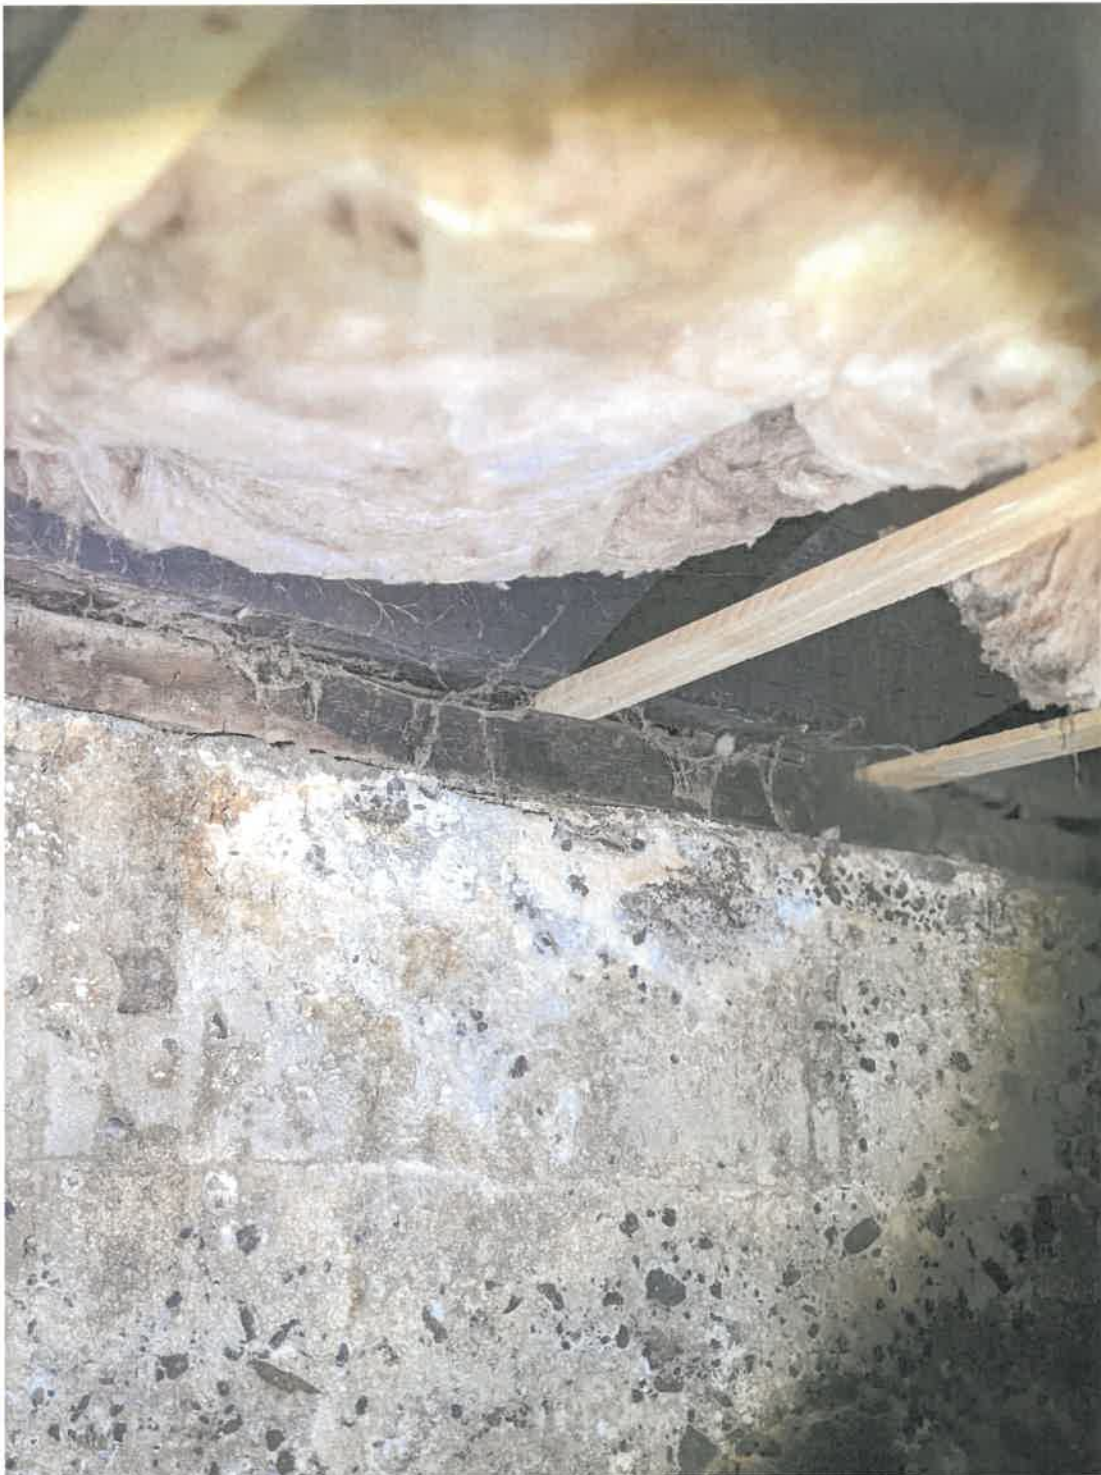
FIGURE 20: CLOSE-UP OF CHARRED RIM JOIST LEFT IN PLACE. IT IS RECOMMENDED TO REMOVE AND REPLACE THIS ELEMENT.

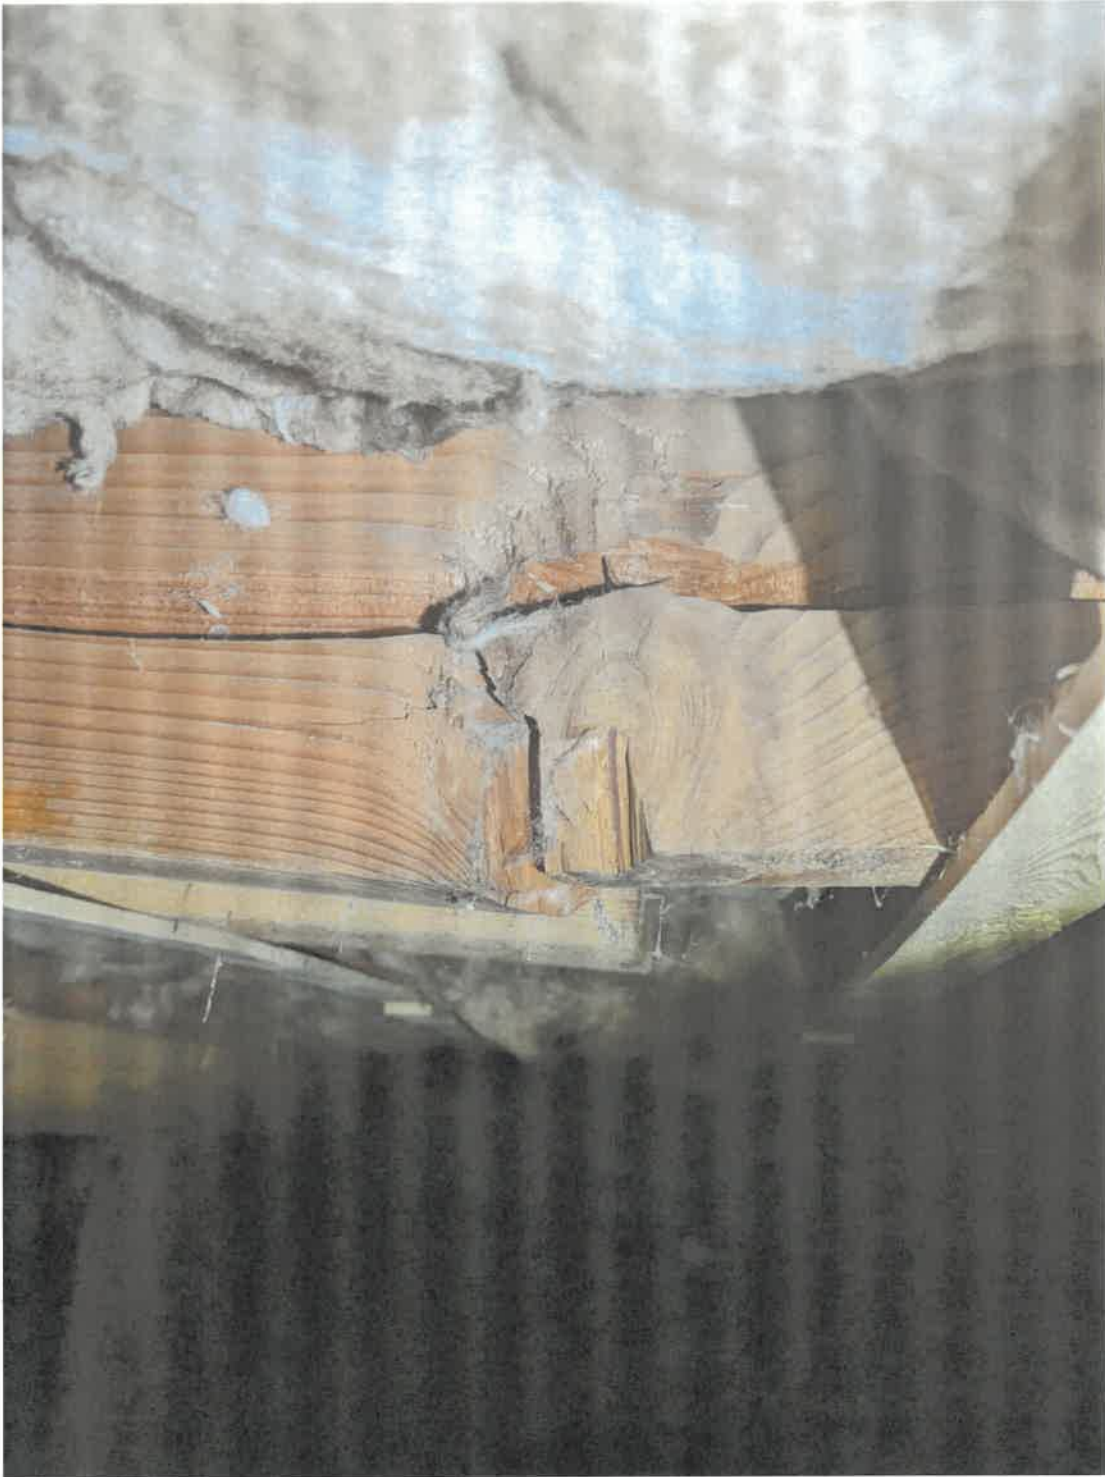
**FIGURE 21: DAMAGED JOIST CAUSED BY KNOT IN HIGHLY STRESSED REGION. IT IS RECOMMENDED TO REINFORCE THIS JOIST AND/OR REPLACE.**

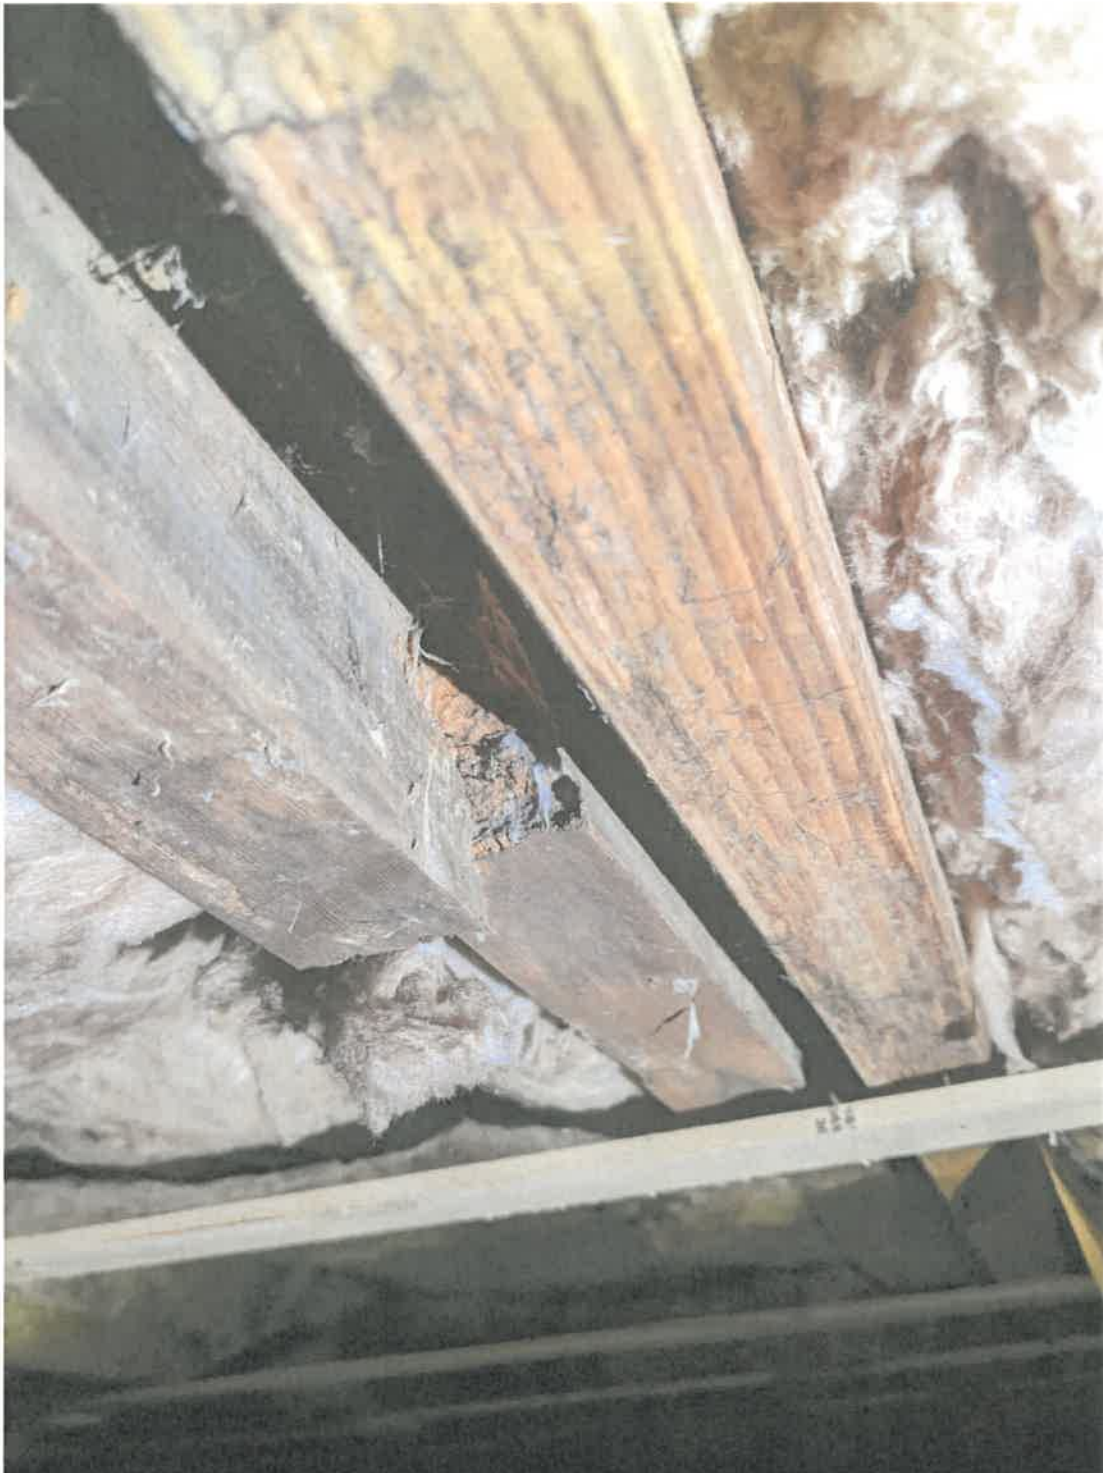
Throughout the main hall floor framing, some split and damaged joists were present. Some of the joists have significant damage requiring reinforcement and/or replacement. This may be caused by slope of grain/knots in the wood at highly stressed portions (see Figure 21), or large notches which reduced the load-carrying capacity (see Figure 22). Many floor joists have checks

FIGURE 22: NOTCHED OR DAMAGED JOIST (LEFT) REINFORCED WITH NEW JOIST (RIGHT).

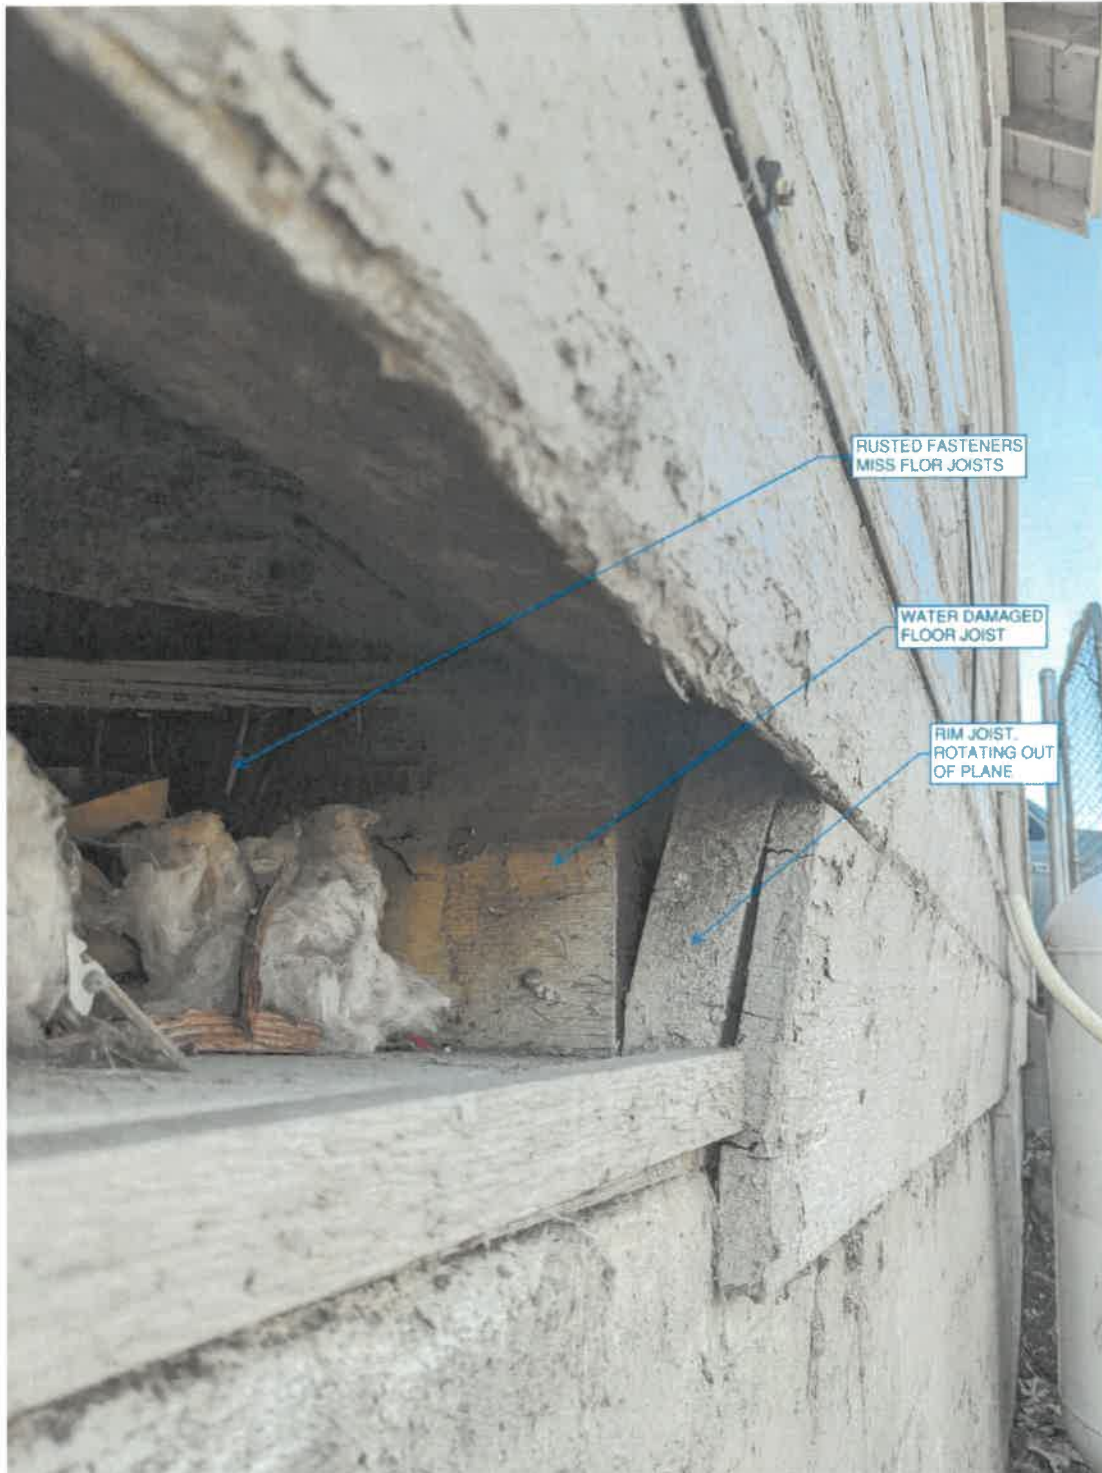
1. The roof framing of the structure is inadequate to support the current loading demands. Thus, the roof has experienced bowing and is spreading outward as it attempts to move downward. This has created out-of-plane loading at the top of the wall, causing it to rotate outward.
2. The floor sheathing at the east end of the wall was cut short and does not extend to the rim joist. Because of this, the rim joist is unrestrained and has buckled and rotated outward (see Figure 23).

FIGURE 23: EAST WALL AT MOST SEVERE LOCATION OF WALL MOVEMENT. THE RIM JOIST WAS NOT INSTALLED TO THE SHEATHING TO RESIST IT FROM ROTATING OUT-OF-PLANE, CAUSING THE WALL TO PULL AWAY FROM THE STRUCTURE.

We do not believe that this condition is immediately hazardous, however, it should be closely monitored. If this were to fail, it is likely to be a continual gradual failure rather than a sudden collapse. As such, if further displacement is observed the building should be closed until repairs are made, but can continue to be used for small groups at the present time. **To reduce further out-of-plane wall movement, it is recommended to add capacity to the roof framing system through a full roof replacement or reinforcement of collar ties/webs.** Although it may be technically feasible to reinforce the roof system, we believe that it would be extremely difficult and is unlikely to be cost effective relative to installing new roof trusses. **Additionally, new floor sheathing and rim joists at the main hall should be installed to adequately support the floor framing. This will require removing a portion of the flooring and floor sheathing a minimum of four feet from the exterior wall and reinstalling new floor sheathing and rim joists in the affected areas. The sections of the wall that is sliding off of the rim joist will also need to be replaced.**

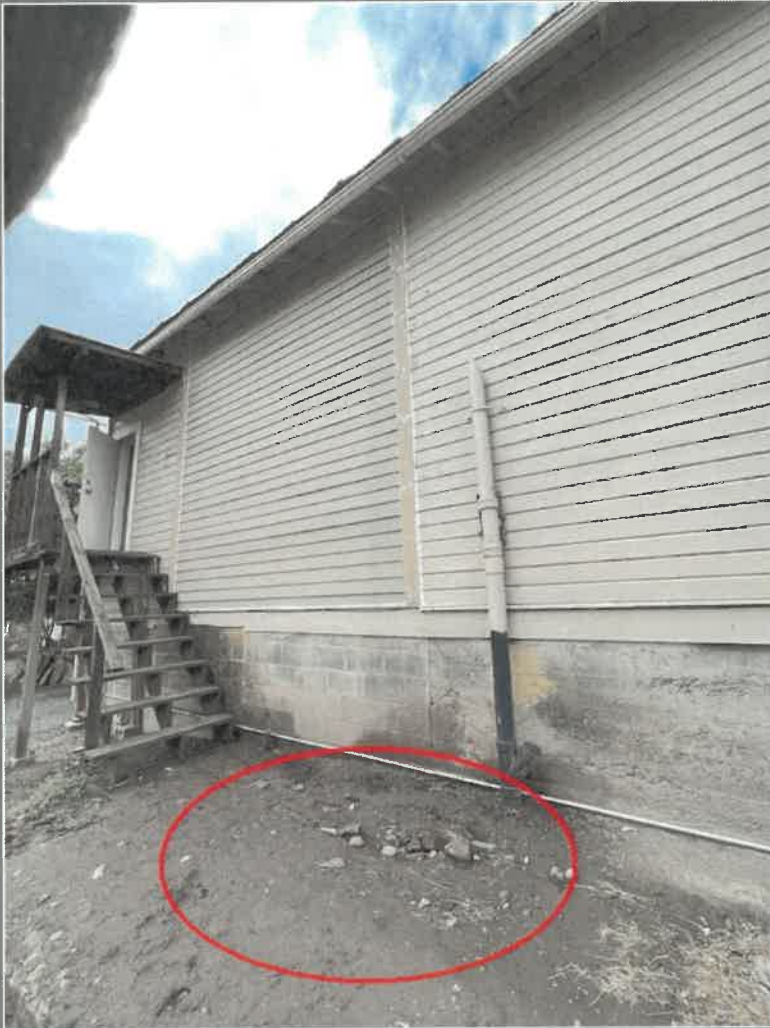
A. Item 1(Picture)

**A.** (1) Evidence suggests ponding or standing water can occur at the left side (facing front). The remaining sides of the building indicate similar conditions or fair to poor drainage depending on the amount of rain. Ponding or standing water can effect the foundation leading to undesirable settlement. A qualified person should repair or replace as needed.

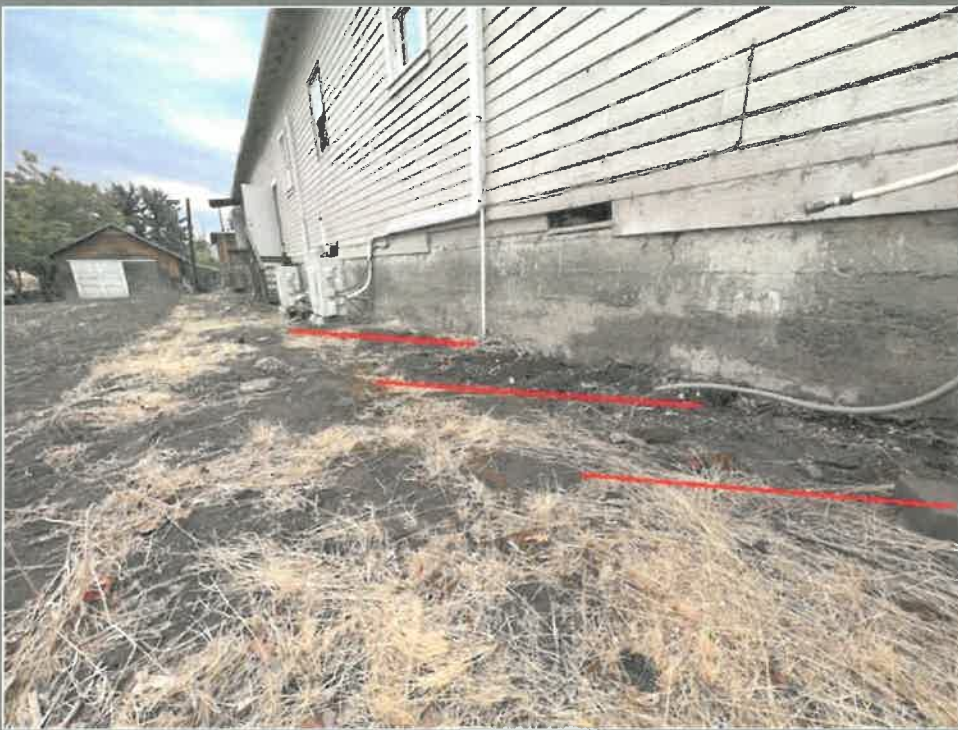
A. Item 2(Picture)

(2) The Eastern edge of the building had a negative grade that slopes runoff towards foundation footing. This can cause foundation settlement issues. Recommend repair by a licensed landscaper.

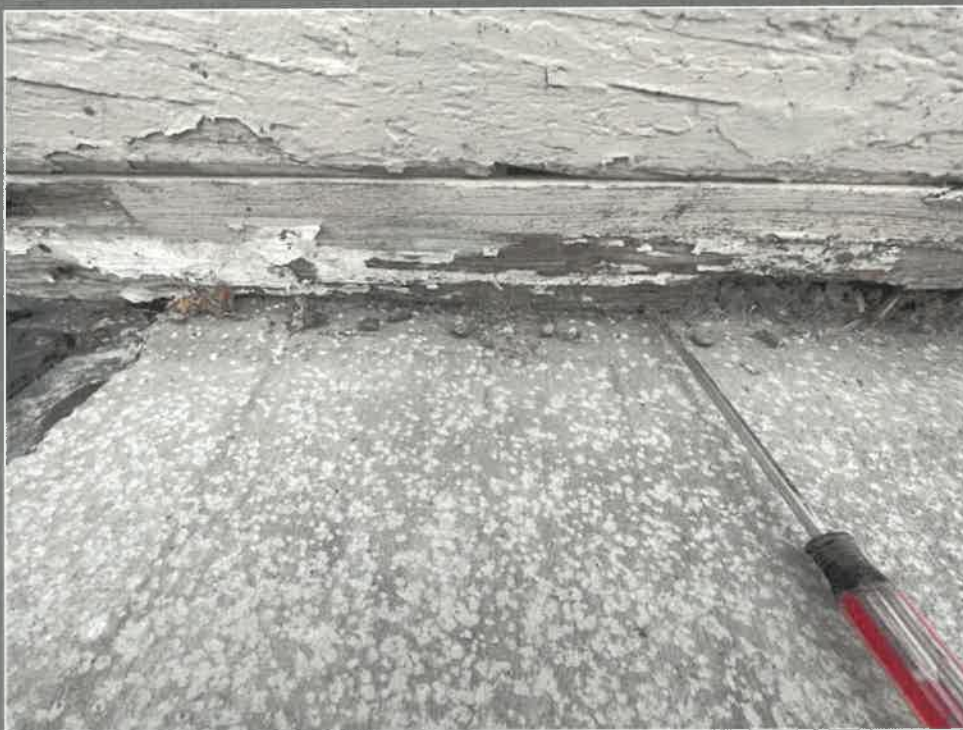
**E.** The side walk along deschutes ave and 4th street was in contact with the buildings wooden components. Concrete absorbs and holds moisture. This can create ideal conditions for wood decay and attract wood destroying organisms. As wood decay's it loses its structural integrity. Much of the area along the side walk with Deschutes avenue has active wood decay and a permanent moisture source from the above grade sidewalk. Recommend creating separation of the buildings wooden components from the sidewalk. This can be done by building a waterproof barrier that is properly flashed at the bottom course of siding then sealing wooden components to a point below the top edge of the foundation. Recommend evaluation by a licensed structural engineer and any necessary repairs.

E. Item 1(Picture) Wood decay at sidewalk

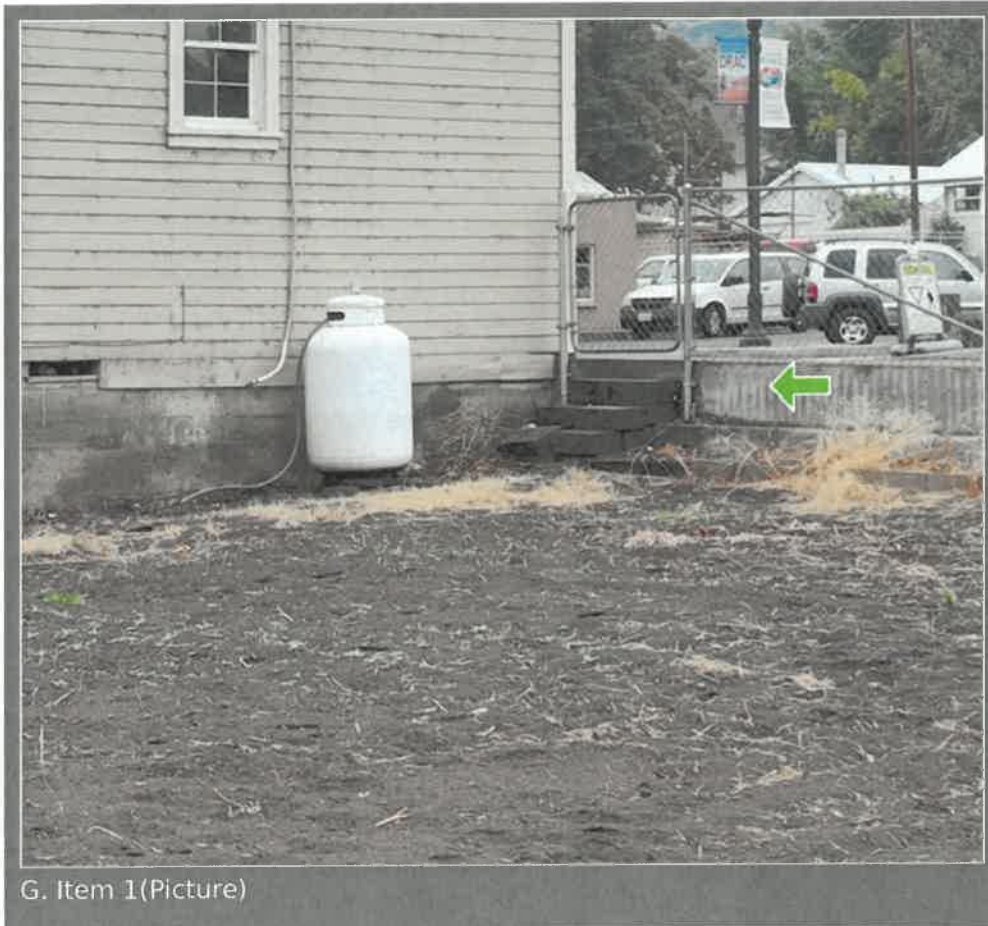
**H.** The exterior stairs on the Eastern side of the building had a non-graspable hand rail that was loose at both stairs. This is a safety issue. Recommend repair by a licensed carpenter.

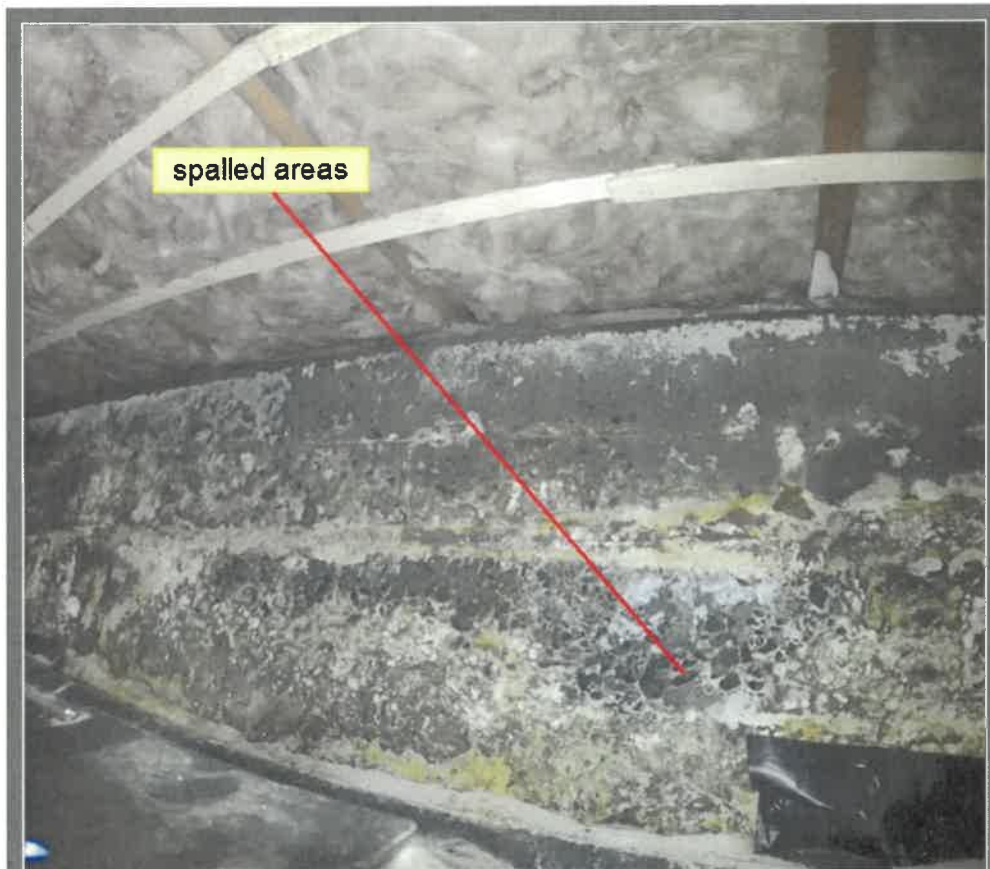
A. Item 1(Picture)

**A.** (1) The foundation walls are in poor condition overall. The walls have evidence of heavy efflorescence (moisture and salts driven through the concrete) and subsequent spalling from the osmotic pressures. The foundation was poured at a time when parge coating the exterior portion of the wall below grade was not practiced. Consequently, hydrostatic pressure continues to act on the foundation through time gradually. Recommend evaluation by a licensed foundation contractor.

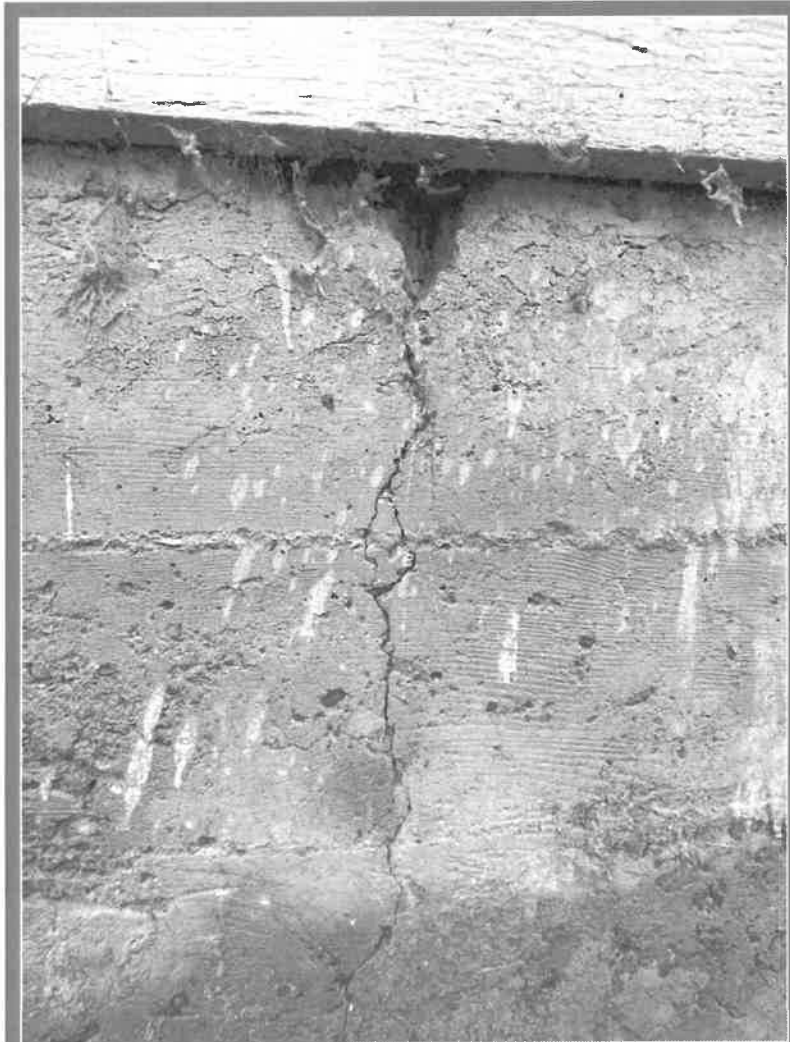
(2) The foundation was cracked on both the exterior and interior sides. Some of these cracks were traced through the stem wall and footer. Of the cracks observed the typical pattern was of tension and shear cracking as shown in the photographs. Tension cracks open in a "V" shape and indicate a pulling apart action. Shear cracking are tight with step over cracking in areas that intersect with the main crack again as the sides slide past in a differential settlement pattern. These cracks occur in highly saturated poorly drained soils at the footing. Under these soil conditions the soil yields to the downward forces resulting in uneven support and cracking foundation areas. It's important to note that the Eastern and South Eastern corner exhibit the most foundation damage and are subject to the most drainage and negative grade problems at the foundation. Recommend evaluation by a licensed structural engineer and all necessary repairs.

A. Item 2(Picture) Shear cracking broken foundation sliding past each other.

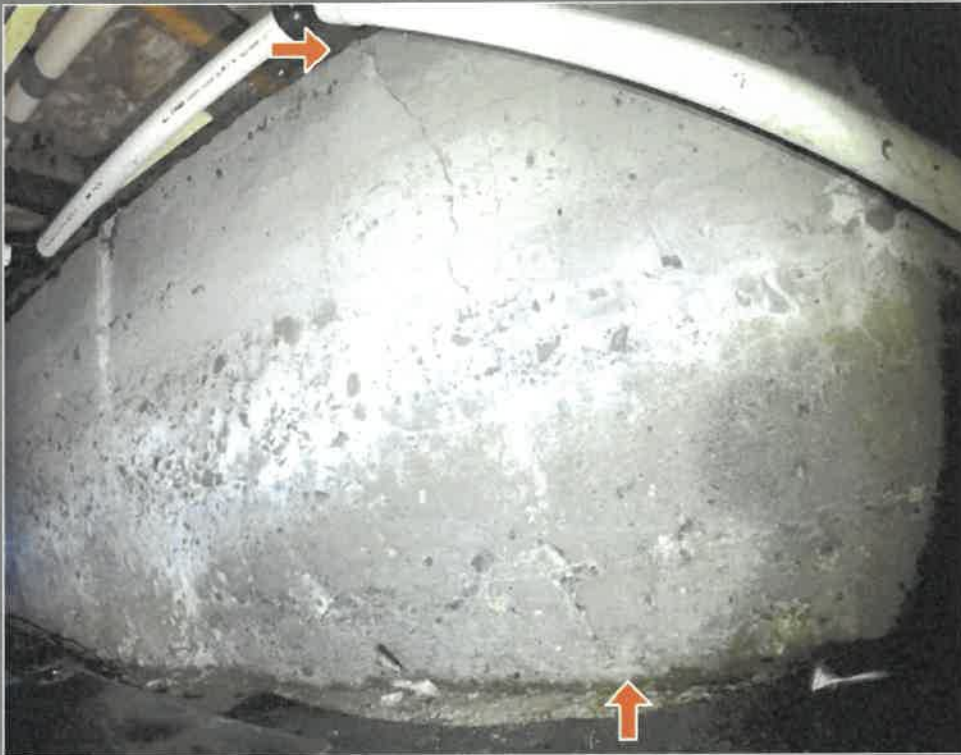
A. Item 3(Picture) Opposite side of crack in item 2

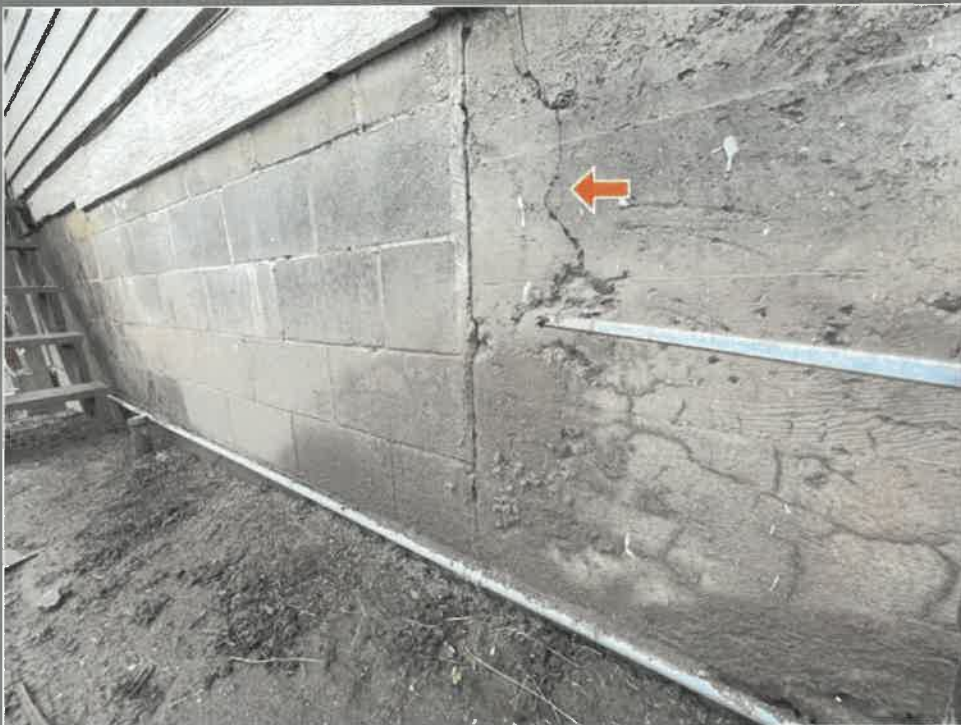
A. Item 4(Picture) Cracking at corner of original building

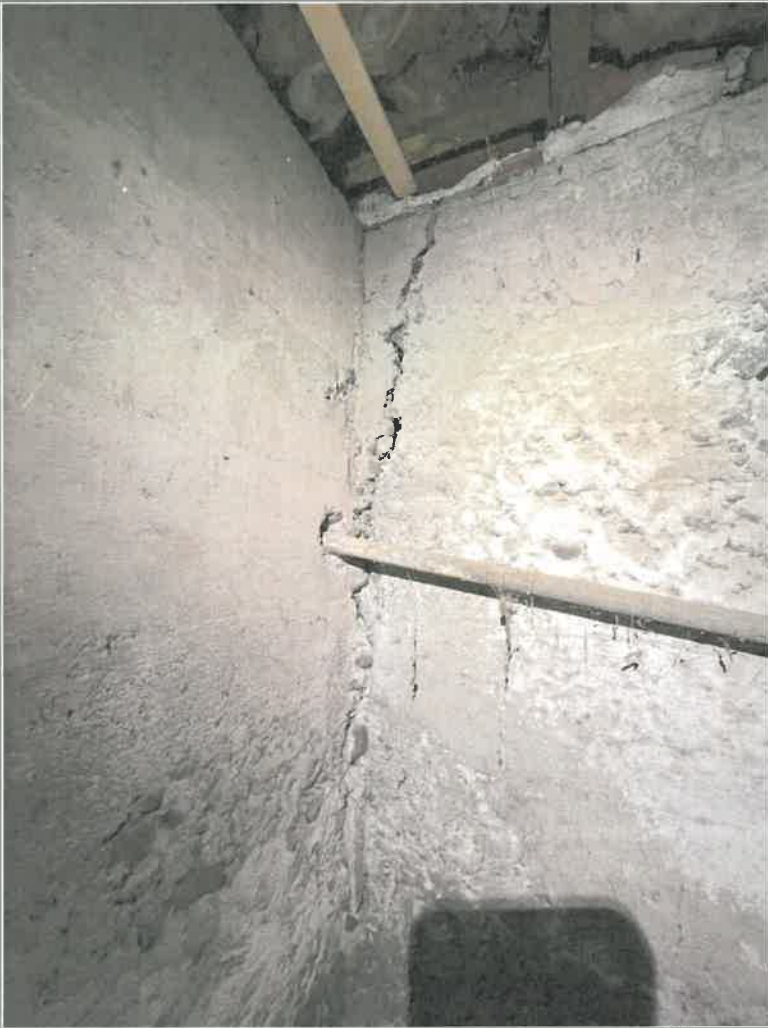
A. Item 5(Picture) opposite side of Item 4

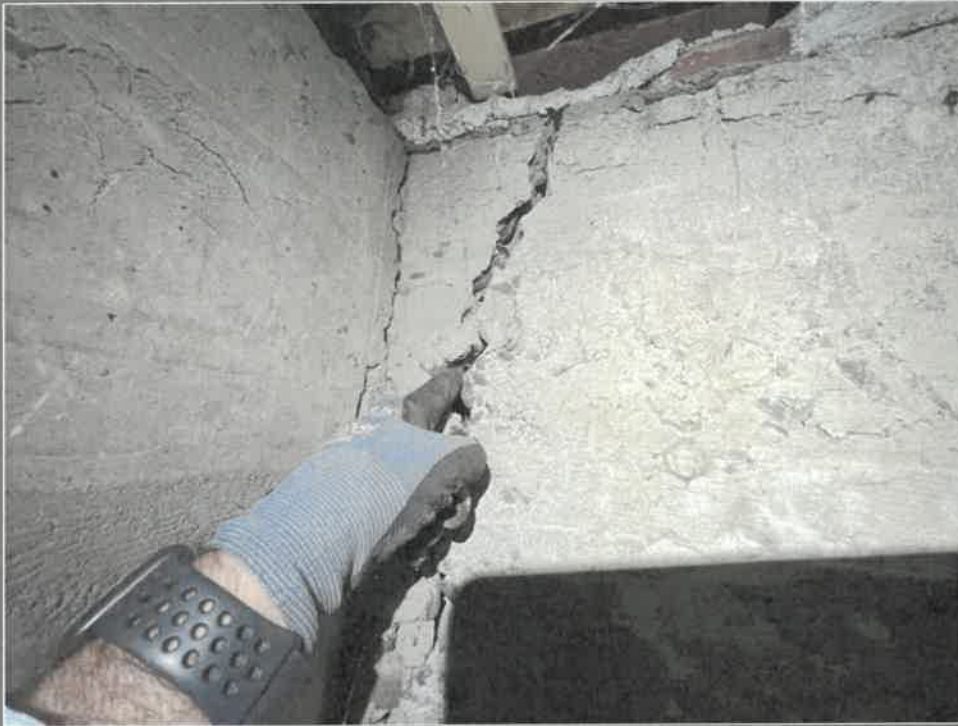
A. Item 6(Picture) Pull apart tension crack. Building pulling away to East.

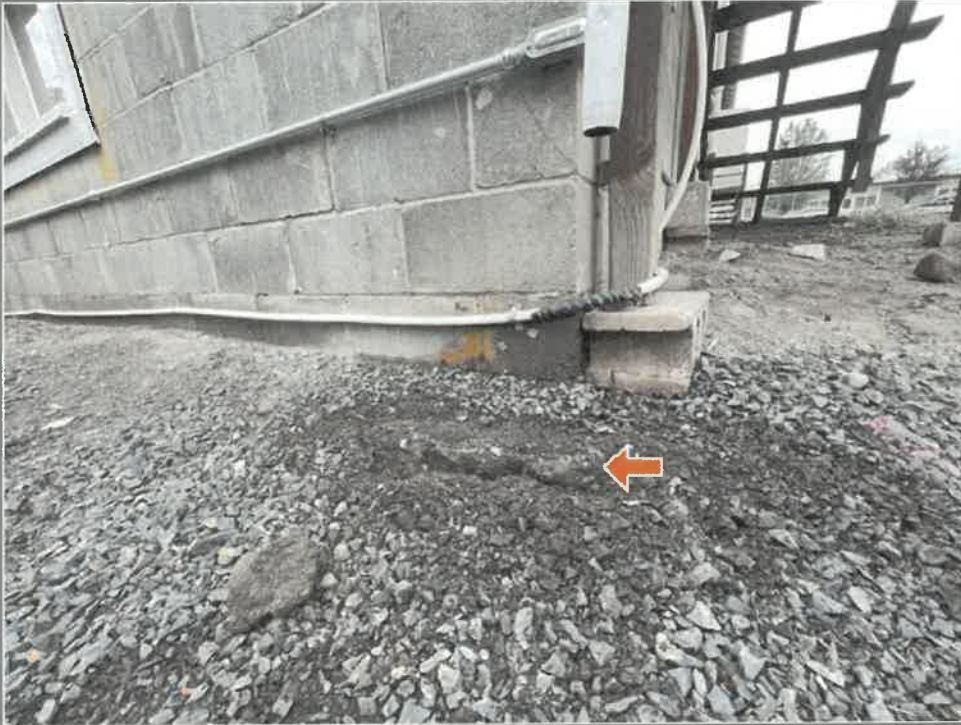
A. Item 9(Picture)

(3) The foundation for the addition had exposed footing. This indicates the foundation is not set below frost line. Another factor that can cause building foundation distress is frost heave. Frost heave can lift the foundation causing cracking and settlement issues. The footing should be placed below frost line for the area by a licensed foundation contractor. Lastly it is evident the footing design does not consider soil conditions or wind loading on the building due to the thickness of the footing.
