## MEETING AGENDA & PUBLIC HEARING NOTICE

City Council

Wednesday, July 24, 2024

Subject: Inspection report regarding current structural condition of the Legion Hall Building at 311 Deschutes Avenue in Maupin, Oregon

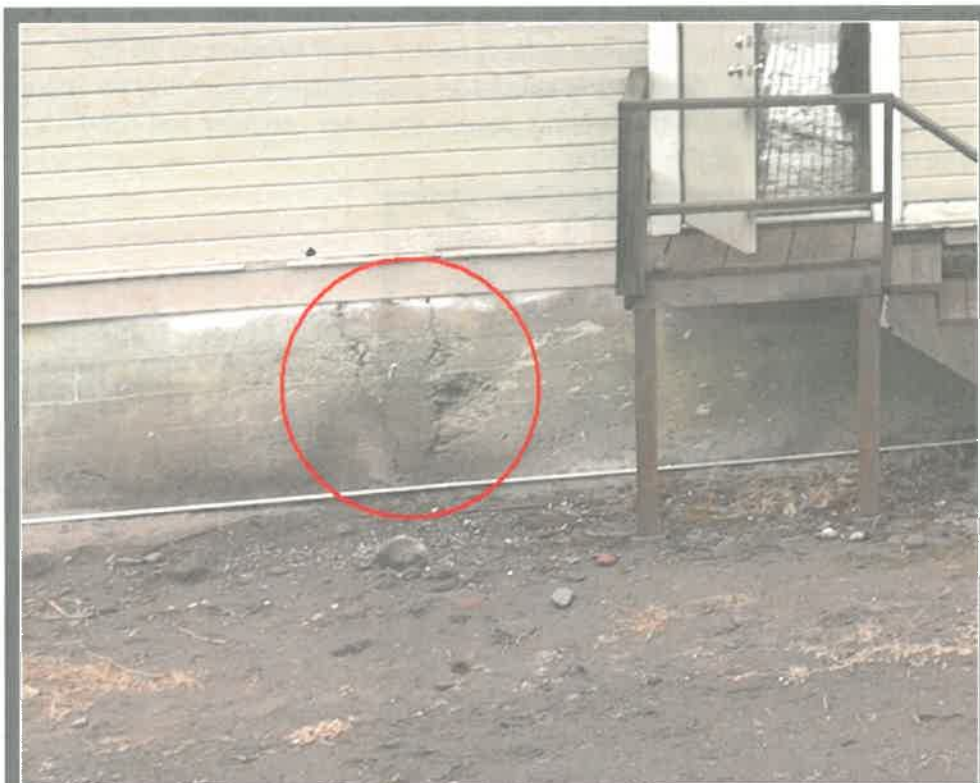
A. Item 10(Picture) Shear cracking at exit door

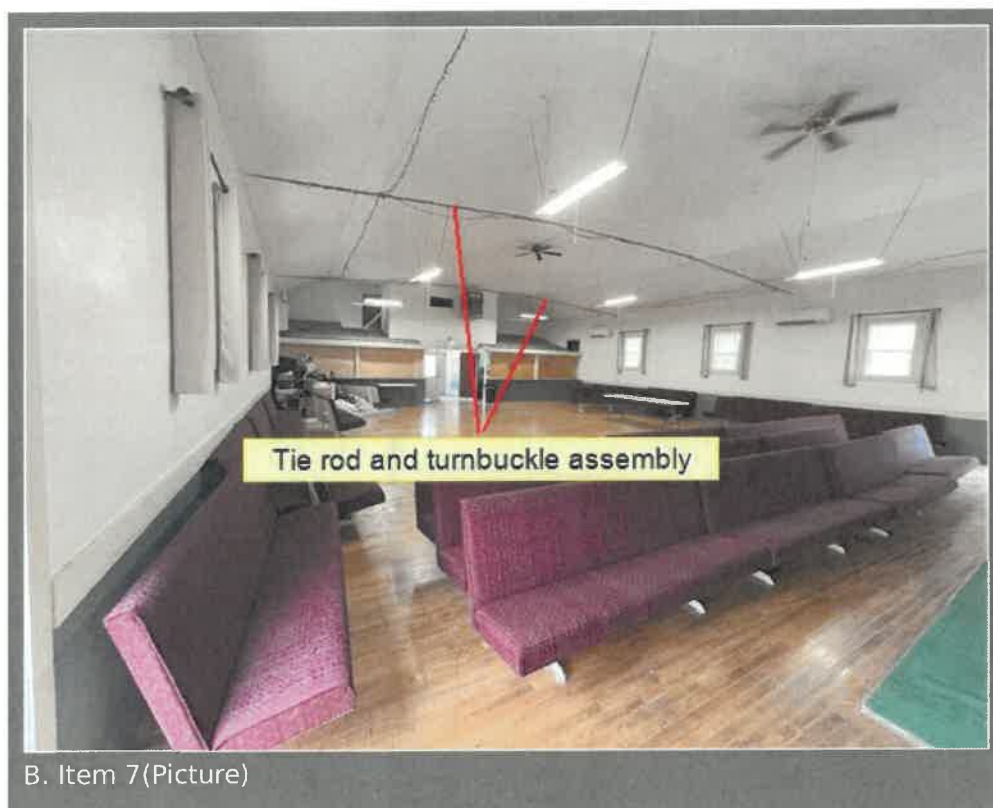
B. Item 7(Picture)

(3) The building wall assembly in the main assembly area was supported at the top plate by a system of tie rods tensioning turnbuckles, washers and bolts over a deadman wood blocking at the exterior sides. Due to the roof spread mentioned in Inspection item 1 the stud bays outside of the wall tensioning system have bulged outward. This has caused the bottom plate to come away from the floor near the kitchen. This is a serious structural issue. Recommend evaluation by a licensed structural engineer and any necessary repairs.

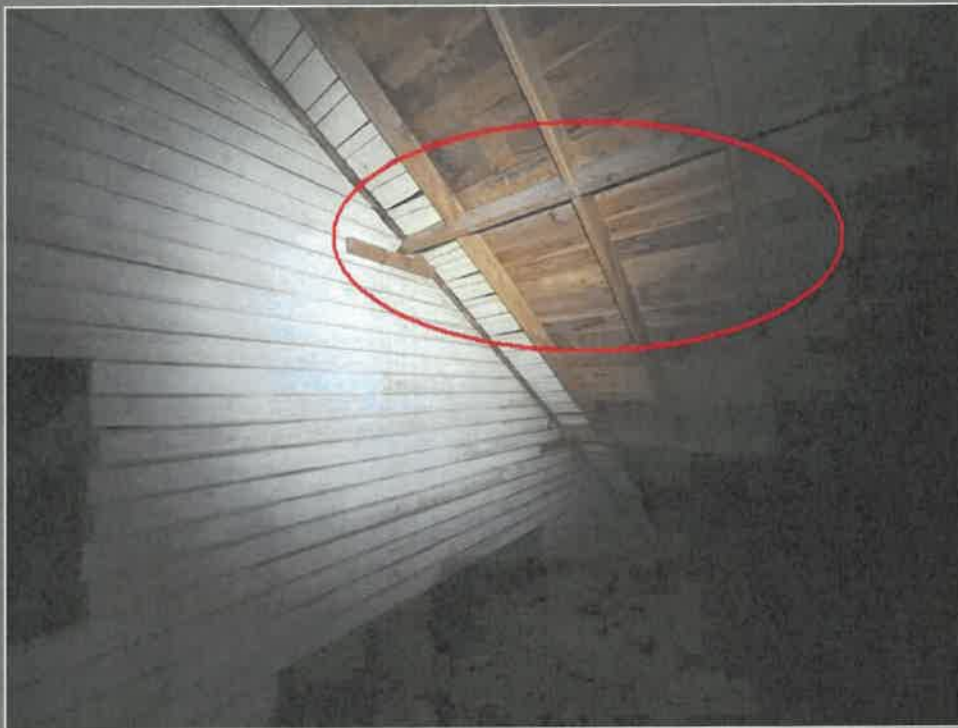
B. Item 14(Picture)

(4) The addition attic space had rafters that had been cut mid-span. This is a hazard. Rafters should not be notched or cut mid-span. Recommend evaluation and any necessary repairs by a licensed structural engineer.

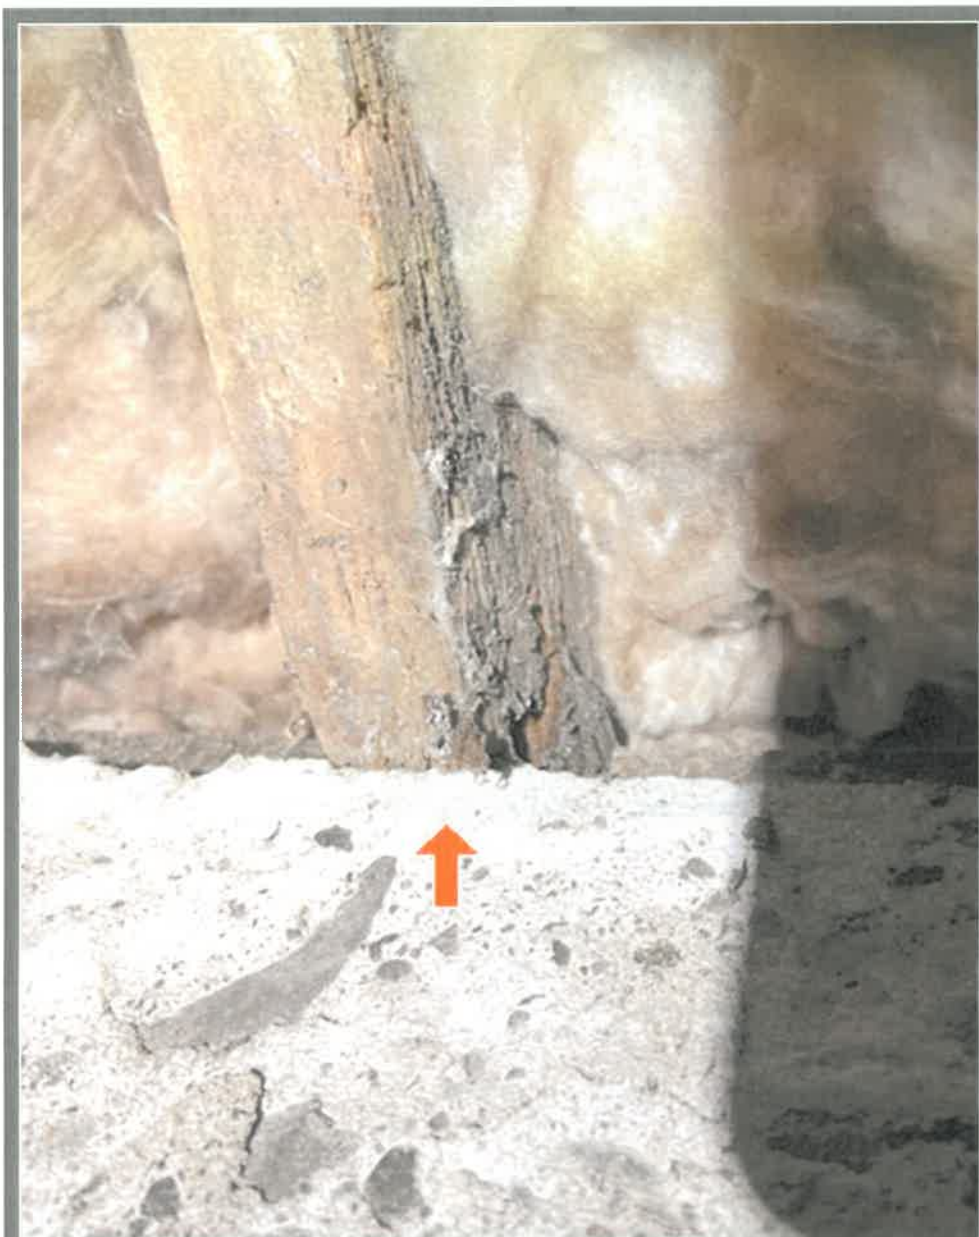
B. Item 15(Picture)

(5) Many of the floor joists and girders had brown rot decay and white rot decay evidence at the time of the inspection. This is an indication that active decay and moist conditions has been taking place for many years. Many structural members underfloors have been compromised do to extensive decay.

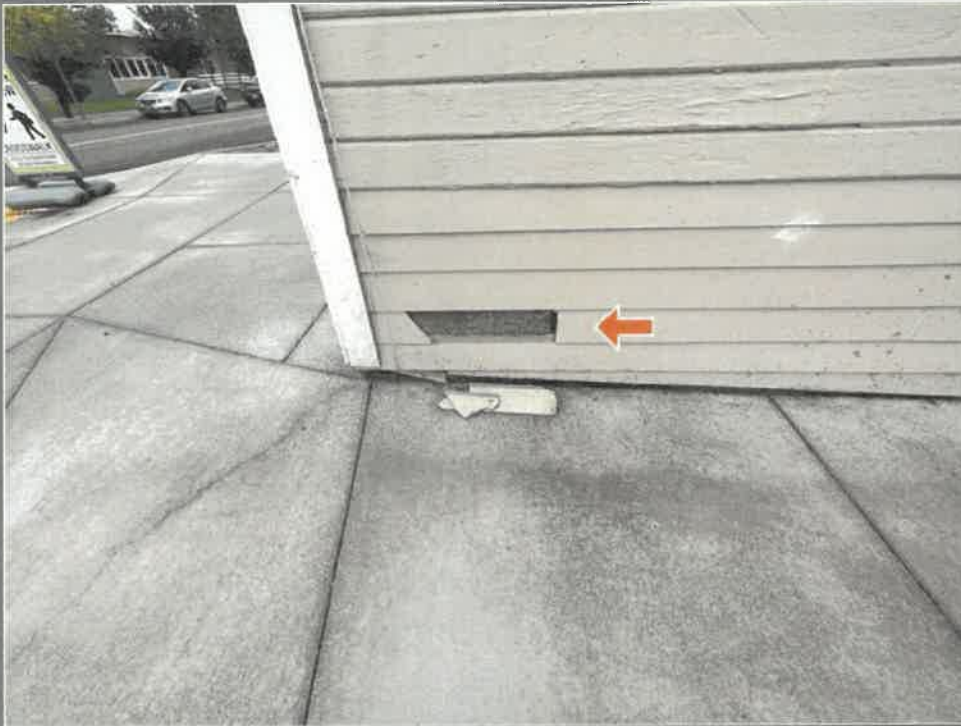
D. Item 1(Picture)

(2) Cementous siding damaged exposing cellulose insulation inside. Cellulose when exposed to moisture can cause wood decay and create unhealthy conditions such as mold. Recommend repair / replace by a licensed contractor.

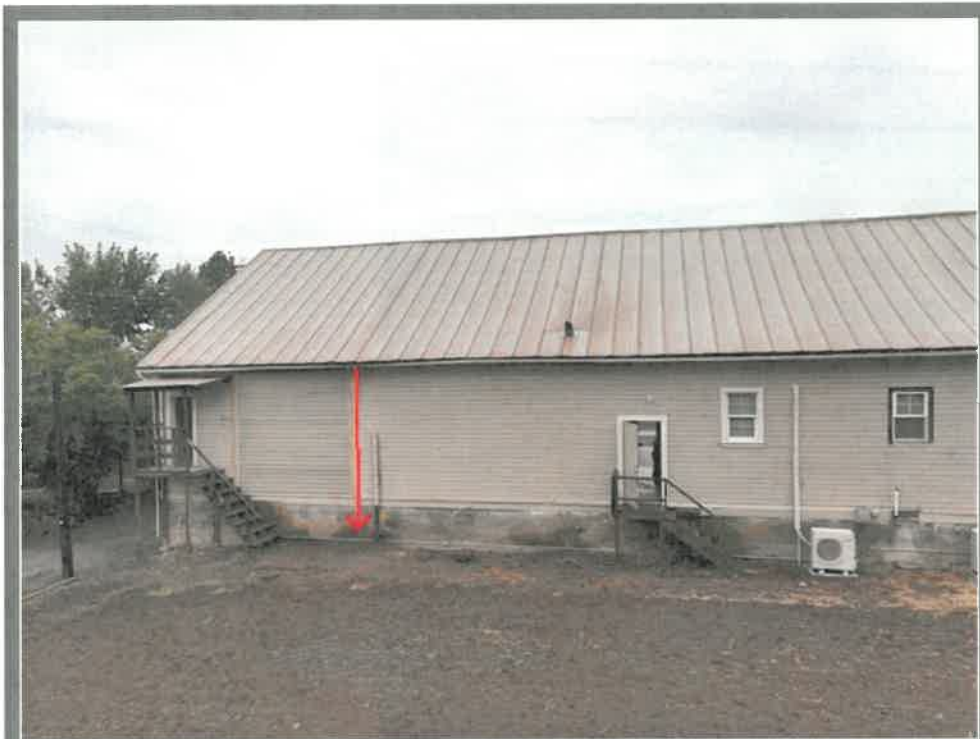
F. Item 1(Picture)

**F.** The steep metal roof over shoots the gutter in many areas resulting in a heavy drip line and concentration of moisture at the foundation footing. This accumulation of moisture can cause serious foundation issues such as the ones indicated in this report. Roof runoff should be conveyed away from the foundation by at least 10' Recommend repair by a licensed gutter contractor.

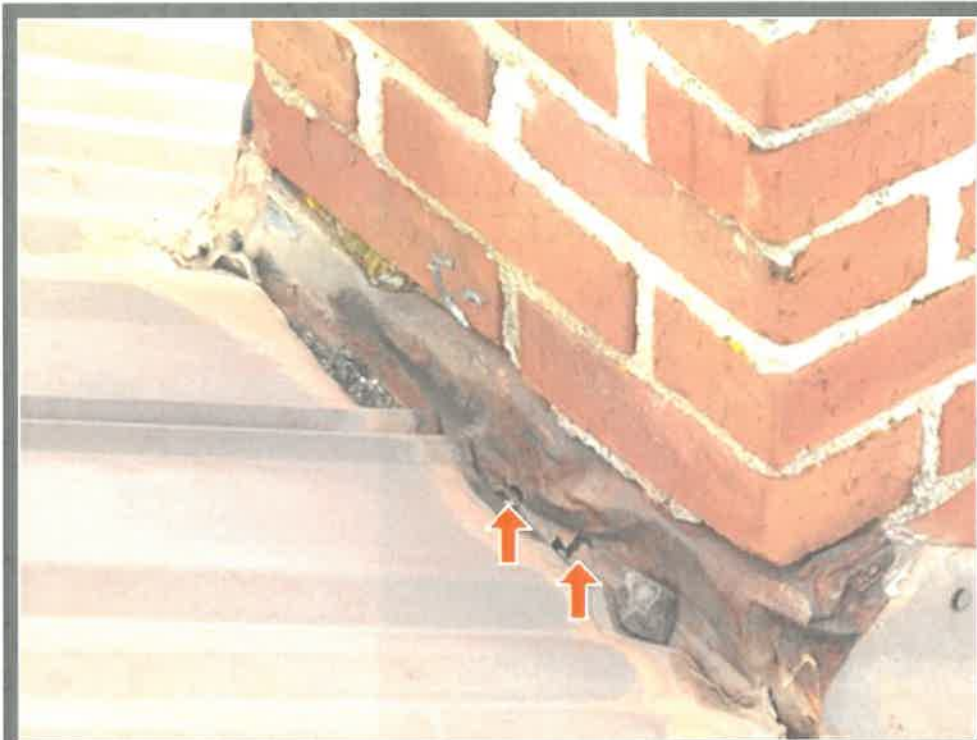
H. Item 1(Picture)

**H. (1)** The chimney flashing was corroded with holes that allow water infiltration into the building assembly. This can cause wood decay. Recommend repair by a licensed roofing contractor.

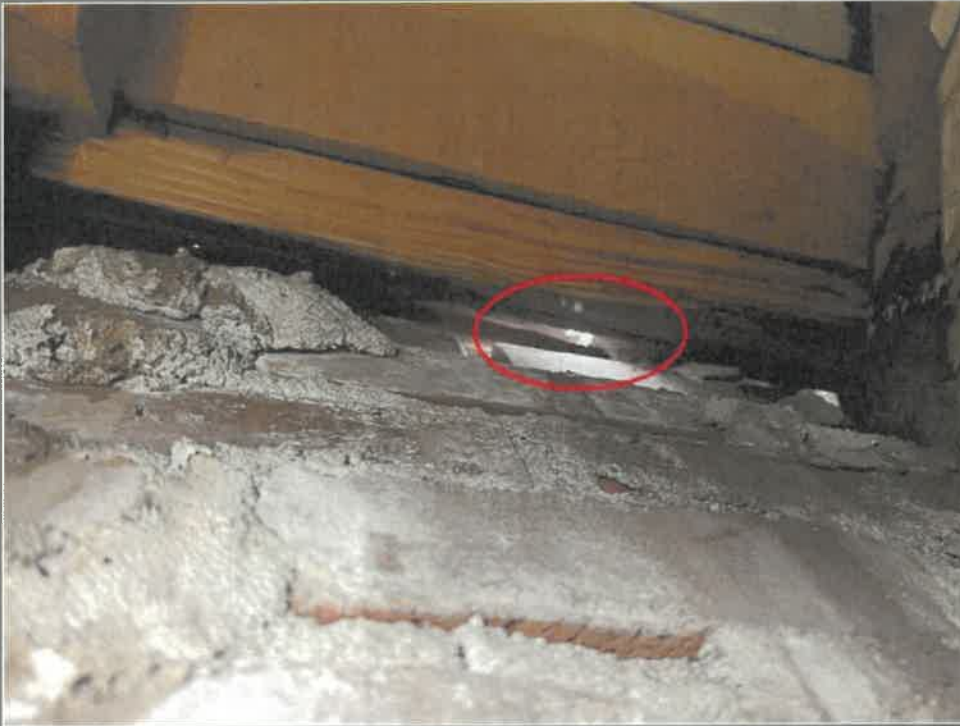
H. Item 3(Picture) Holes through flashing

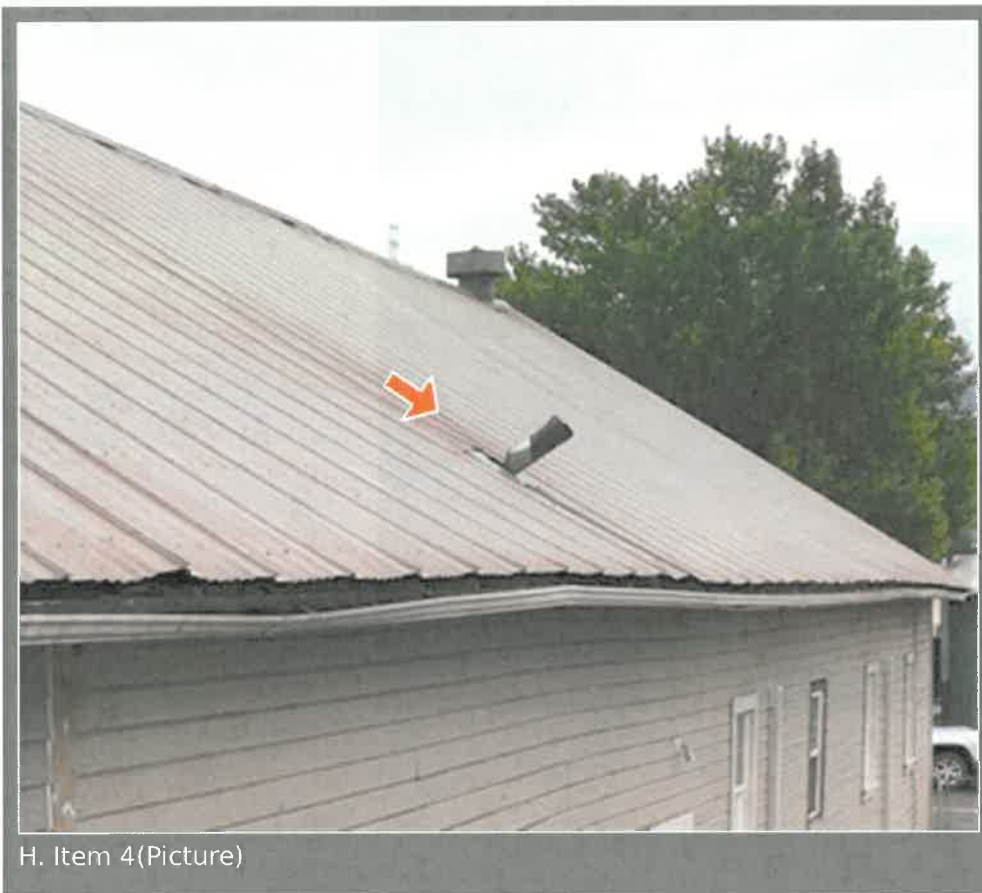
H. Item 4(Picture)

(2) Chimney flashing and pipe were damaged. This can allow moisture intrusion into the wooden components below resulting in costly repairs and unhealthy conditions. Recommend repair by a licensed roofing contractor.

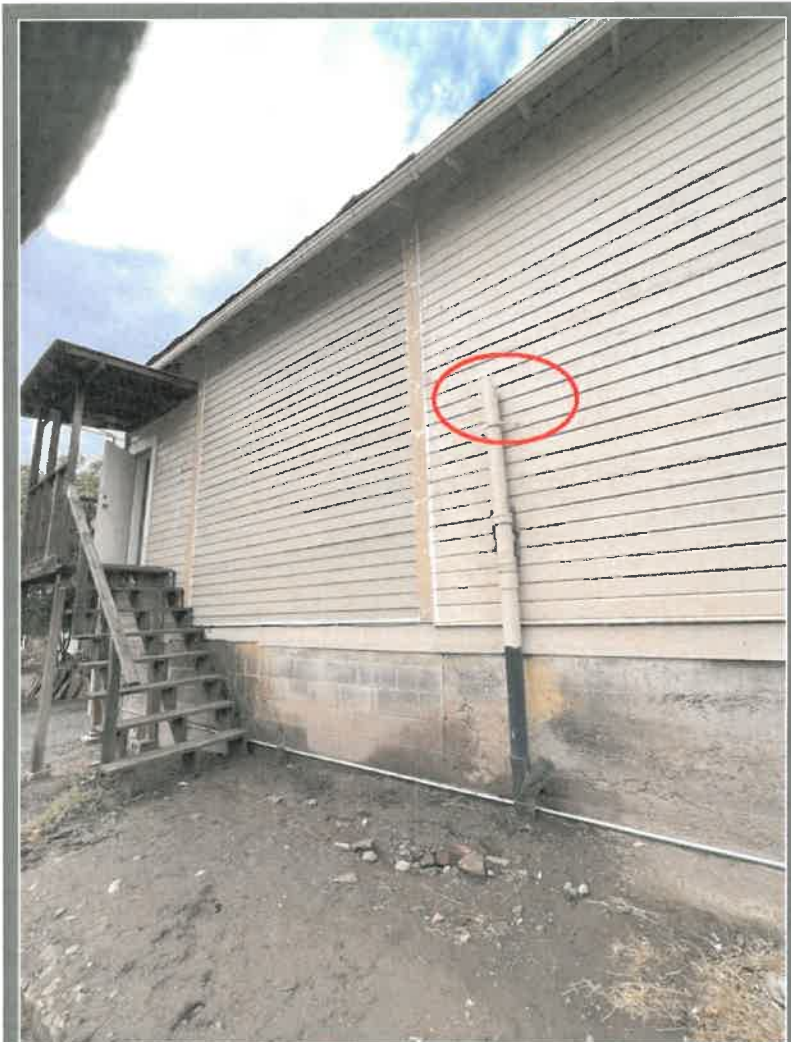
B. Item 1(Picture)

- A.** The plumbing water supply and distribution fixtures were in good condition.
- B.** (1) The plumbing drain waste and vent systems were in fair condition. Notable exceptions will be in this report.
- (2) The plumbing vent was broken off below the soffit. This could cause sewer gas to enter the building. Recommend repair / replace by a licensed plumber.

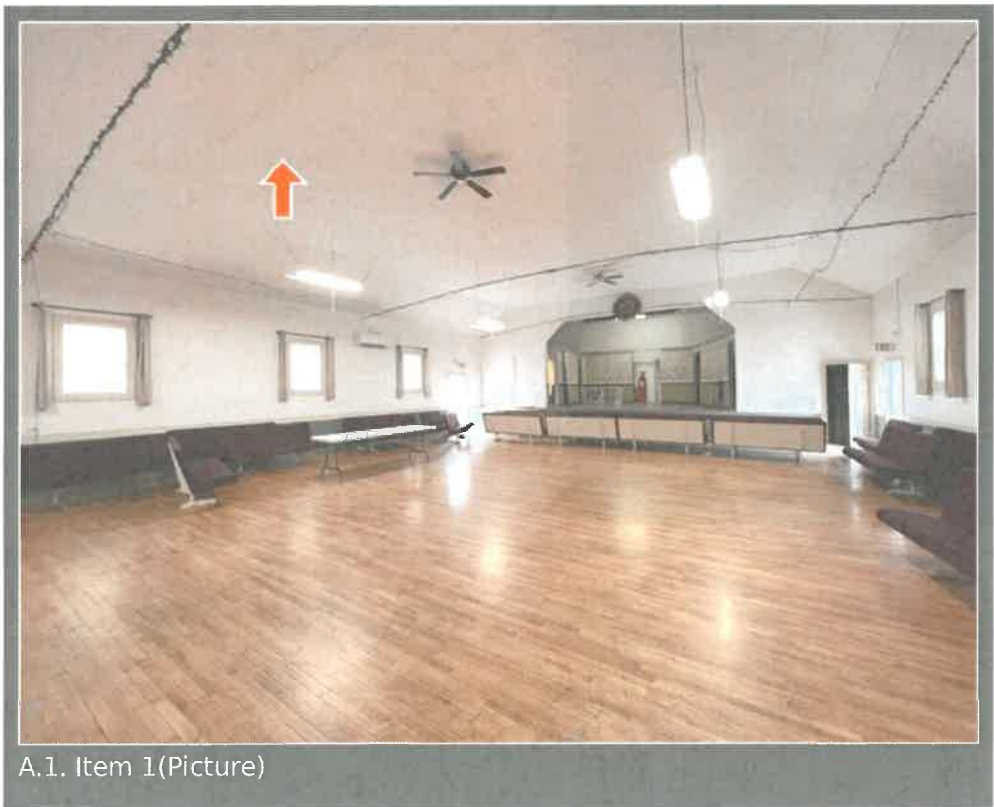
A.1. Item 1(Picture)

**A.1.** The ceilings were in fair condition. The ceiling tiles were consistent with asbestos ceiling tiles from the late 1950's. Asbestos ceiling tiles when disturbed (airborne) and friable can be a serious health concern. Removal should only be done by qualified contractors. Asbestos ceiling tiles do not pose a threat if left undisturbed.

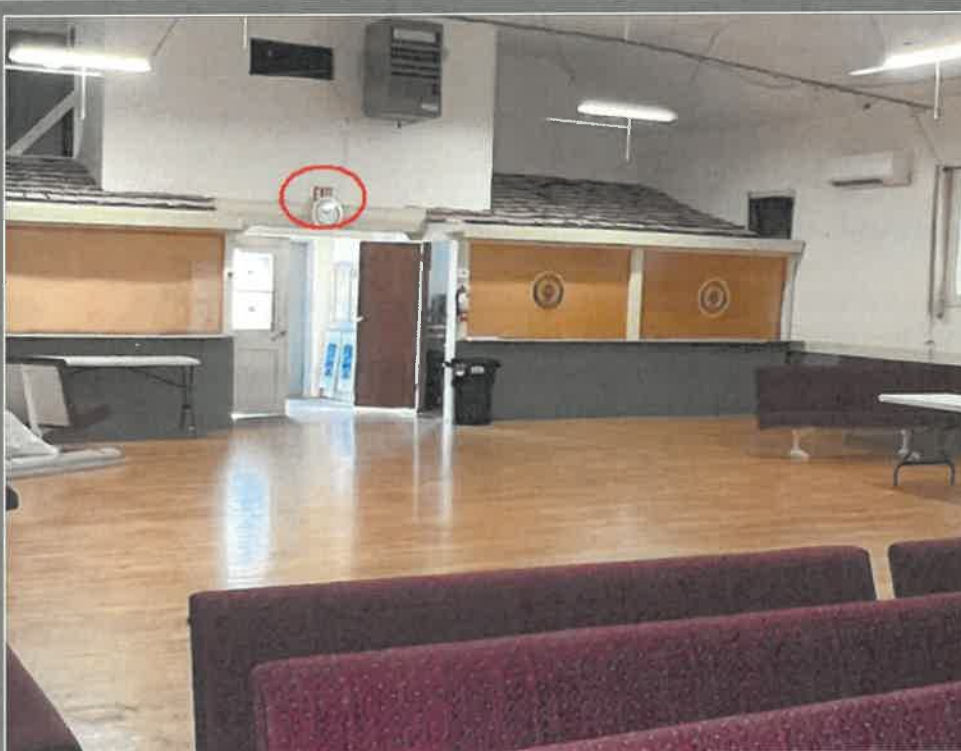
G. Item 1(Picture)

- A.** Inspector observed at the time of inspection overhead wire crossing a fire access road was taller than 13'6".
- B.** Inspector observed the building to have good address signage or visibility.
- C.** Inspector did not observe the storage of fuels or combustibles without proper separation from heaters or shielding to prevent ignition. Flammable conditions were not present at the time of the inspection.
- D.** None present
- E.** A fire extinguisher was located in a conspicuous locations in the building not more than 75' travel distance.
- F.** None present
- G.** The exit sign at the front entry was not illuminated at the time of the inspection and was partially obscured by a clock. This is a hazard. Recommend repair by a licensed electrician.

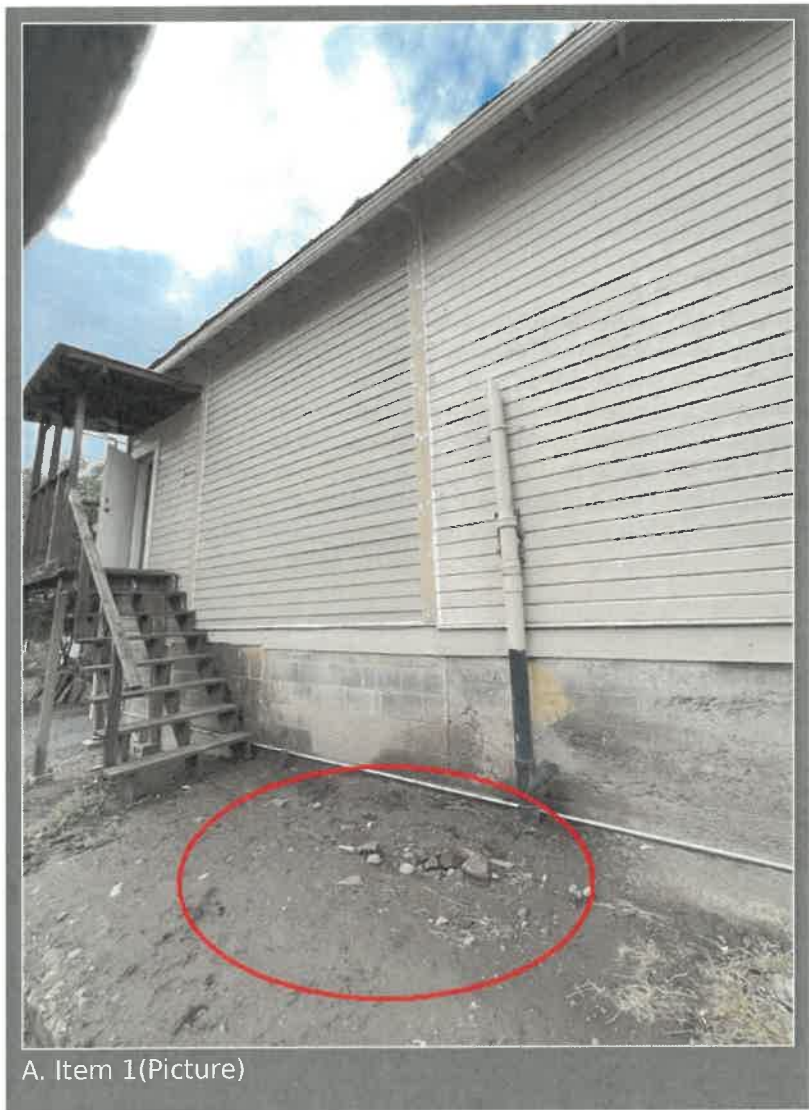
A. Item 1(Picture)

(1) Evidence suggests ponding or standing water can occur at the left side (facing front). The remaining sides of the building indicate similar conditions or fair to poor drainage depending on the amount of rain. Ponding or standing water can effect the foundation leading to undesirable settlement. A qualified person should repair or replace as needed.

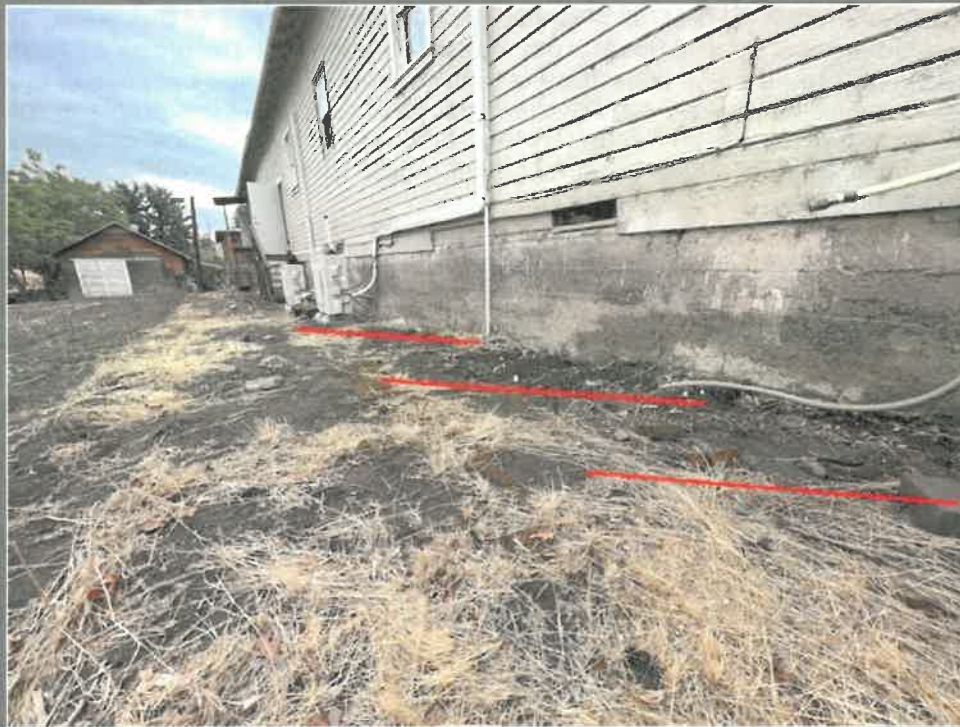
A. Item 2(Picture)

(2) The Eastern edge of the building had a negative grade that slopes runoff towards foundation footing. This can cause foundation settlement issues. Recommend repair by a licensed landscaper.

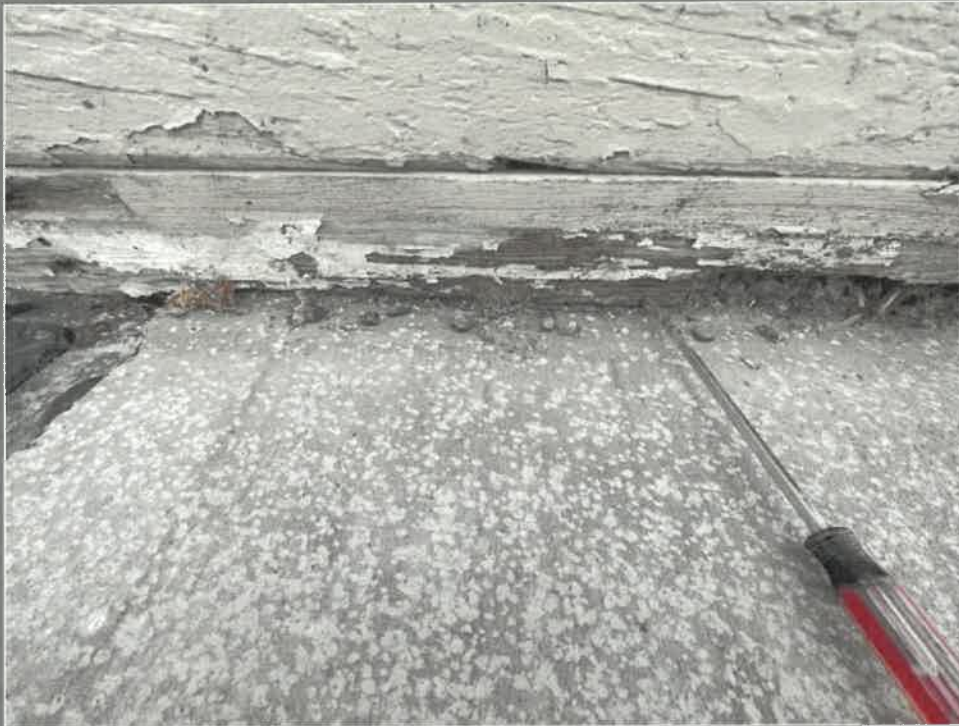
The side walk along Deschutes ave and 4th street was in contact with the buildings wooden components. Concrete absorbs and holds moisture. This can create ideal conditions for wood decay and attract wood destroying organisms. As wood decay's it looses it's structural integrity. Much of the area along the side walk with Deschutes avenue has active wood decay and a permanent moisture source from the above grade sidewalk. Recommend creating separation of the buildings wooden components from the sidewalk. This can be done by building a waterproof barrier that is properly flashed at the bottom course of siding then sealing wooden components to a point below the top edge of the foundation. Recommend evaluation by a licensed structural engineer and any necessary repairs.

E. Item 1(Picture) Wood decay at sidewalk

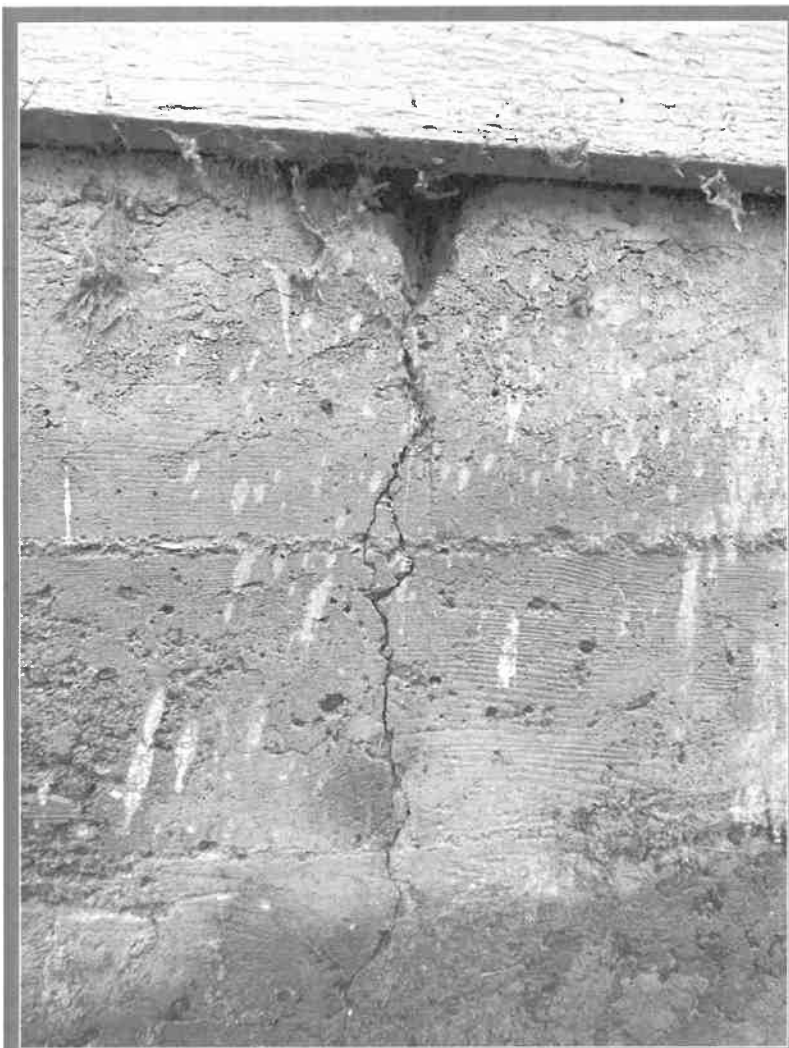
(2) The foundation was cracked on both the exterior and interior sides. Some of these cracks were traced through the stem wall and footer. Of the cracks observed the typical pattern was of tension and shear cracking as shown in the photographs. Tension cracks open in a "V" shape and indicate a pulling apart action. Shear cracking are tight with step over cracking in areas that intersect with the main crack again as the sides slide past in a differential settlement pattern. These cracks occur in highly saturated poorly drained soils at the footing. Under these soil conditions the soil yields to the downward forces resulting in uneven support and cracking foundation areas. It's important to note that the Eastern and South Eastern corner exhibit the most foundation damage and are subject to the most drainage and negative grade problems at the foundation. Recommend evaluation by a licensed structural engineer and all necessary repairs.

A. Item 2(Picture) Shear cracking broken foundation sliding past each other.

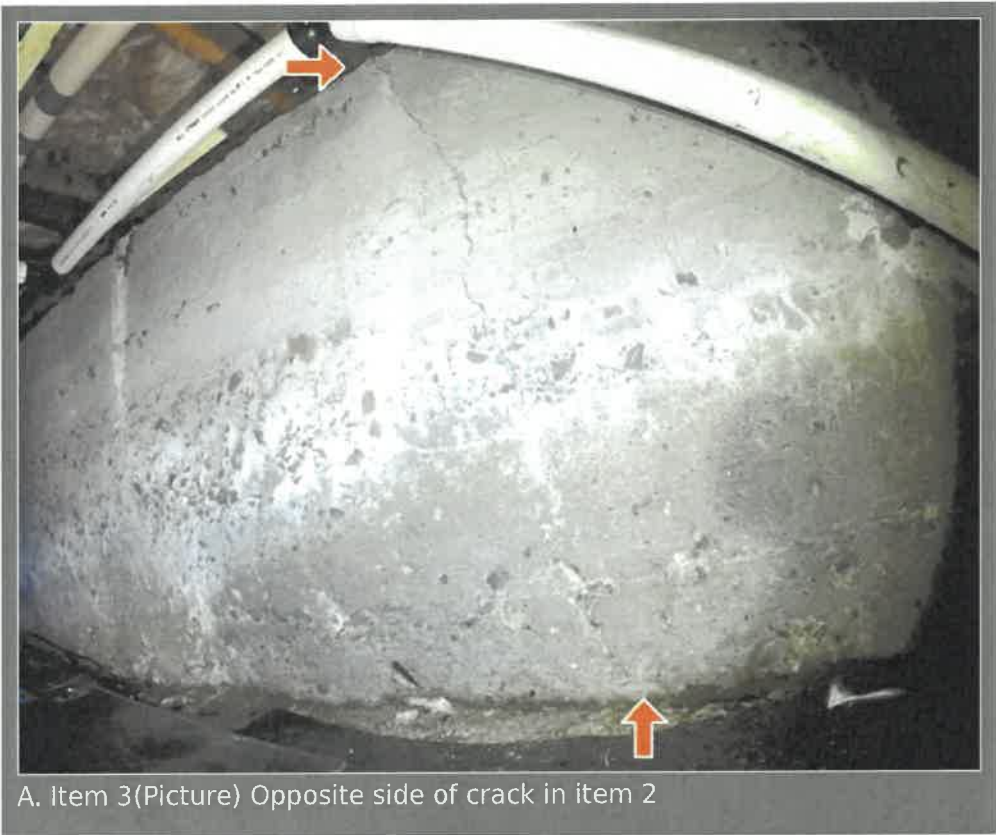
A. Item 3(Picture) Opposite side of crack in item 2

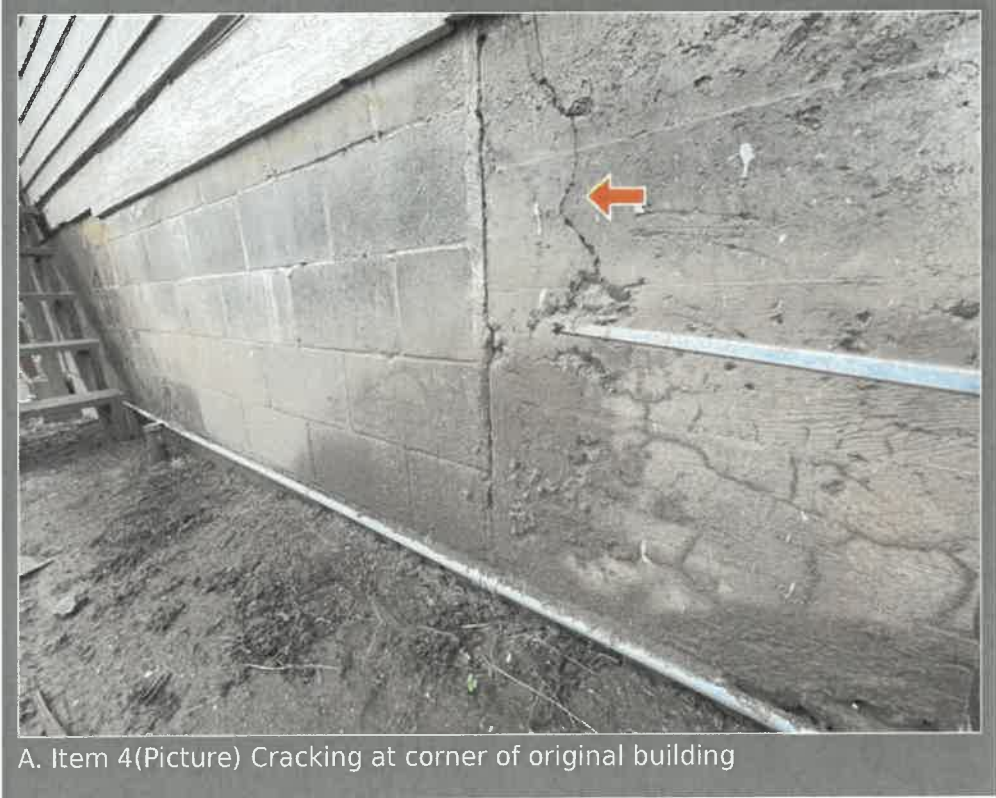
A. Item 4(Picture) Cracking at corner of original building

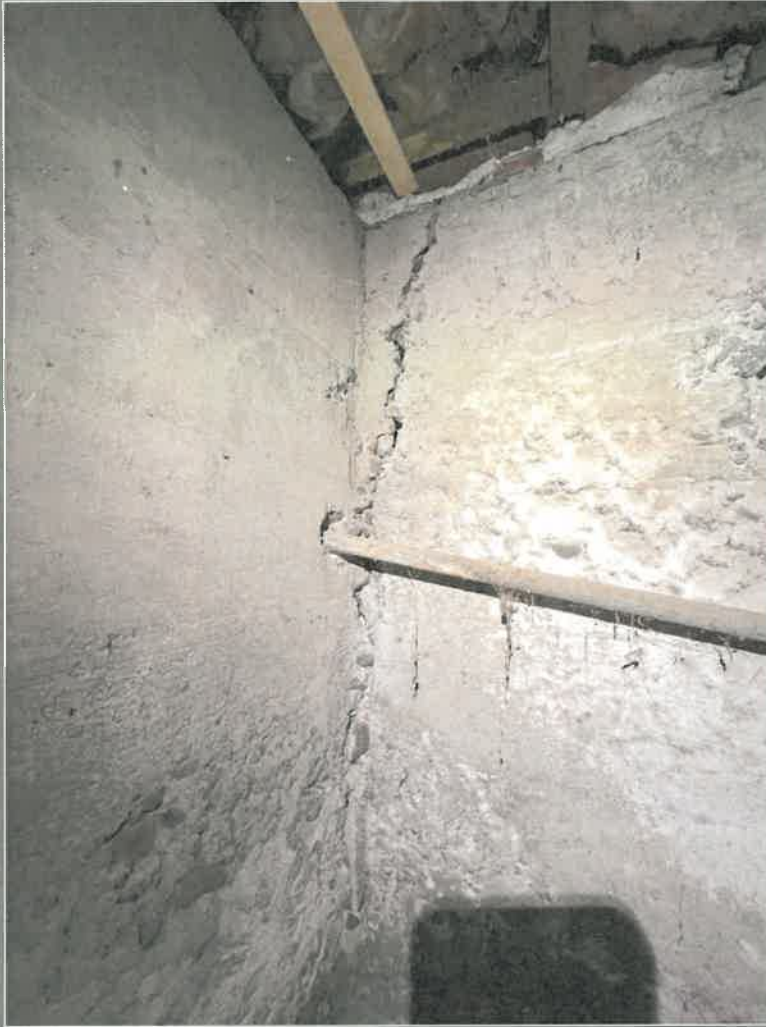
A. Item 5(Picture) opposite side of Item 4

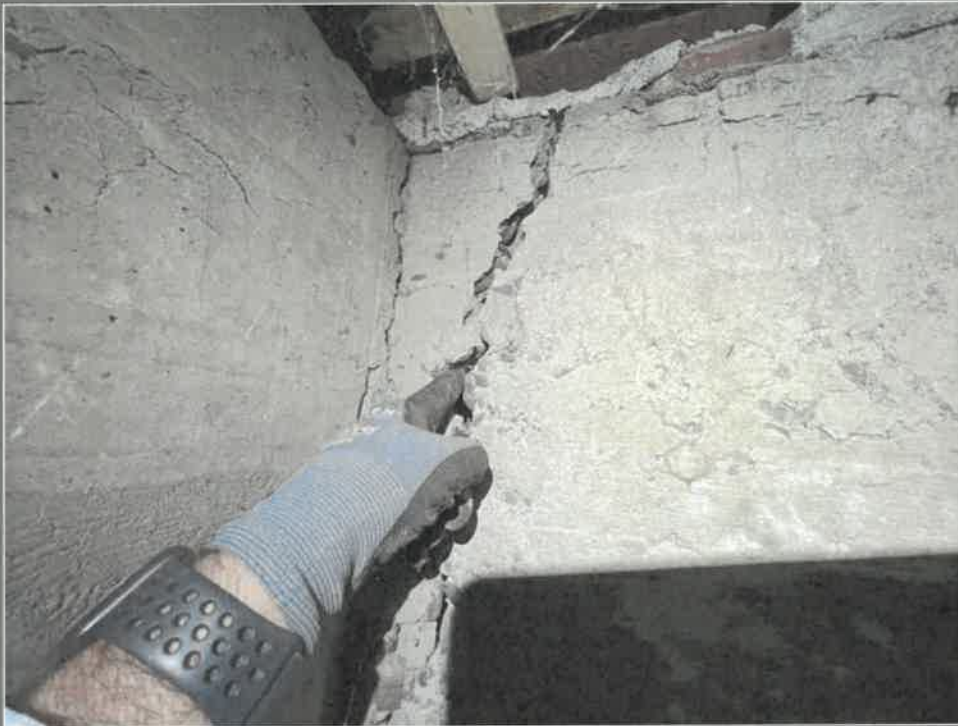
A. Item 6(Picture) Pull apart tension crack. Building pulling away to East.

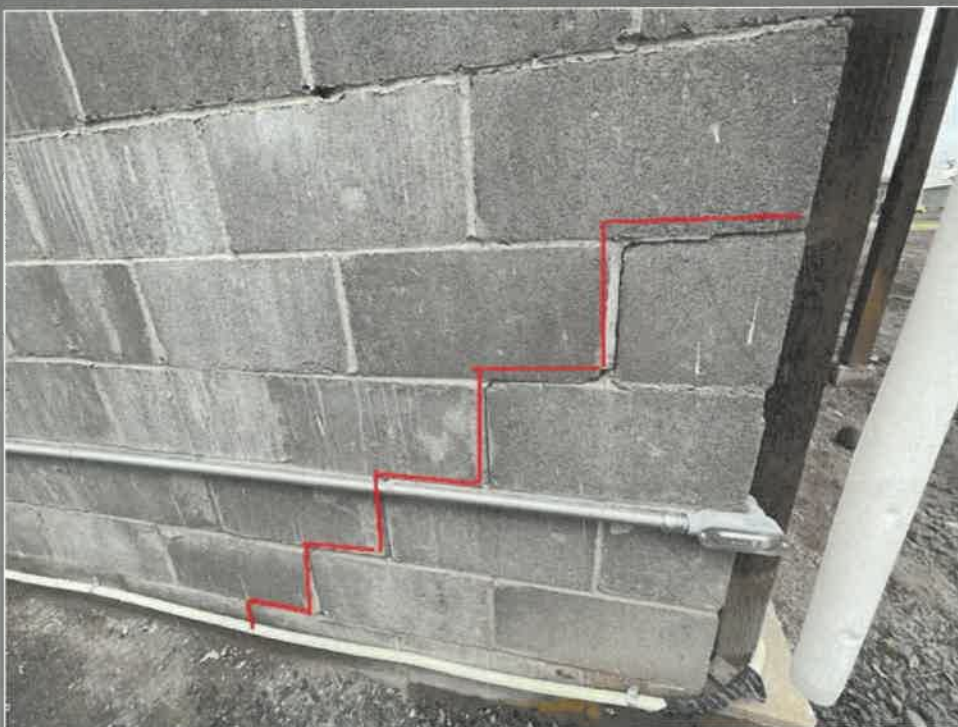
A. Item 7(Picture) Differential settlement at SE corner of addition.

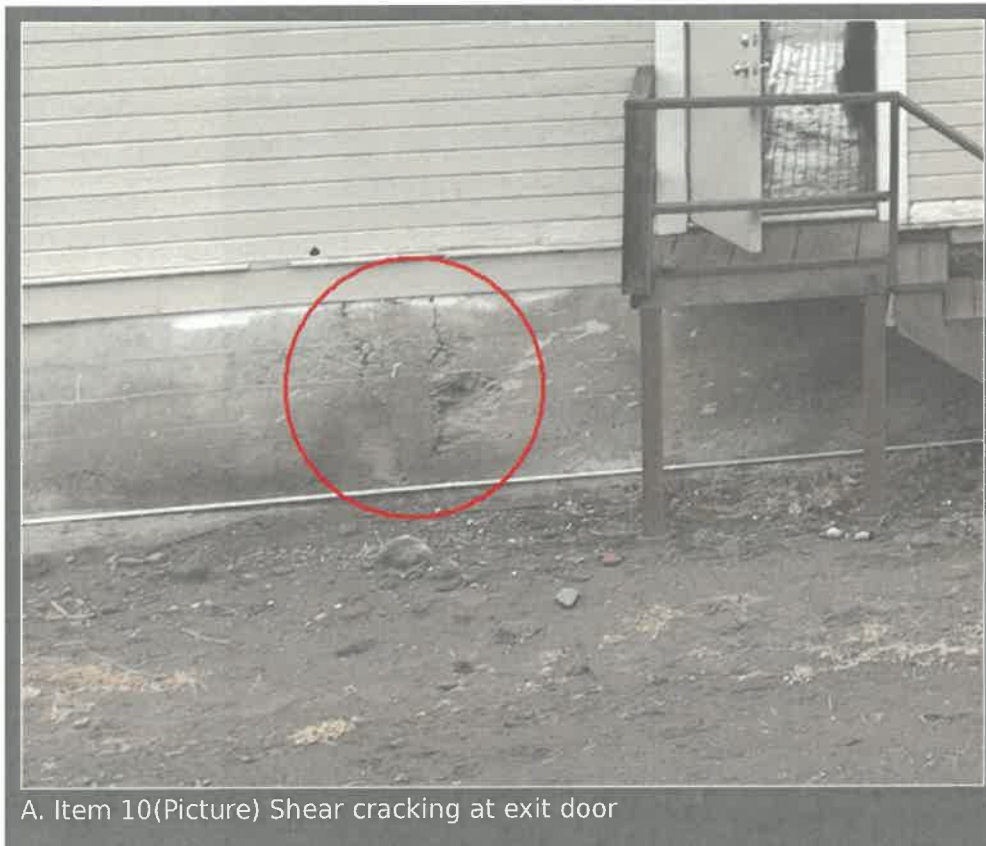
A. Item 10(Picture) Shear cracking at exit door

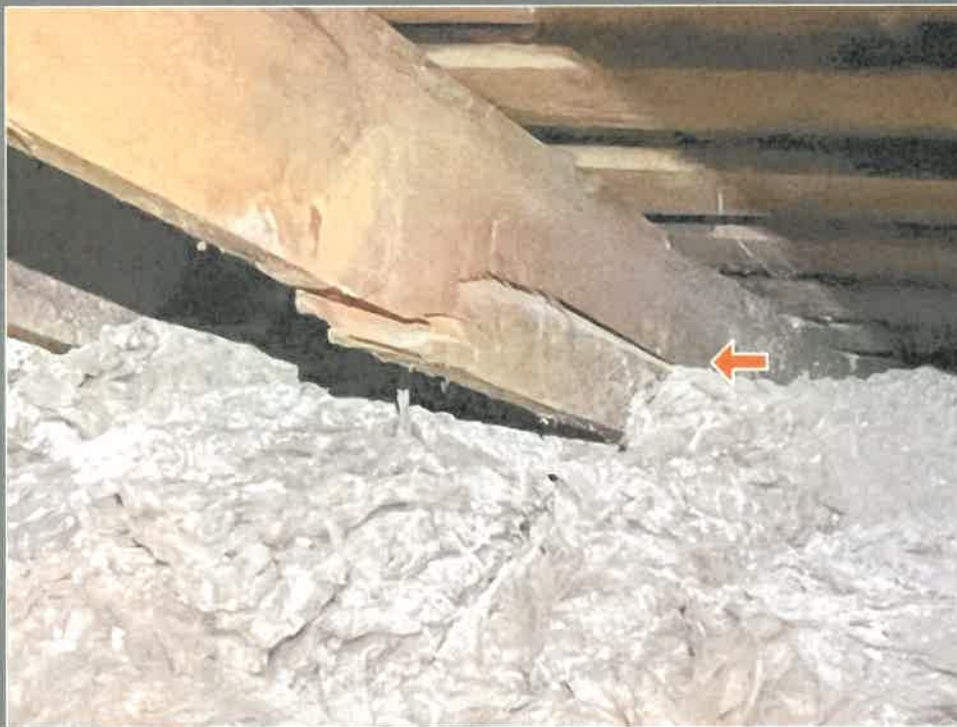
B. Item 1(Picture)

(1) In the attic the assembly consisted of conventional framing of rafters with a ridge beam, rafter ties, and webs. Building distress was found mostly on the Eastern side (same side as cracked foundation) of the building. The rafter ties along the middle 1/3 were cracked from excessive tension forces. This happens when roof spread is occurring. Roof spread is a condition of excessive uniform loading such as snow that causes the rafters to open like a pair of scissors putting excessive tension on the rafter tie. This has caused a serious structural issue with multiple cracked and broken rafters. This is a hazard and could cause the roof to collapse. Recommend evaluation by a licensed structural engineer and all necessary repairs.

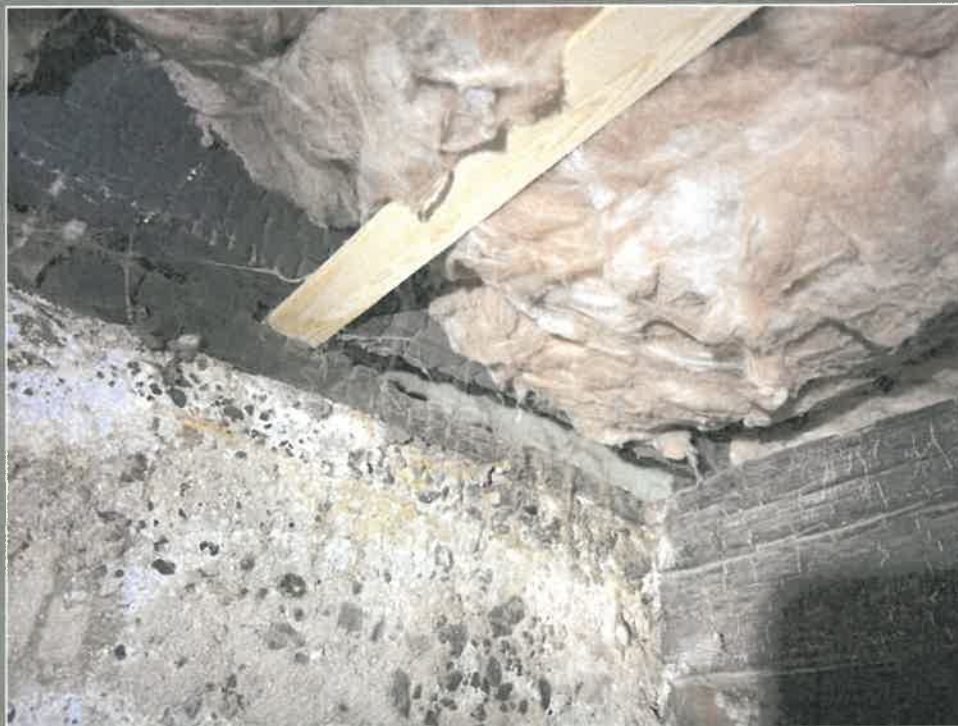
B. Item 18(Picture)

(6) The area under the foyer was subject to a fire in the past. Many structural components are still charred with unknown integrity. Recommend evaluation by a licensed structural engineer.

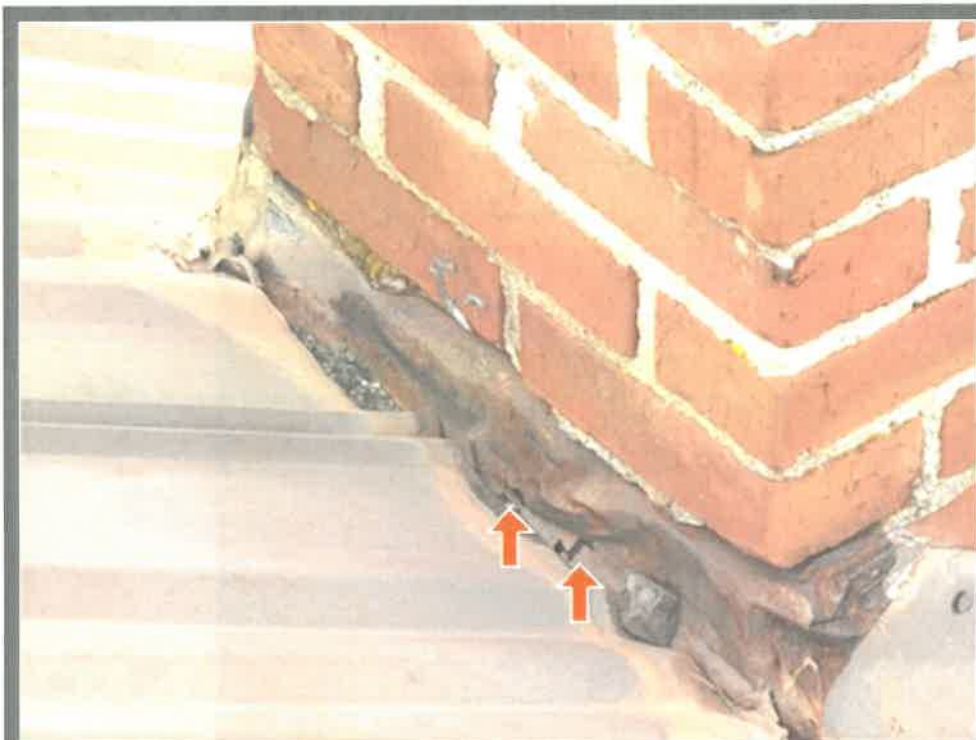
H. Item 1(Picture)

(1) The chimney flashing was corroded with holes that allow water infiltration into the building assembly. This can cause wood decay. Recommend repair by a licensed roofing contractor.

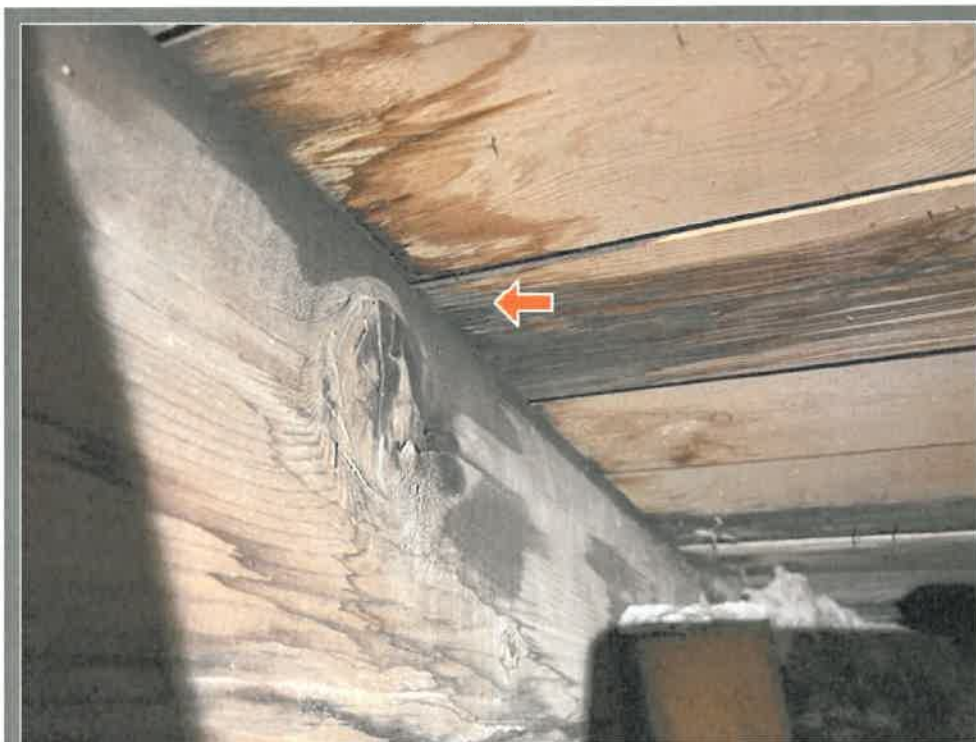
H. Item 2(Picture) Moisture damage from rusted flashing
