## MEETING AGENDA & PUBLIC HEARING NOTICE

City Council

Wednesday, July 24, 2024

Subject: Inspection report regarding current structural condition of the Legion Hall Building at 311 Deschutes Avenue in Maupin, Oregon

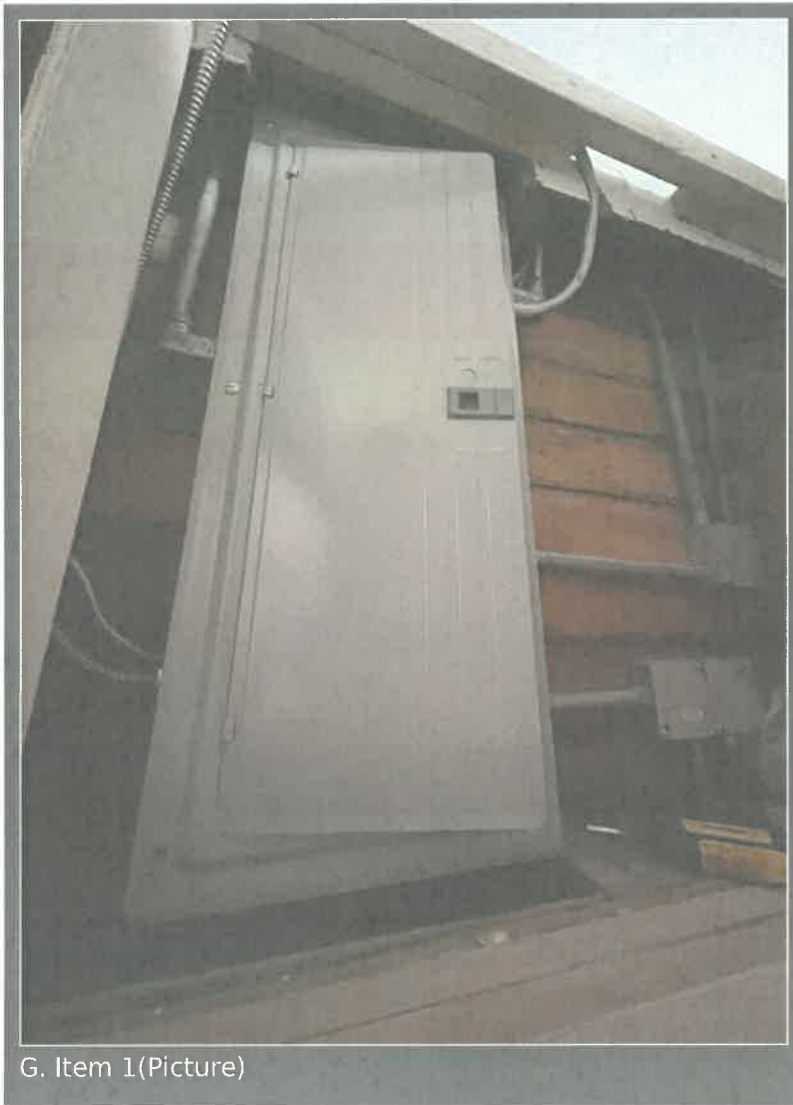
The main service panel did not have proper working clearance. The panel was over 78" tall and the panel was enclosed inside a wall limiting proper working clearance of 36 inches deep and 30 inches wide in front of the panel. This is a hazard. Recommend repair by a licensed electrician.

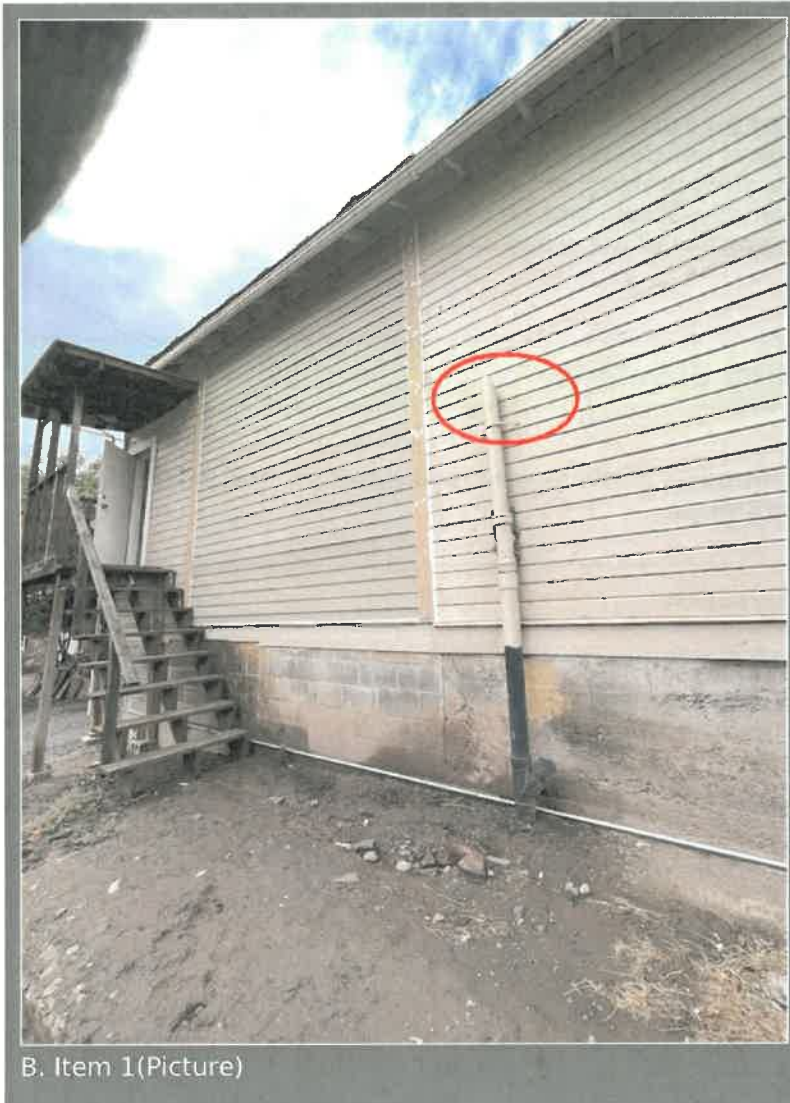
(2) The plumbing vent was broken off below the soffit. This could cause sewer gas to enter the building. Recommend repair / replace by a licensed plumber.
