## MEETING AGENDA & PUBLIC HEARING NOTICE

City Council

Wednesday, July 24, 2024

Subject: Inspection report regarding current structural condition of the Legion Hall Building at 311 Deschutes Avenue in Maupin, Oregon

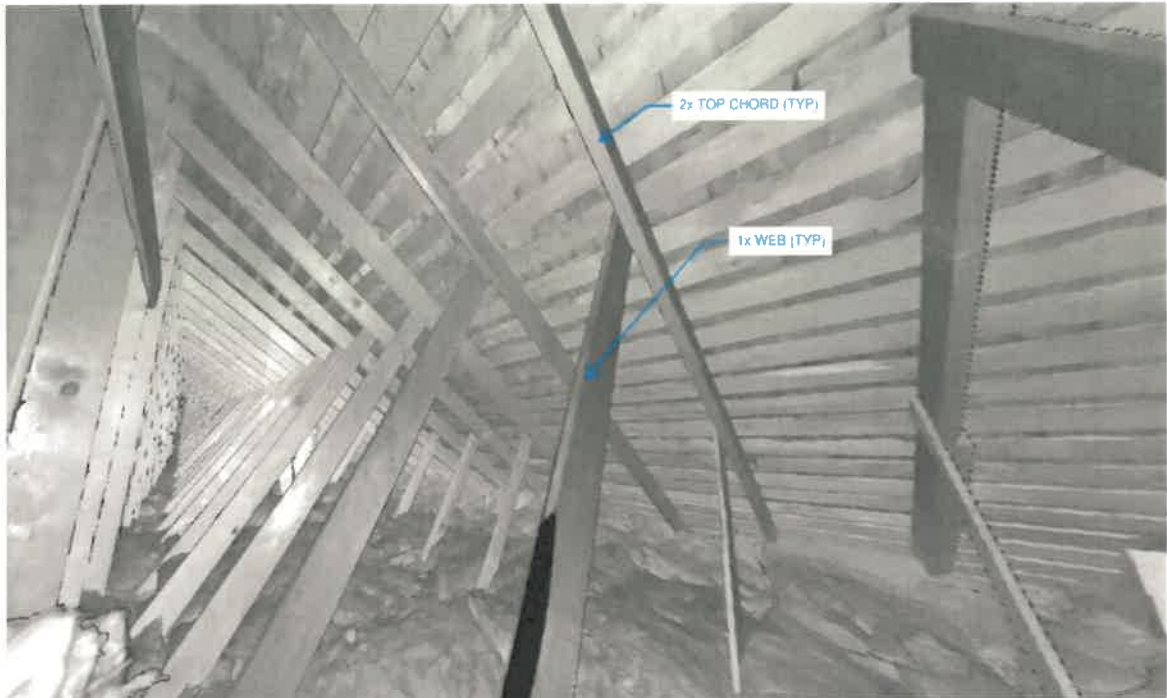
At the main hall, the roof is framed with wooden trusses that are spaced approximately two feet on center (see Figure 24). The top chords are 2x8 members, with 2x6 ceiling framing that also functions as a collar tie, while the webs are 1x materials. The roof sheathing consists of 1x horizontal lumber. The 1x truss webs are inadequate for the roof loads because they are quite slender, which contributes to the bowing in the roof identified from the exterior. Furthermore, inadequate roof framing causes roof spread, applying out-of-plane loads onto the exterior bearing walls. This is causing the tops of the walls to show significant deflection between the steel tie rods and contributes to the wall movement previously mentioned.

FIGURE 24: FRAMING OF MAIN HALL ROOF, CONSISTING OF WOODEN TRUSSES WITH 2X CHORDS AND 1X WEBS.

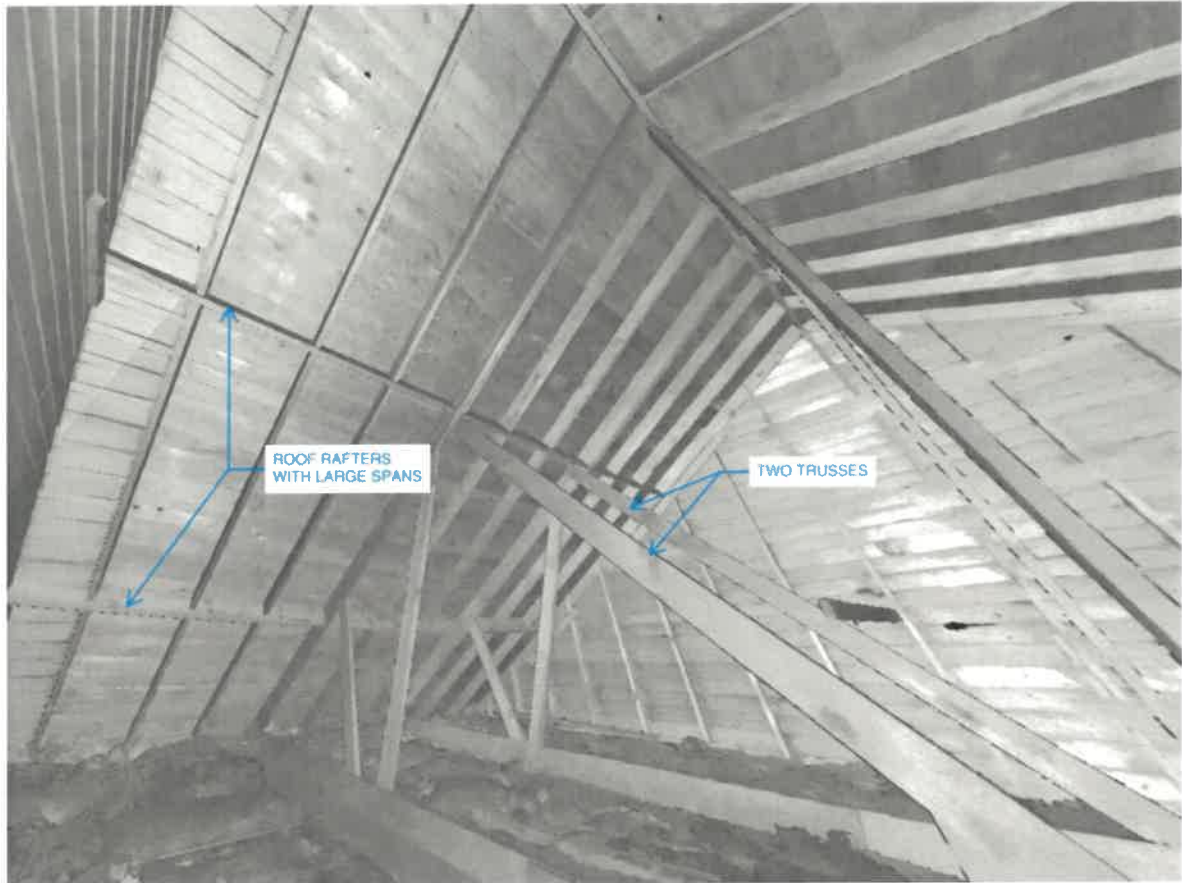
At the costume room addition, the roof framing consists of 2x rafters with spans up to 8-feet, and are significantly undersized for current loads and standards. There are two trusses which consist of 2x and 1x lumber (see Figure 25). **Again, this framing system is significantly under-designed to today's standards, and a new roof system is recommended if the building is to be restored.**

FIGURE 25: ROOF FRAMING AT COSTUME ROOM ADDITION, CONSISTING OF 2X ROOF RAFTERS WITH TWO TRUSSES.

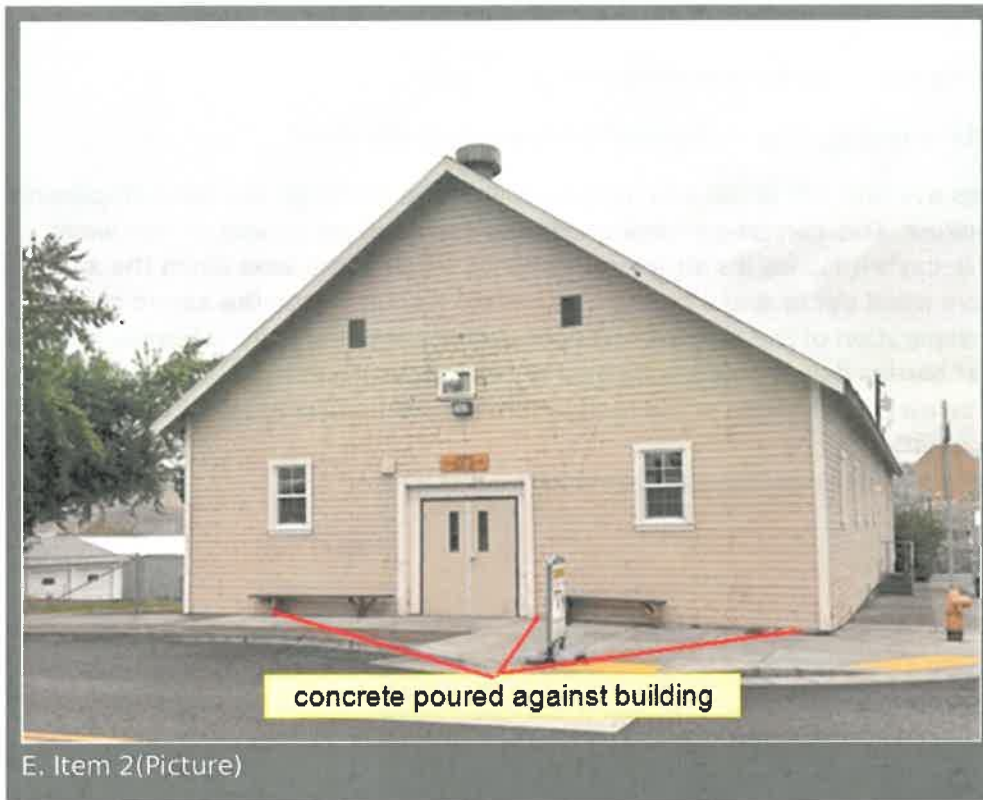
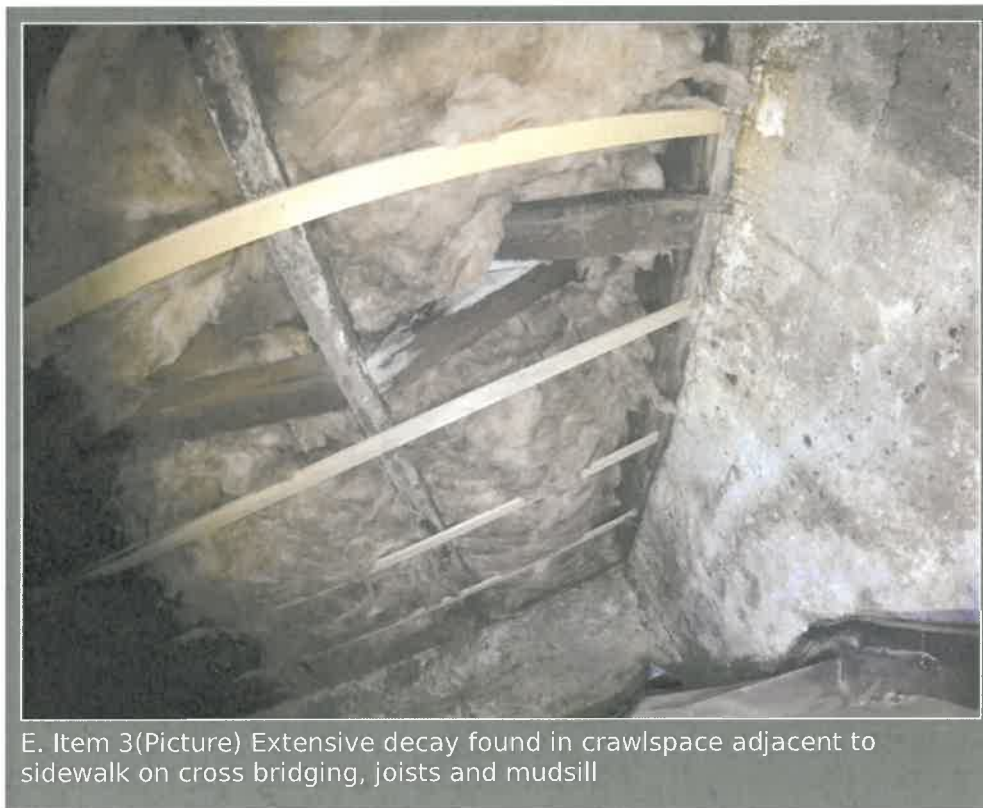
**E.** The side walk along deschutes ave and 4th street was in contact with the buildings wooden components. Concrete absorbs and holds moisture. This can create ideal conditions for wood decay and attract wood destroying organisms. As wood decay's it loses its structural integrity. Much of the area along the side walk with Deschutes avenue has active wood decay and a permanent moisture source from the above grade sidewalk. Recommend creating separation of the buildings wooden components from the sidewalk. This can be done by building a waterproof barrier that is properly flashed at the bottom course of siding then sealing wooden components to a point below the top edge of the foundation. Recommend evaluation by a licensed structural engineer and any necessary repairs.

E. Item 1(Picture) Wood decay at sidewalk

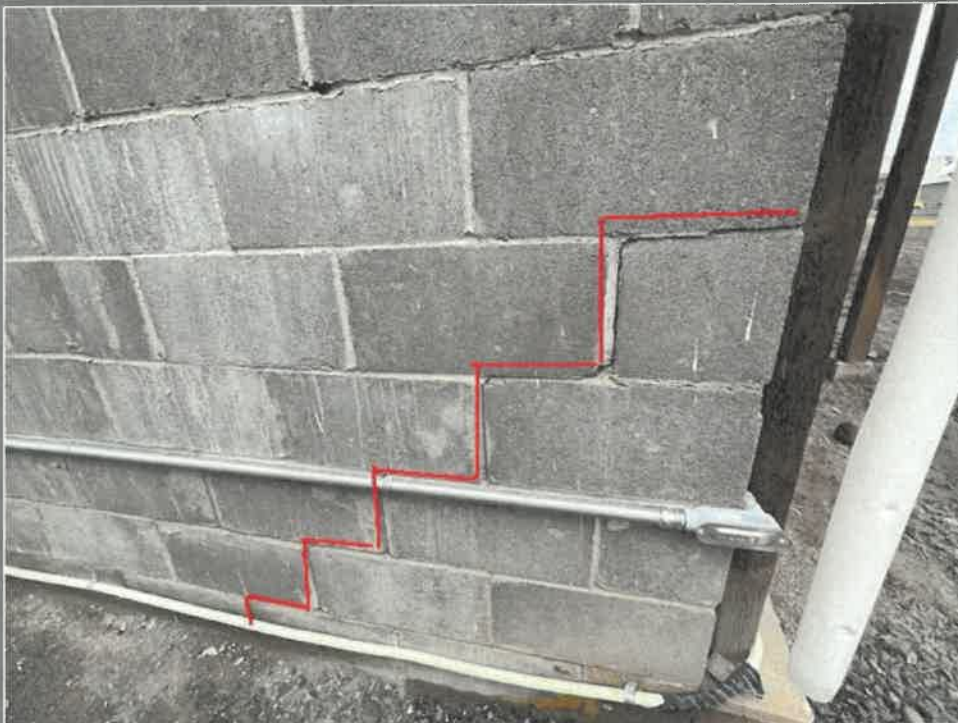
(2) The foundation was cracked on both the exterior and interior sides. Some of these cracks were traced through the stem wall and footer. Of the cracks observed the typical pattern was of tension and shear cracking as shown in the photographs. Tension cracks open in a "V" shape and indicate a pulling apart action. Shear cracking are tight with step over cracking in areas that intersect with the main crack again as the sides slide past in a differential settlement pattern. These cracks occur in highly saturated poorly drained soils at the footing. Under these soil conditions the soil yields to the downward forces resulting in uneven support and cracking foundation areas. It's important to note that the Eastern and South Eastern corner exhibit the most foundation damage and are subject to the most drainage and negative grade problems at the foundation. Recommend evaluation by a licensed structural engineer and all necessary repairs.

A. Item 7(Picture) Differential settlement at SE corner of addition.

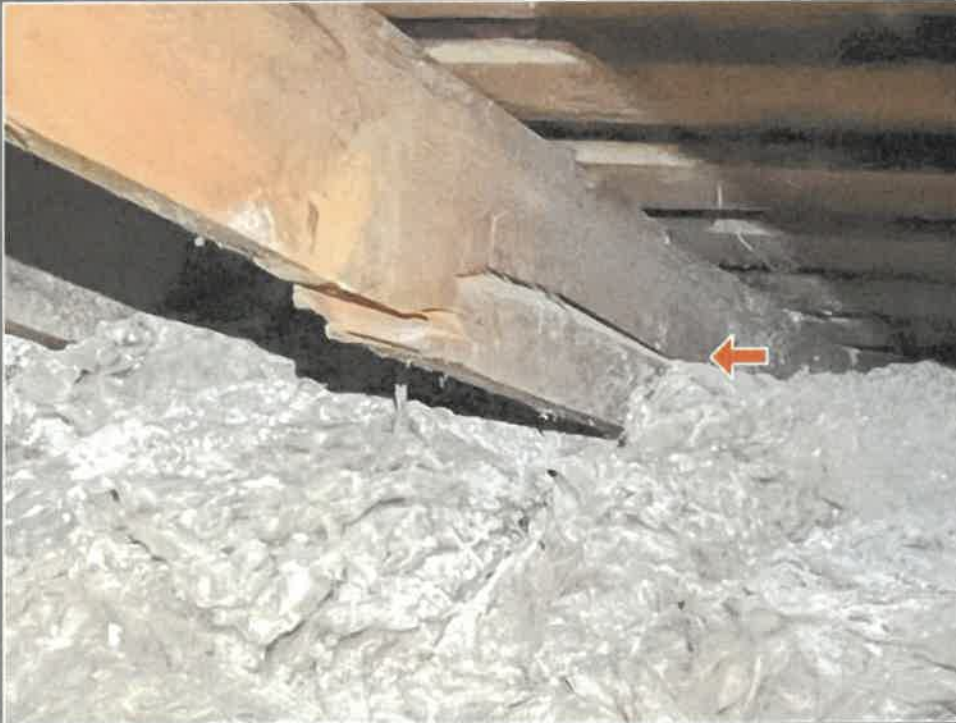
B. Item 1(Picture)

**B.** (1) In the attic the assembly consisted of conventional framing of rafters with a ridge beam, rafter ties, and webs. Building distress was found mostly on the Eastern side (same side as cracked foundation) of the building. The rafter ties along the middle 1/3 were cracked from excessive tension forces. This happens when roof spread is occurring. Roof spread is a condition of excessive uniform loading such as snow that causes the rafters to open like a pair of scissors putting excessive tension on the rafter tie. This has caused a serious structural issue with multiple cracked and broken rafters. This is a hazard and could cause the roof to collapse. Recommend evaluation by a licensed structural engineer and all necessary repairs.

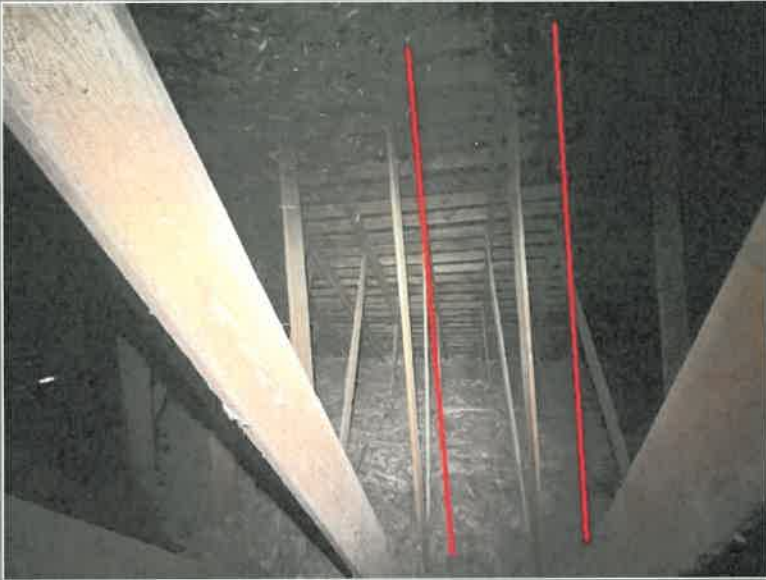
B. Item 6(Picture)

(2) The rafters and webbing was racked towards the front of the building. This is due to the lack of lateral bracing. Excessive lateral movement of the roof assembly can result in roof collapse. Recommend evaluation by a licensed structural engineer.

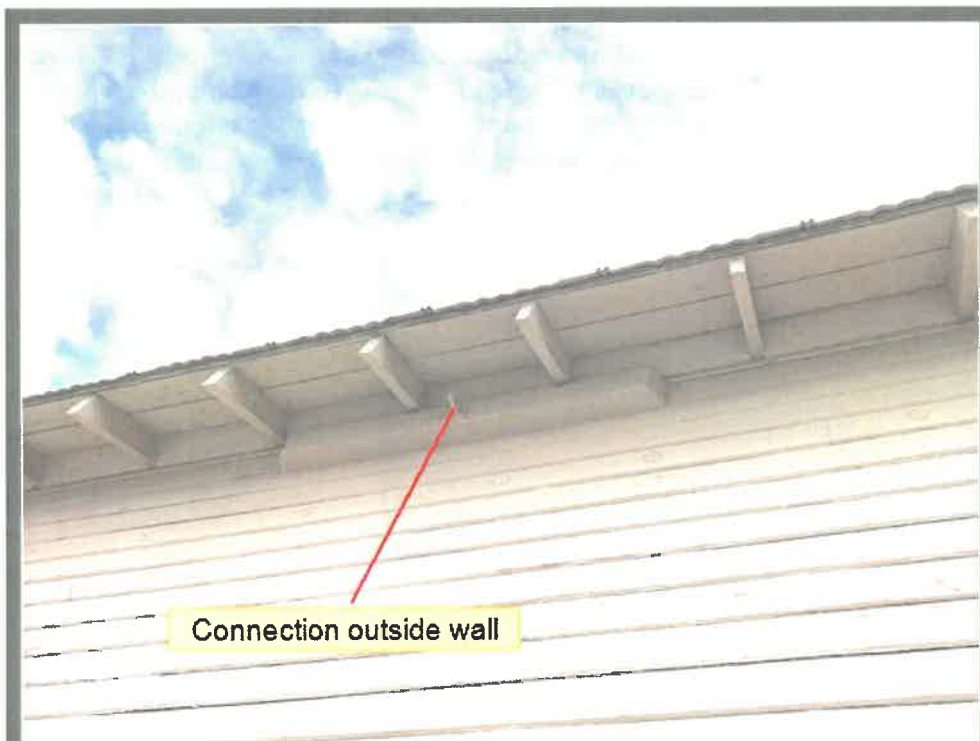
(3) The building wall assembly in the main assembly area was supported at the top plate by a system of tie rods tensioning turnbuckles, washers and bolts over a deadman wood blocking at the exterior sides. Due to the roof spread mentioned in Inspection item 1 the stud bays outside of the wall tensioning system have bulged outward. This has caused the bottom plate to come away from the floor near the kitchen. This is a serious structural issue. Recommend evaluation by a licensed structural engineer and any necessary repairs.

Connection outside wall

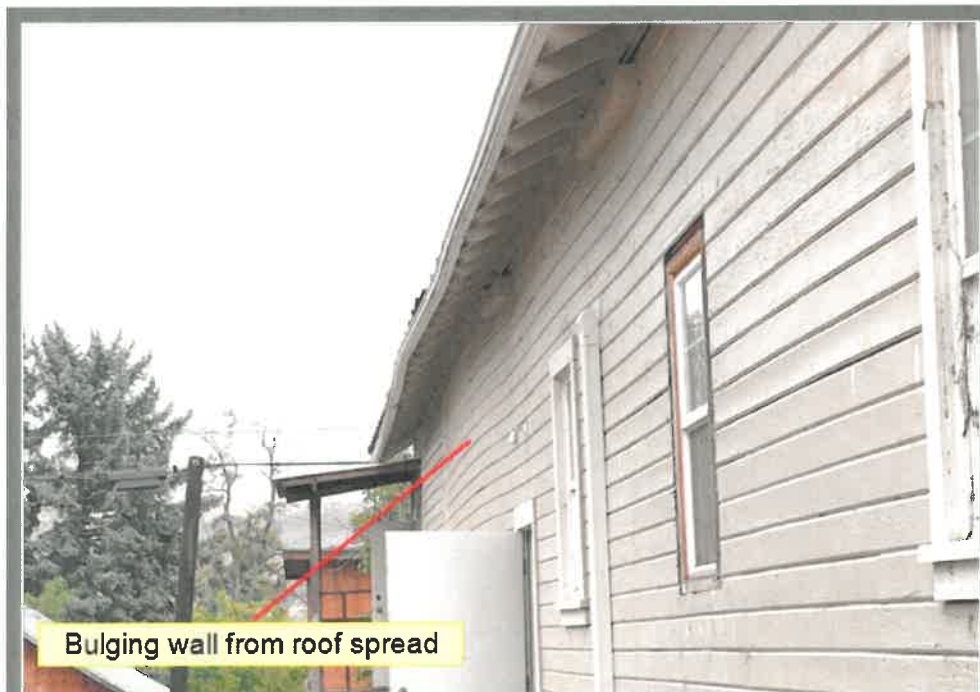
Bulging wall from roof spread

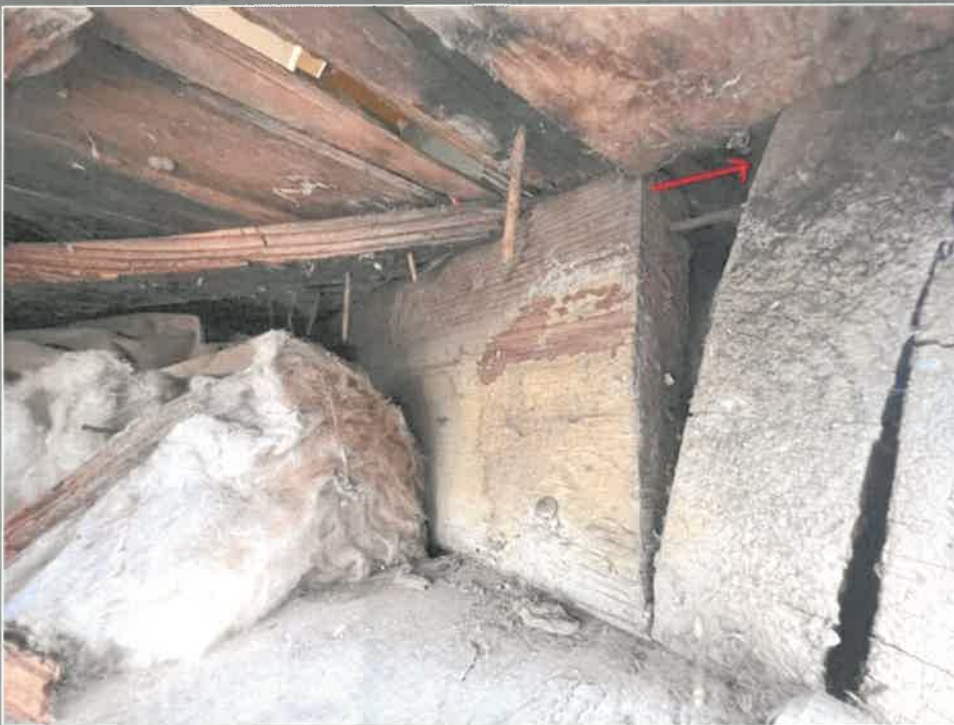
B. Item 13(Picture) As walls are pushed off the rim joist is pulling away as well. Eastern side near bottom plate bulge

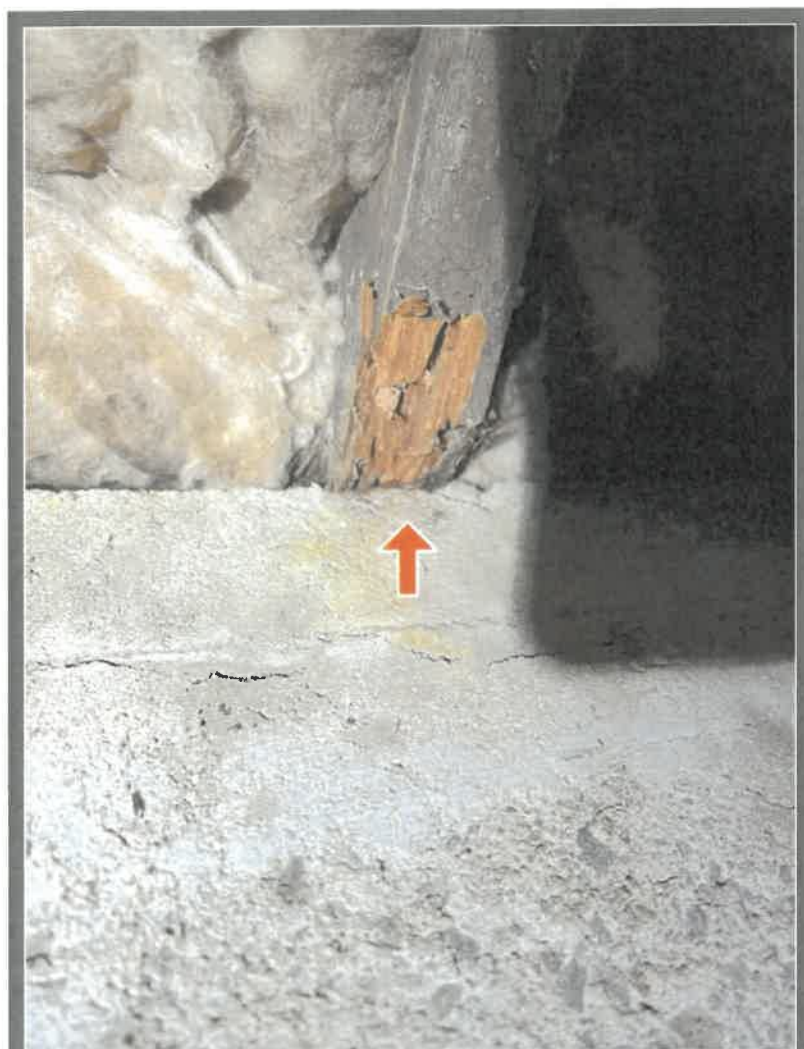
B. Item 16(Picture)

(5) Many of the floor joists and girders had brown rot decay and white rot decay evidence at the time of the inspection. This is an indication that active decay and moist conditions has been taking place for many years. Many structural members underfloors have been compromised do to extensive decay.

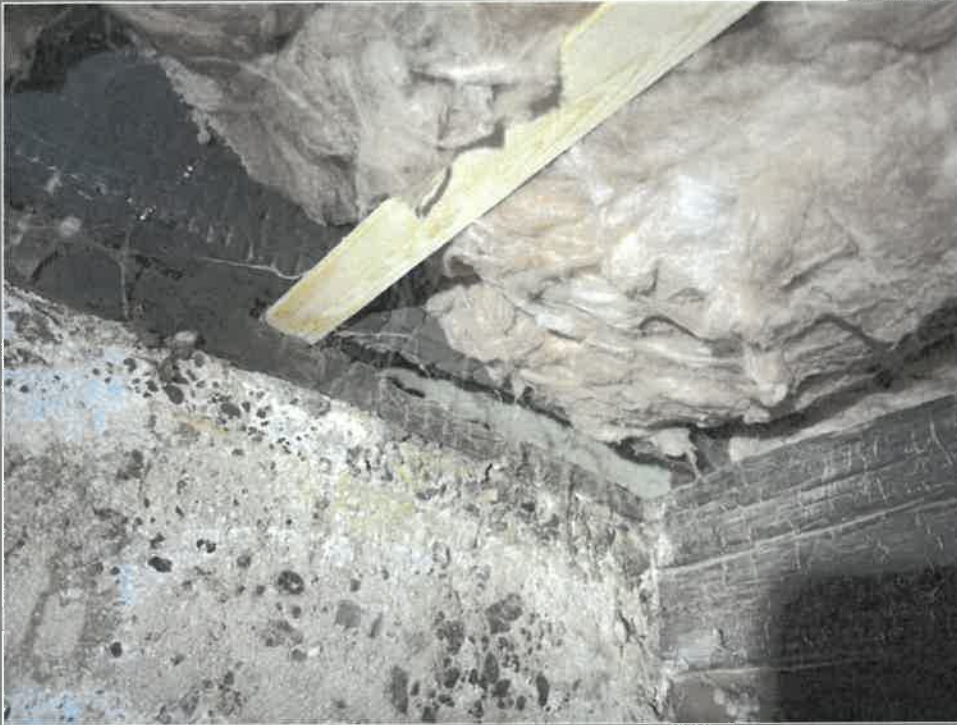
B. Item 18(Picture)

(6) The area under the foyer was subject to a fire in the past. Many structural components are still charred with unknown integrity. Recommend evaluation by a licensed structural engineer.

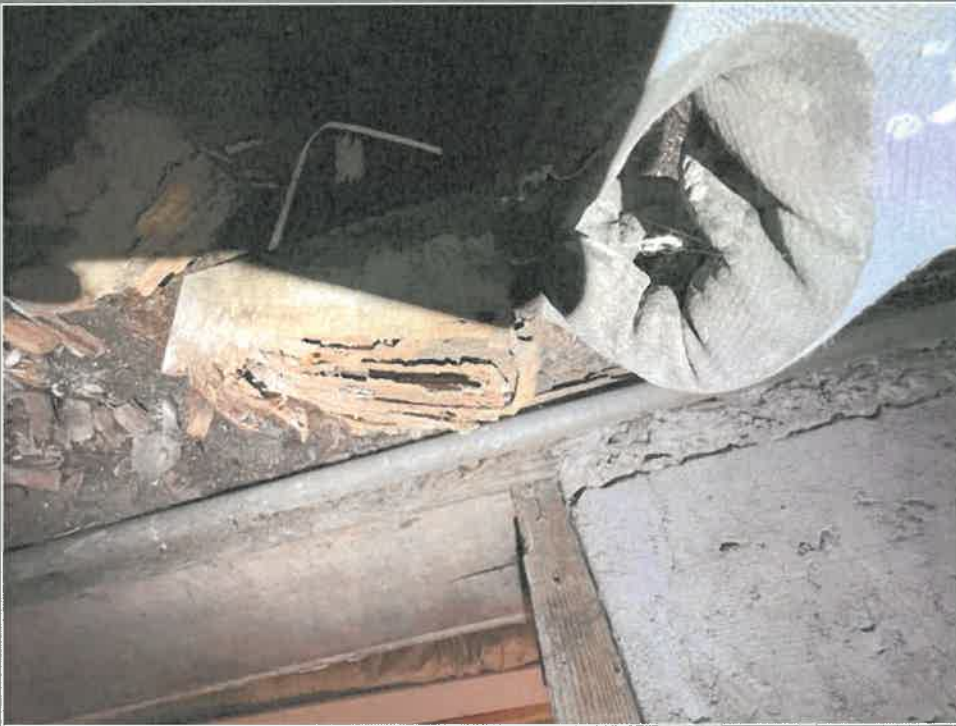
(7) Inspector observed evidence of termite activity with their signature linear galleries along the spring wood grain on lumber in contact with soil. No bodies or wings were found. Recommend evaluation and treatment by a licensed pest contractor.

B. Item 19(Picture) In crawlspace wood debris was prevalent under vapor barrier and above.

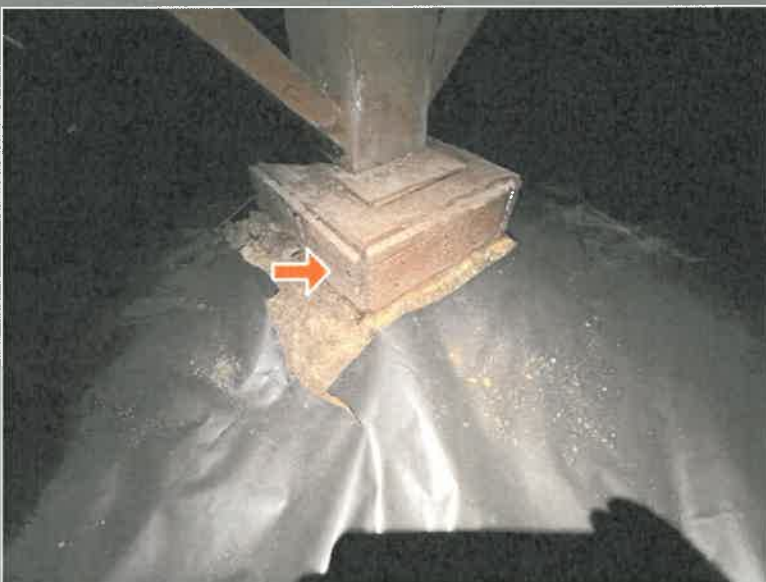
B. Item 20(Picture) Wooden forms left in place in contact with earth is perfect habitat for termites.

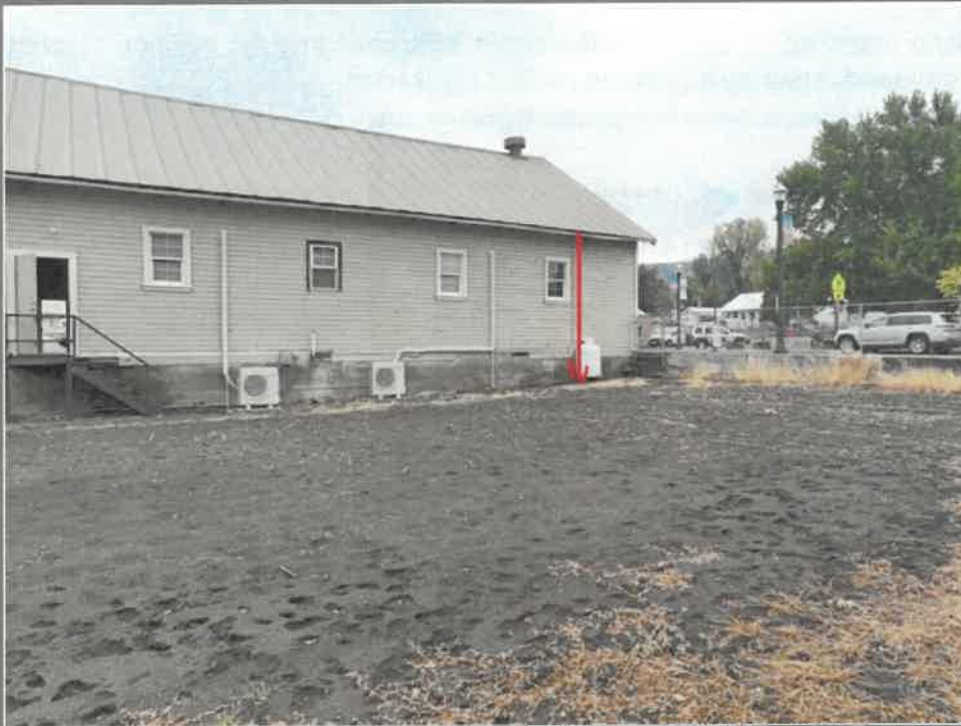
F. Item 2(Picture)

**F.** The steep metal roof over shoots the gutter in many areas resulting in a heavy drip line and concentration of moisture at the foundation footing. This accumulation of moisture can cause serious foundation issues such as the ones indicated in this report. Roof runoff should be conveyed away from the foundation by at least 10' Recommend repair by a licensed gutter contractor.

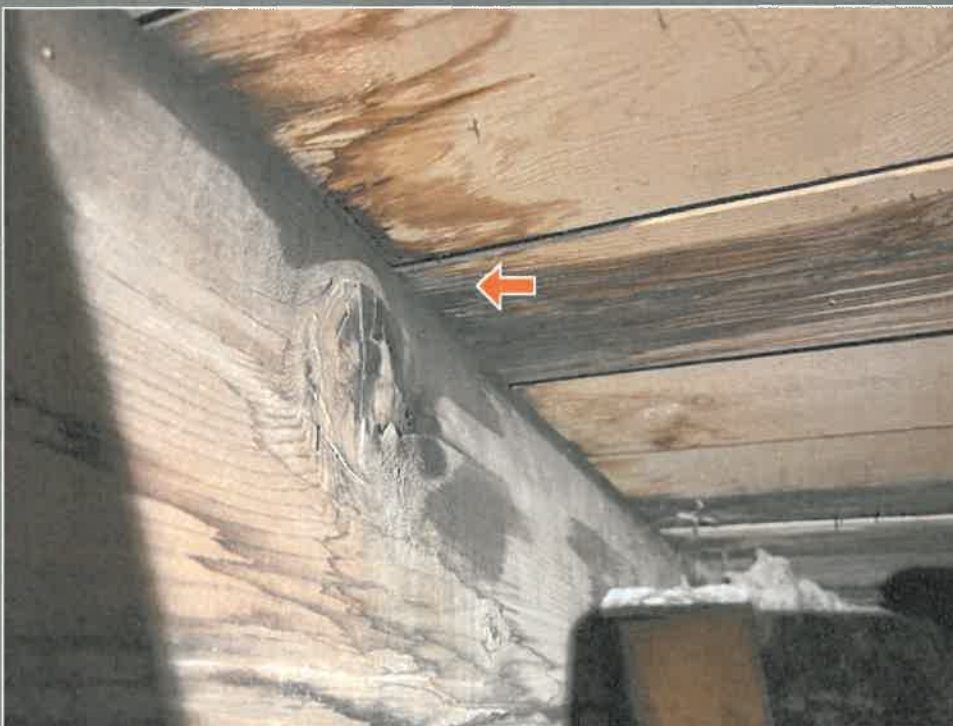
**H. (1)** The chimney flashing was corroded with holes that allow water infiltration into the building assembly. This can cause wood decay. Recommend repair by a licensed roofing contractor.

H. Item 2(Picture) Moisture damage from rusted flashing

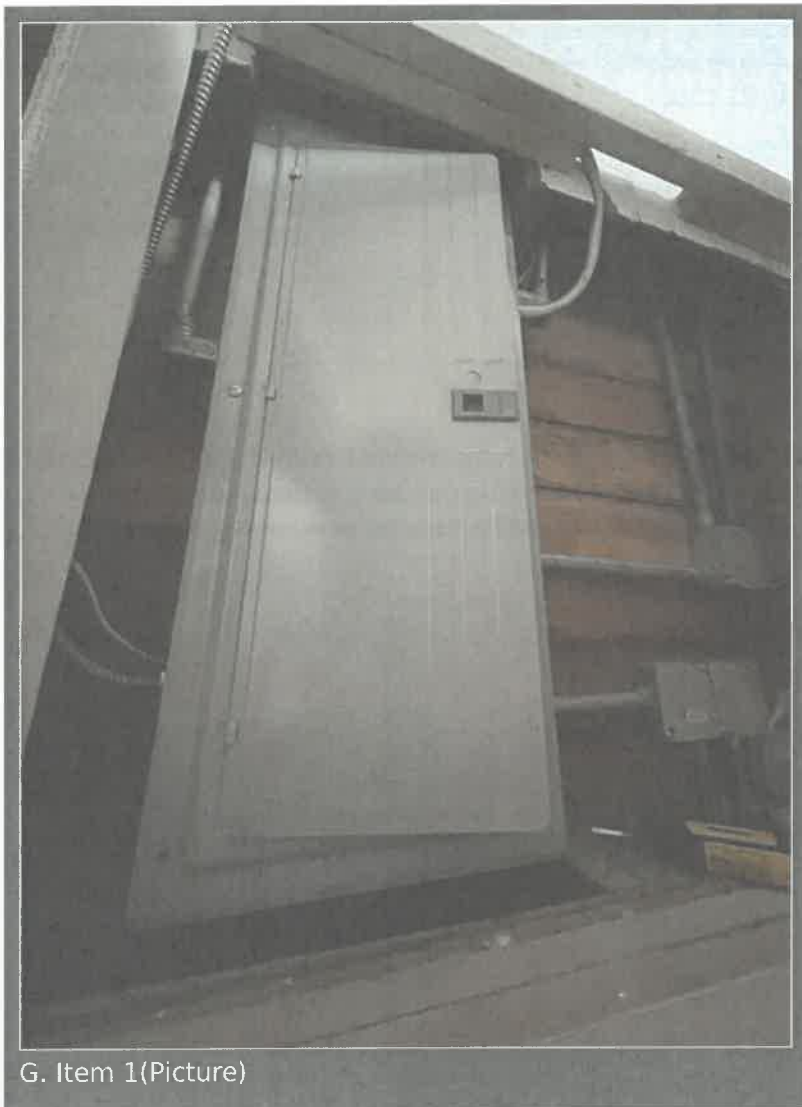
- C.** The domestic hot water production was available in the kitchen only. The hot water production was in good condition.
- D.** The heating equipment was in good condition.
- E.** The air conditioning was provided by the mini split systems and was in good condition.
- F.** The electric service and meter was in good condition overall. Notable exceptions will be in this report.
- G.** The main service panel did not have proper working clearance. The panel was over 78" tall and the panel was enclosed inside a wall limiting proper working clearance of 36 inches deep and 30 inches wide in front of

the panel. This is a hazard. Recommend repair by a licensed electrician.

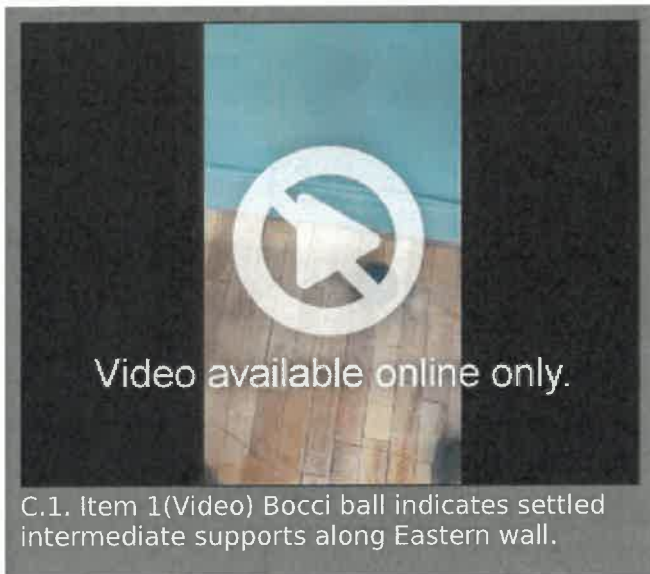
**C.1.** The floors had areas of weakness and low spots from intermediate support settlement. High moisture content in the soil of the crawl space was observed. Recommend proper drainage and grading by a qualified person.

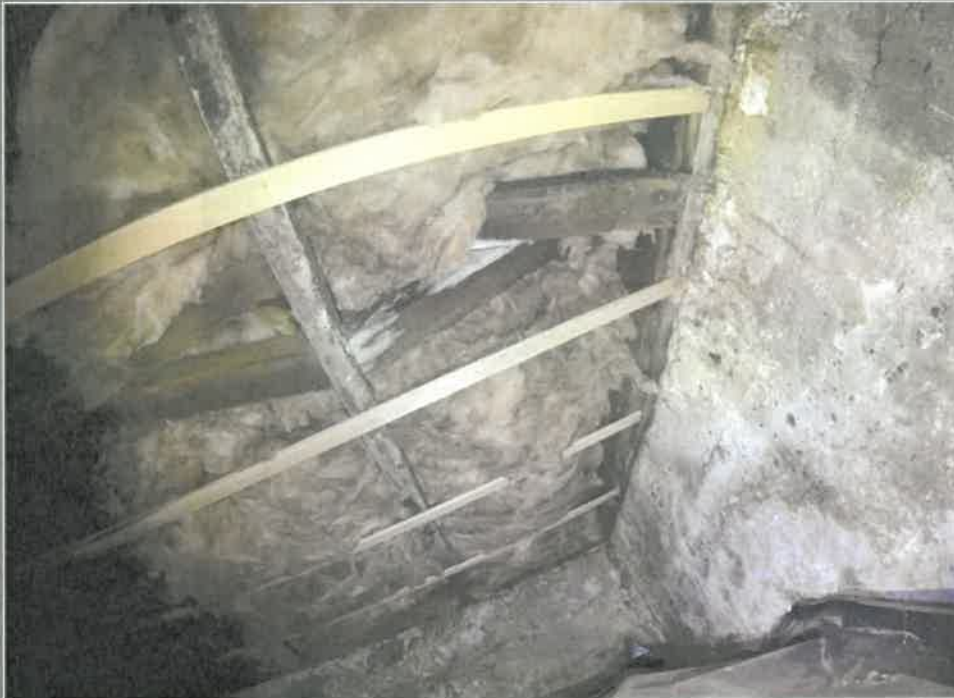
E. Item 3(Picture) Extensive decay found in crawlspace adjacent to sidewalk on cross bridging, joists and mudsill

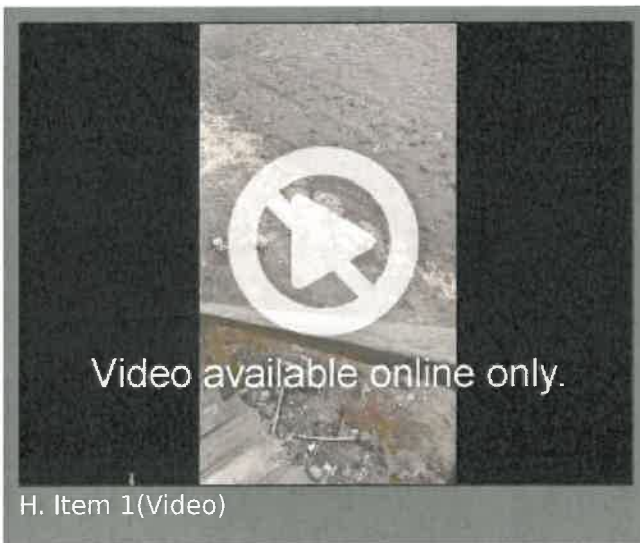
H. Item 1(Video)

The exterior stairs on the Eastern side of the building had a non-graspable hand rail that was loose at both stairs. This is a safety issue. Recommend repair by a licensed carpenter.

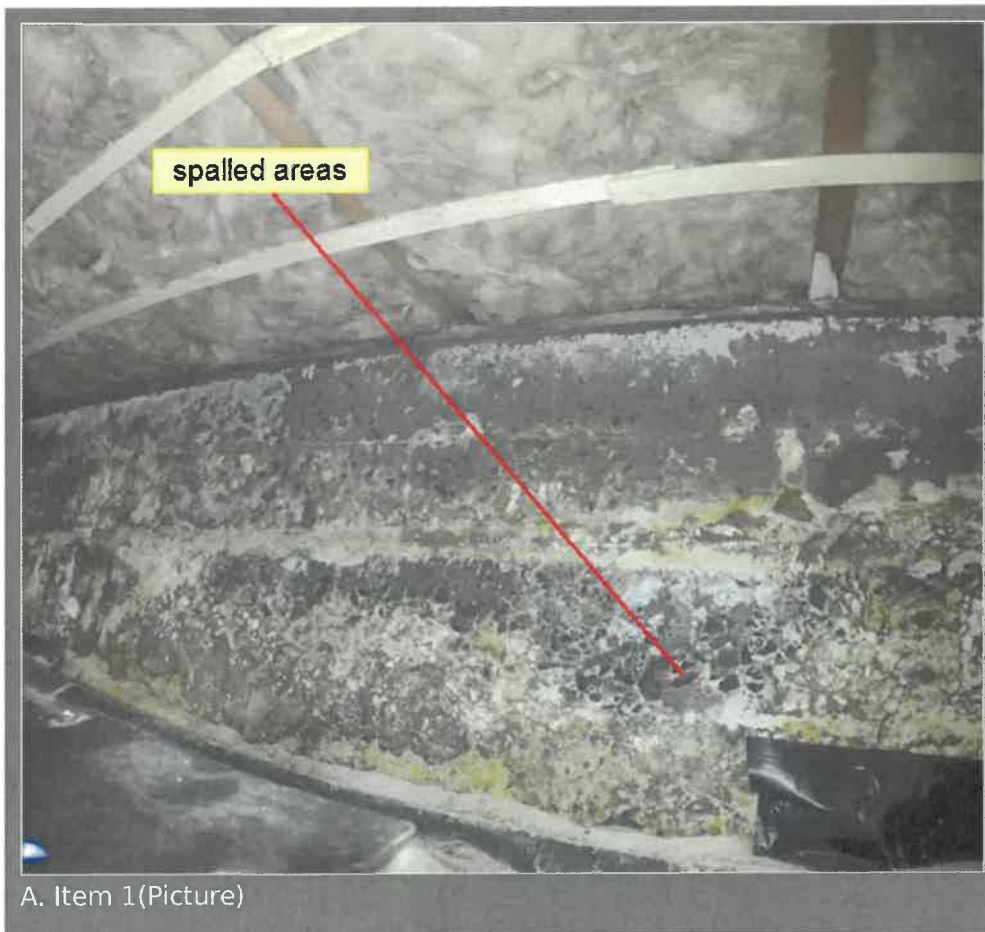
(1) The foundation walls are in poor condition overall. The walls have evidence of heavy efflorescence (moisture and salts driven through the concrete) and subsequent spalling from the osmotic pressures. The foundation was poured at a time when parge coating the exterior portion of the wall below grade was not practiced. Consequently, hydrostatic pressure continues to act on the foundation through

time gradually. Recommend evaluation by a licensed foundation contractor.

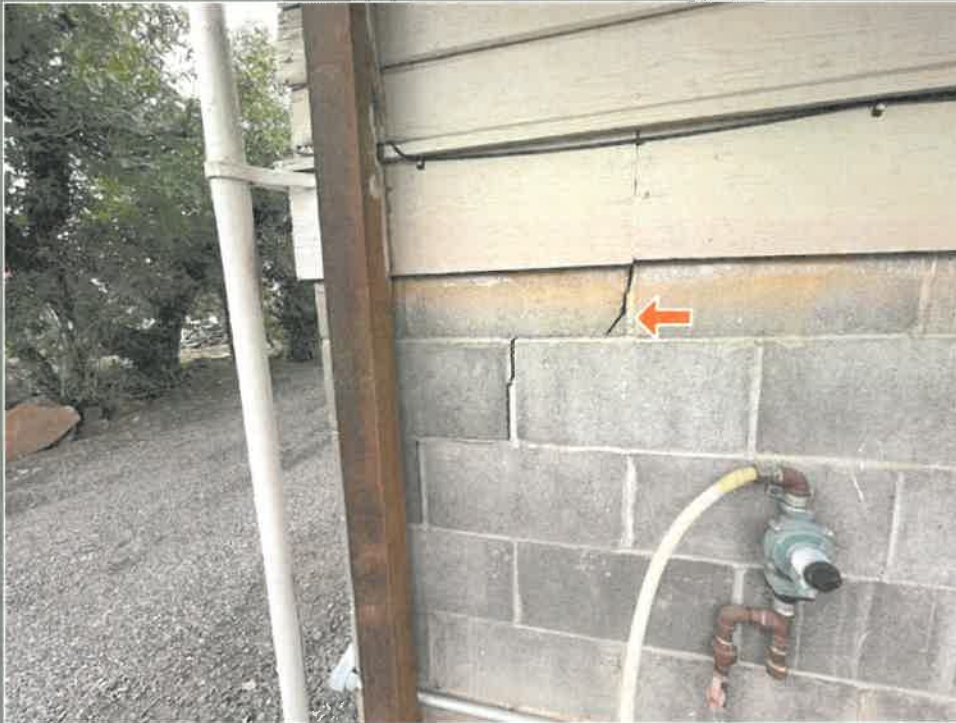
A. Item 8(Picture)

(3) The foundation for the addition had exposed footing. This indicates the foundation is not set below frost line. Another factor that can cause building foundation distress is frost heave. Frost heave can lift the foundation causing cracking and settlement issues. The footing should be placed below frost line for the area by a licensed foundation contractor. Lastly it is evident the footing design does not consider soil conditions or wind loading on the building due to the thickness of the footing.
